CR182 – Hypermotard Technical Updates
 Hypermotard 950 Model Year 2019-2020
 Hypermotard 950 SP Model Year 2019-2020
 Technical Service Bulletin SRV-TSB-19-010

The ongoing product quality tests have revealed the need for some minor technical updates on the motorcycles involved in this Workshop Campaign.

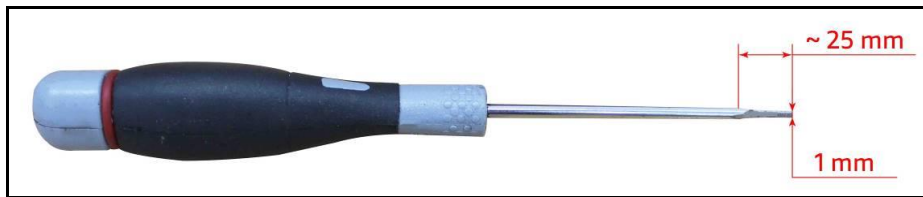
8. To remove the pins from the connector, we recommend using a 1 mm thick, approx. 25 mm long flat screwdriver as shown in the figure (any other tool can be used as long as the same dimensions are respected)

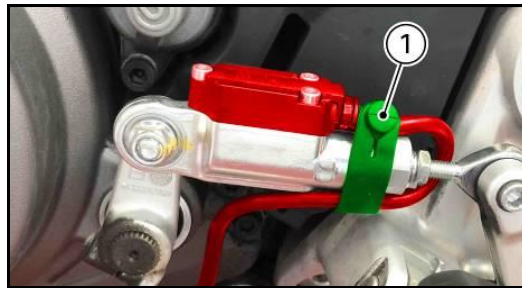
1. Fit the L.62 button **tie (1)** close to the DQS sensor as shown in the figure capturing both sensor upper and lower lengths of the cable

On all Hypermotard 950 Standard version bikes with the accessory DQS sensor kit Part no.96580161B already installed, the kit installation must be updated by following the instructions below

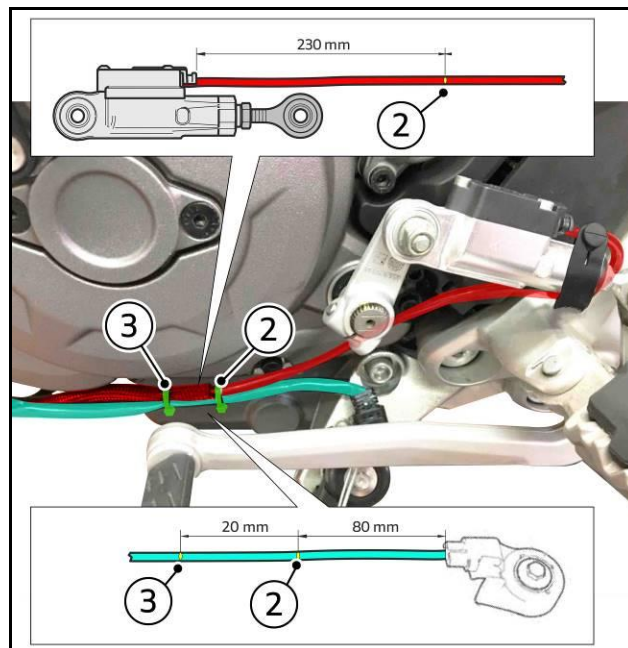
2. Fit the self-locking **ties (2)** and **(3)** in the positions shown in the figure
