SUBJECT: **Customer Satisfaction Program 19B27 – Supplement #1**
 Certain 2019 Model Year F-Super Duty Vehicles
 Uncured Power Steering Hoses

Customer Satisfaction Program 19B27 – Supplement #1
Certain 2019 Model Year F-Super Duty Vehicles
Uncured Power Steering Hoses

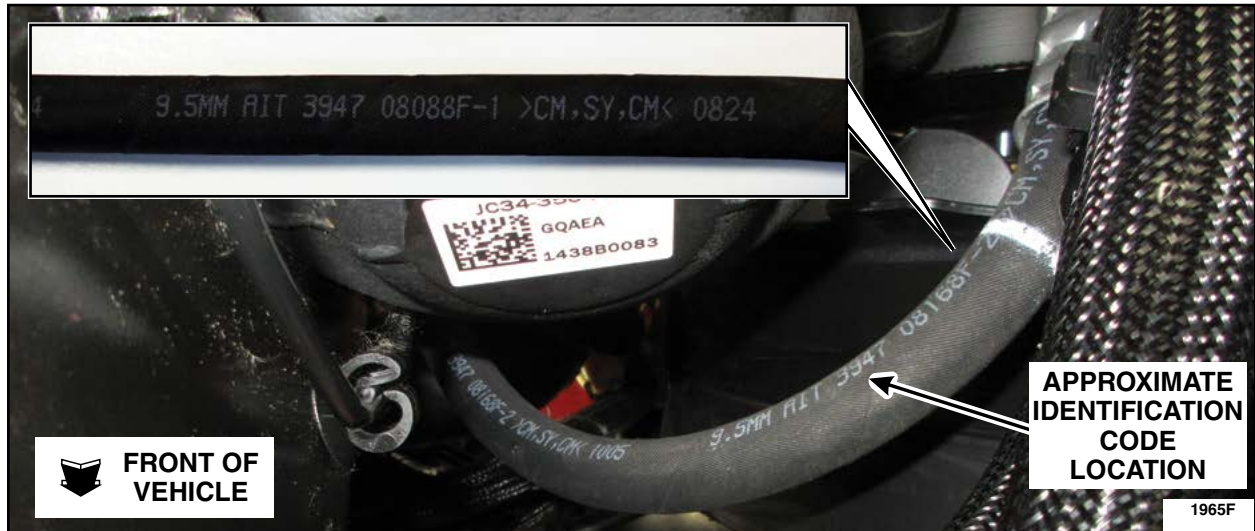
FIGURE 6

6. Locate and inspect the identification codes on the lower rubber section of the power steering pump to Hydro-Boost pressure hose. See Figure 6.

7. Is the code with 'F' at the end 01249F and is the second code equal to or between 1315-1340?

Yes - Replace the affected hose:

- For power steering pump to Hydro-Boost pressure hose. Proceed to Power Steering Pump to Hydro-Boost Pressure Hose Replacement, on Page 5.
- For Hydro-Boost to steering gear pressure hose. Proceed to Hydro-Boost to Steering Gear Pressure Hose Replacement, on Page 12.

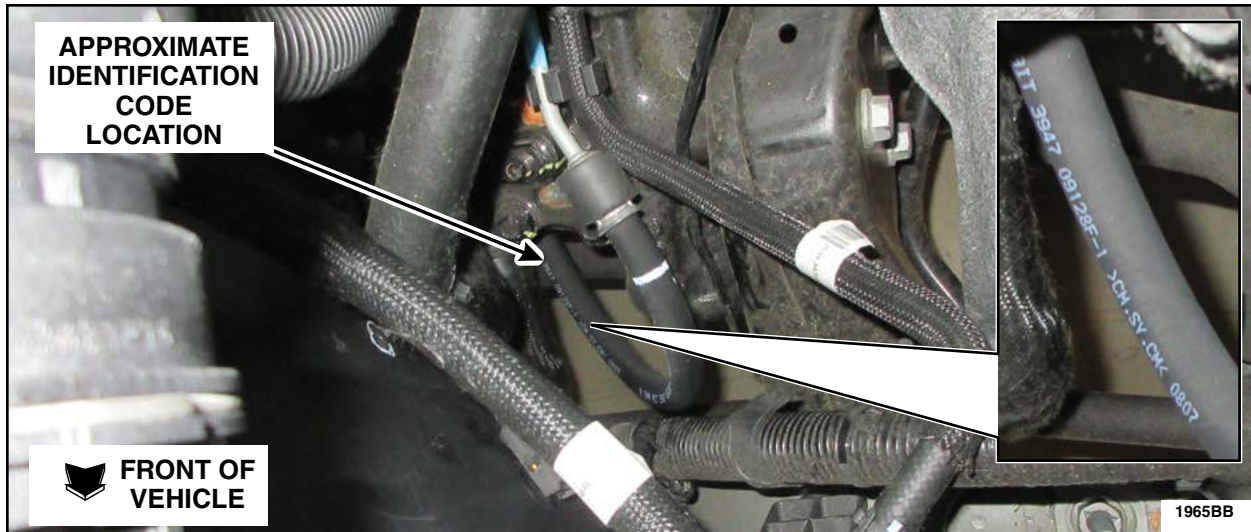
FIGURE 33

2. Inspect the identification code on the rubber section of the power steering pump to steering gear pressure hose. See Figure 33.

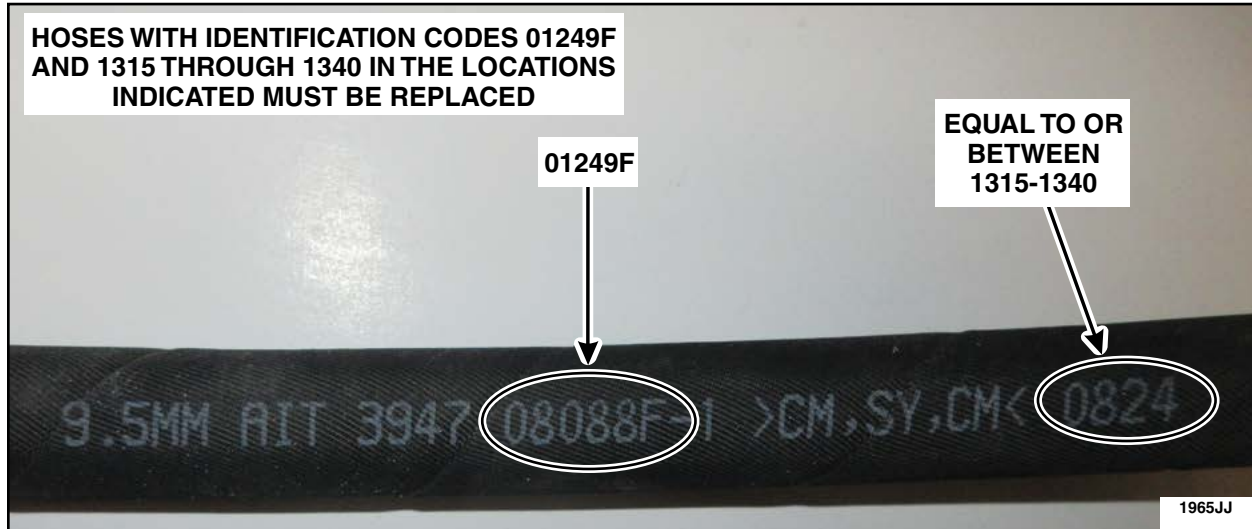
FIGURE 34

3. Compare the identification codes to the list shown below. Is the code with 'F' at the end 01249F and is the second code equal to or between 1315-1340? See Figure 34.

Yes - Proceed to Step 4.

No - Reinstall the convolute by reversing the removal procedure.
