GROUP
BOD

MODEL
2020MY
Telluride (ON)

NUMBER
193

SUBJECT: CROSS BAR KEY COVER
SERVICE PART/REPLACEMENT

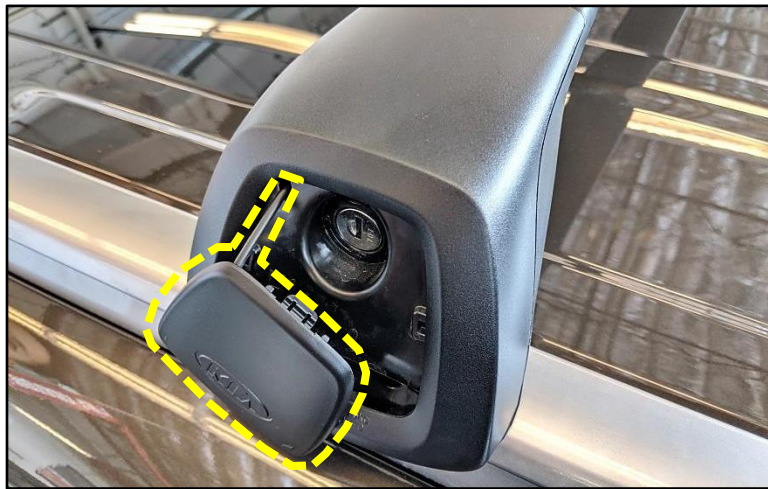
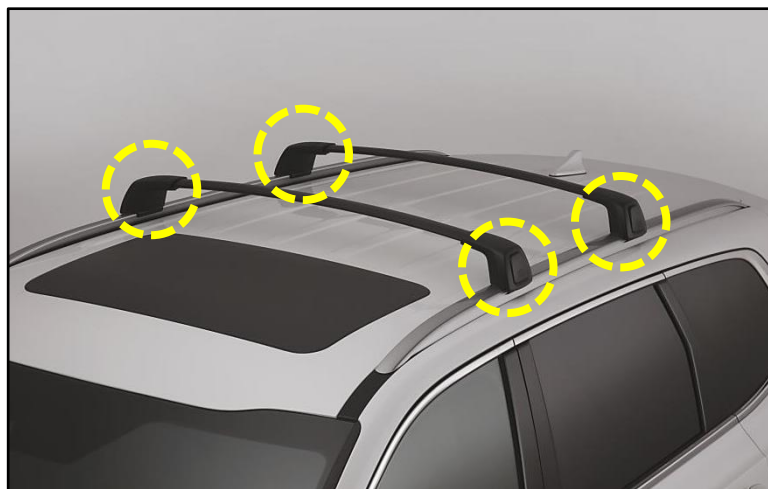
This bulletin provides the procedure to replace the roof cross bar key covers on some 2020MY Telluride (ON) vehicles, which may exhibit the cross bar key cover(s) falling off or noise while driving. Follow the procedure outlined in this bulletin to replace the four (4) cross bar key covers.

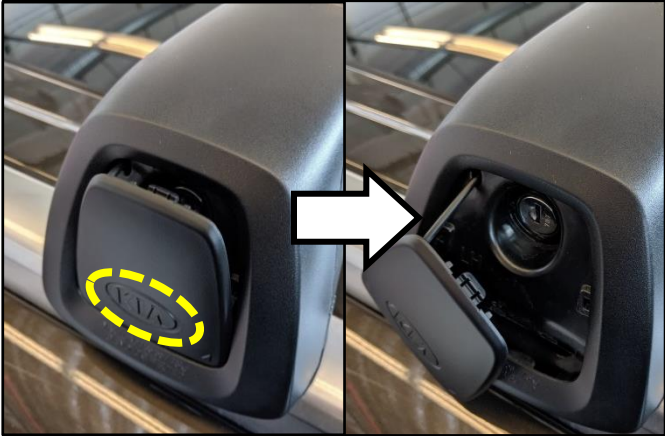
1. Release the four (4) roof cross bar key cover(s) by pressing down on the "Kia" logo at the bottom of the cover(s).

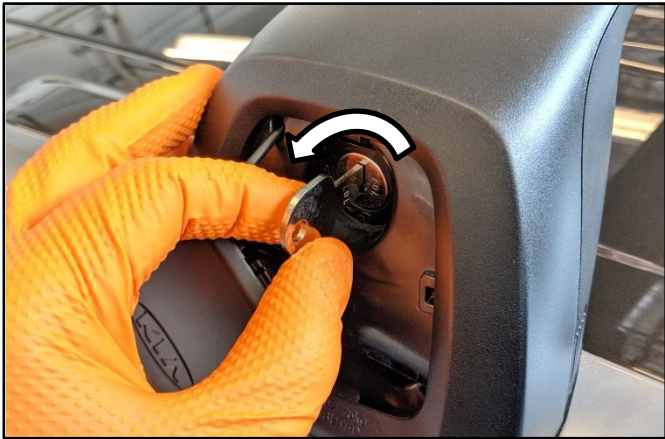
2. Using the supplied accessory key, unlock the four (4) cross bar end covers from both front and rear crossbars.

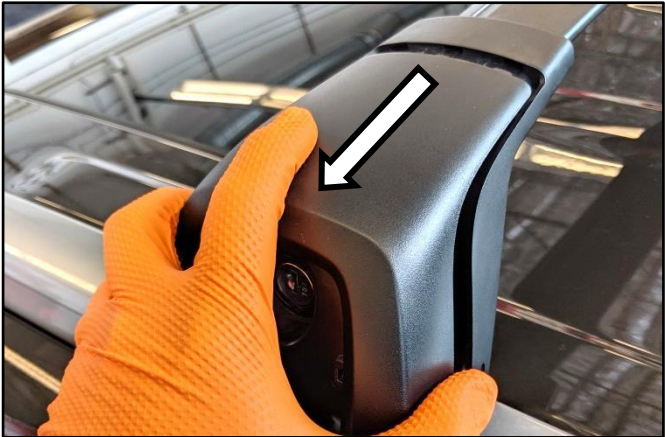
3. Remove all four (4) cross bar end caps.

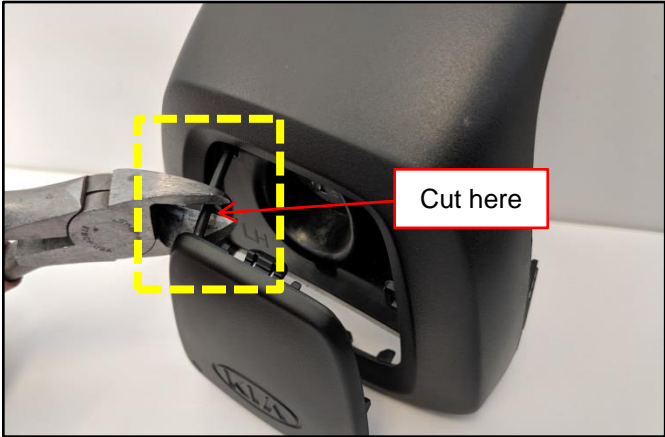
5. Place the removed cross bar end cap(s) on a table and cut off the plastic tether from the key covers using a set of side cutters.

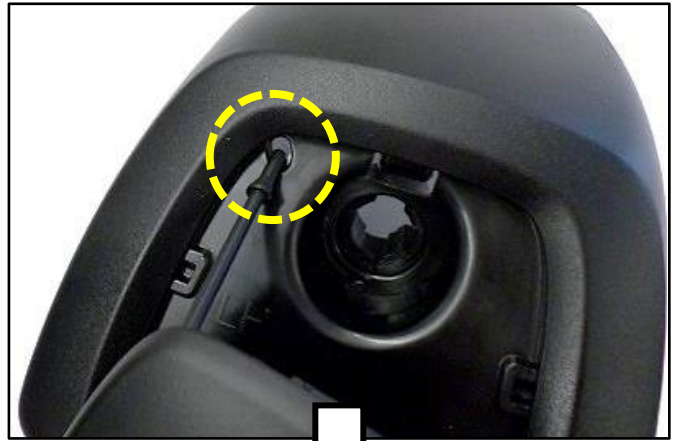
- 6a. Take the new updated cross bar key cover and feed the attached tether in through the front upper left hand hole of the cross bar end cap.

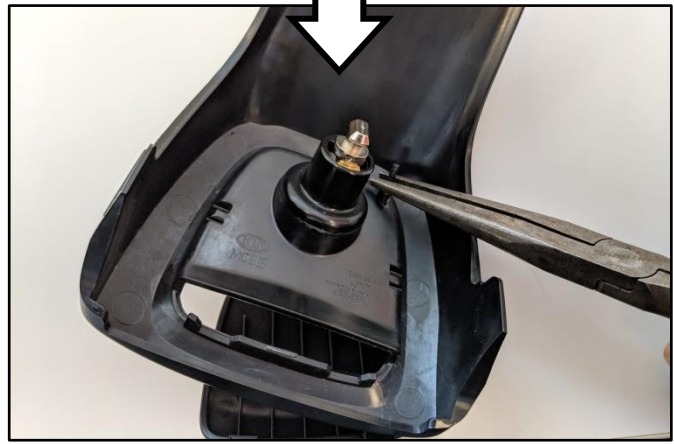
- 6b. On the reverse side of the cross bar end cap, pull the key cover plastic tether through the hole using a set of pliers to retain the key cover to the end cap.

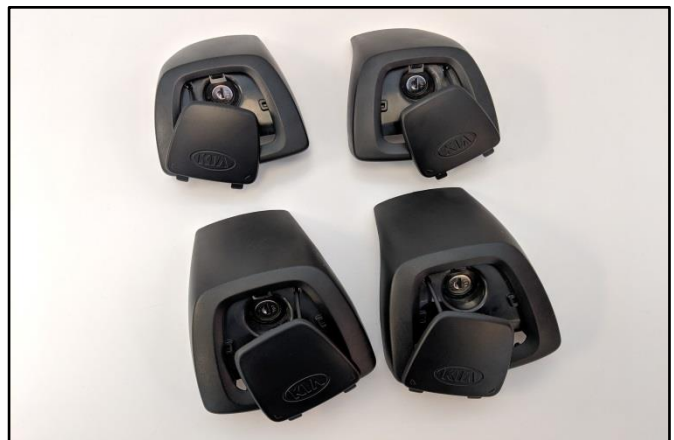
7. Repeat steps 6a through 6b to install the remaining cross bar key covers.

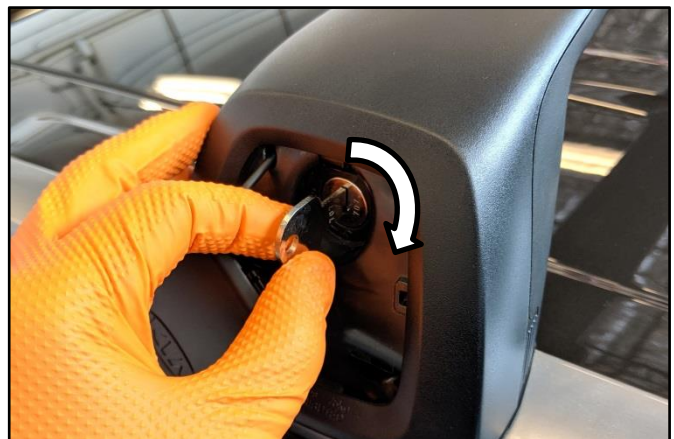
8. Reinstall the four (4) end caps onto the roof cross bars in the reverse order of removal. Ensure to lock all four (4) of the end caps with key.

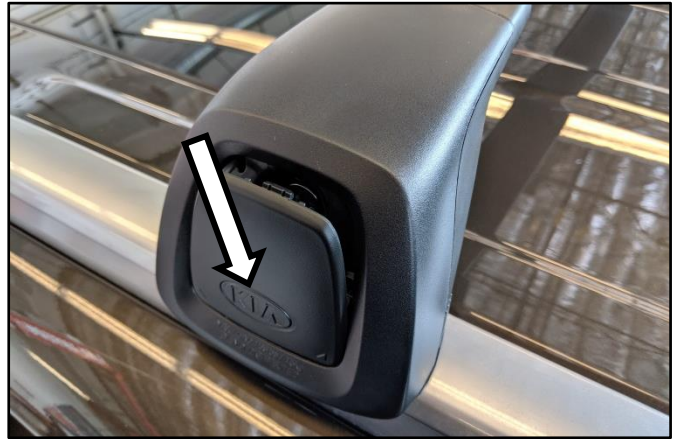
9. Insert the bottom of the key cover into the cross bar end cap.

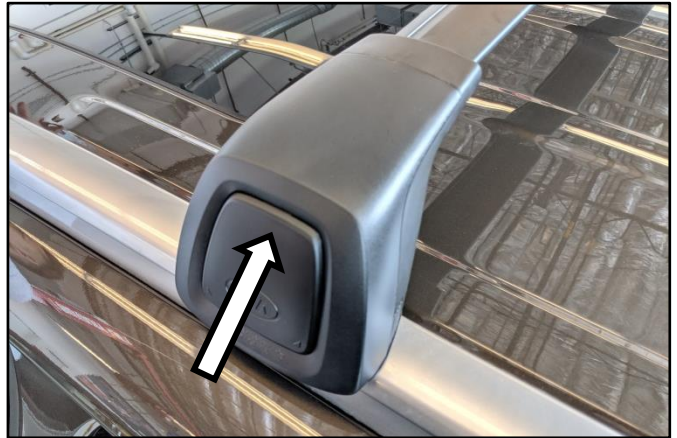
10. Push the top of the key cover to secure the cover to the cross bar end cap.
