SERVICE BULLETIN

Classification: EL18-035a	Reference: NTB19-004a	Date: November 1, 2019
------------------------------	--------------------------	---------------------------

2015-2019 MURANO AND 2016-2019 TITAN; CLIMATE CONTROLLED SEAT INOPERATIVE

APPLIED VEHICLES: 2015-2019 Murano (Z52)
2016-2019 Titan (A61)
APPLIED SYSTEM: Climate Controlled Seats Only

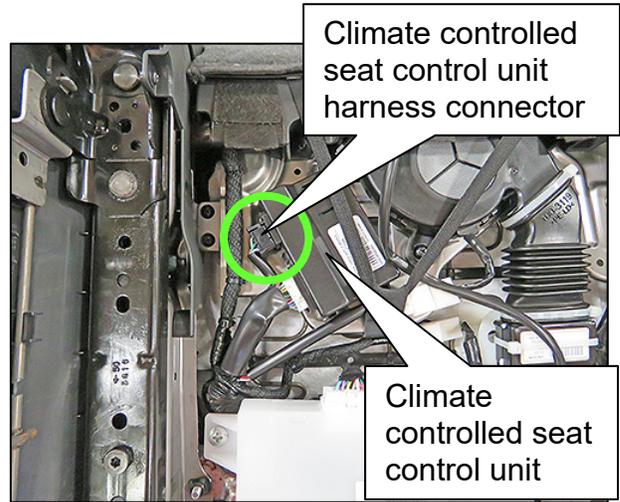
Figure 1

7. Disconnect the **black** climate controlled seat control unit harness connector from the control unit.
8. Visually inspect the harness connector and control unit near the terminals.

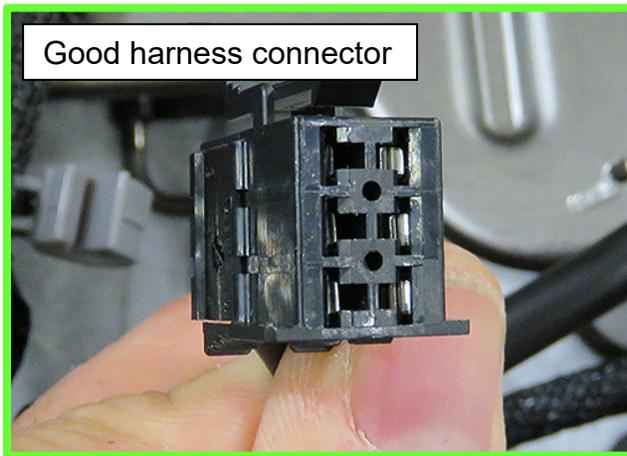
- If the harness connector or the control unit appears similar to Figure 3 and/or Figure 5 (**NG**), proceed to step 9.
- If the harness connector and the control unit appear similar to Figure 2 **and** Figure 4 (**Good harness and connector**), this bulletin does not apply. Refer to the ESM for additional diagnostic information.

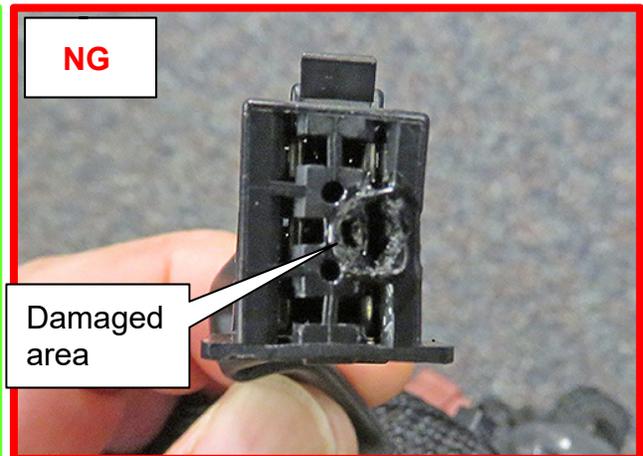
- The harness connector or control unit of the climate controlled seat appears as shown in Figure 3 or Figure 5.

- A. Replace the climate controlled seat control unit.
- B. Drill a hole for the new harness clip.
- C. Replace the harness connector of the climate controlled seat control unit.

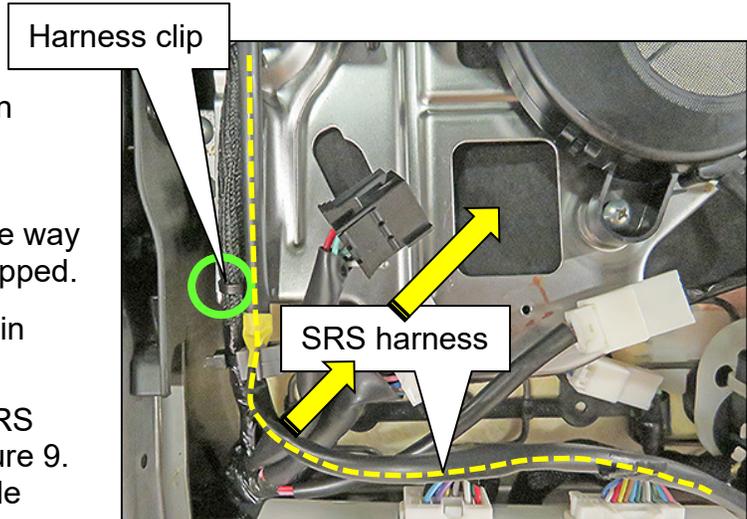
NOTE: Not all seats have the SRS harness routed as shown in Figure 9. Figure 10 shows another possible routing on a different seat.

12. Detach the harness clip shown in Figure 9 from the seat frame.
13. Move the SRS harness out of the way for the following steps, if so equipped.
 - Shown highlighted in yellow in Figure 9.

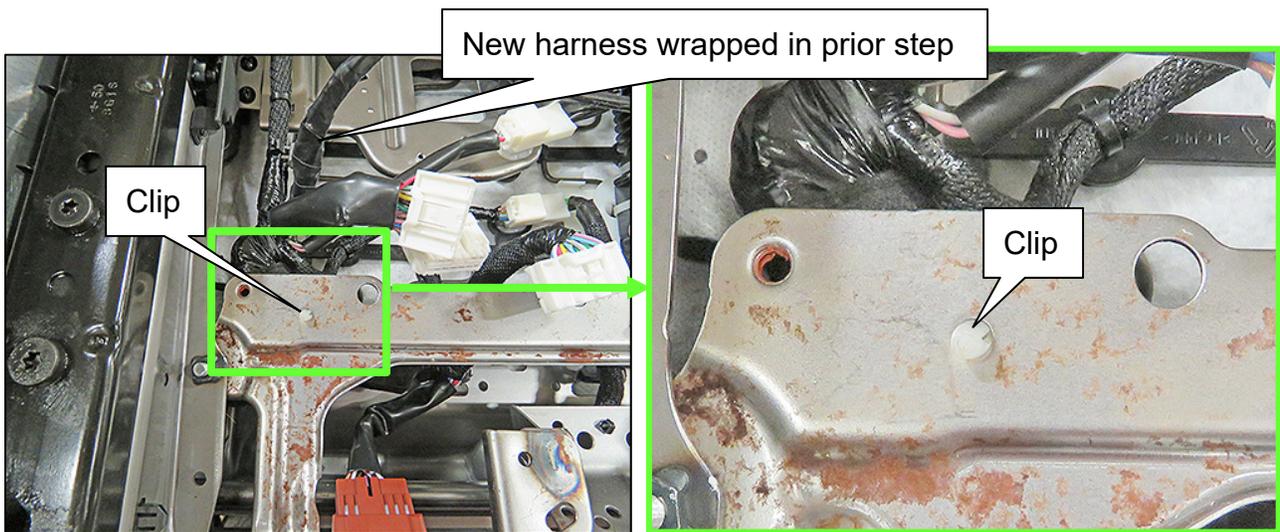
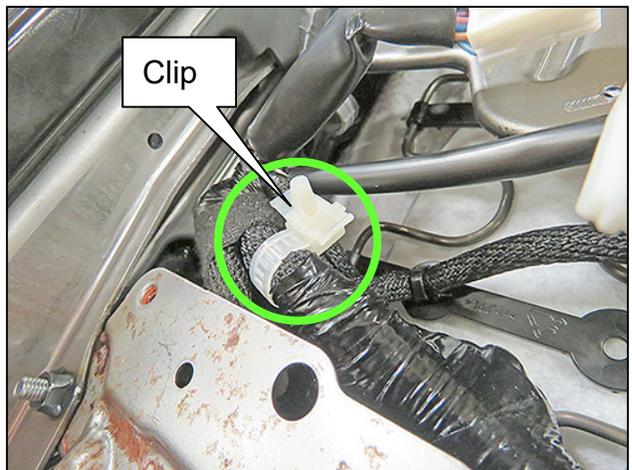
- Clip shown detached from seat frame in Figure 25.

32. Detach the “white harness clip” (clip) from the seat frame. See Figure 24 and Figure 25.

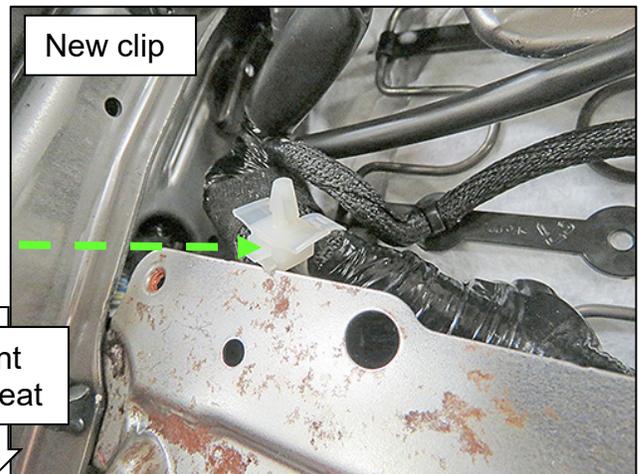
Figure 26

NOTE: On most vehicles this will change the orientation of the new clip 180° relative to the position of the old clip. See Figure 26.

34. Install the new clip onto the harness in the position shown in Figure 26.

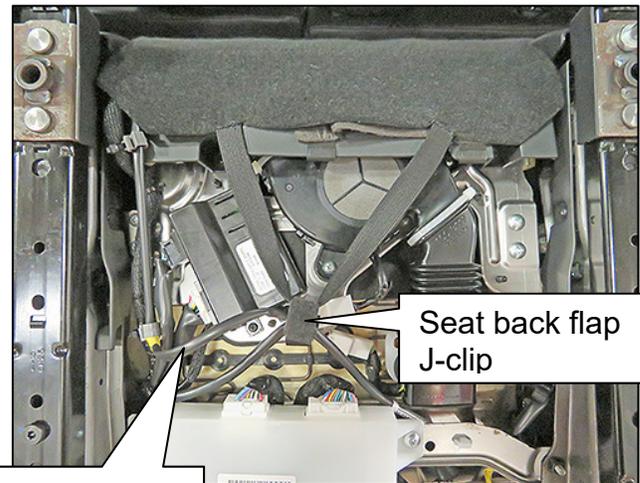
Figure 32

SRS harness

44. Relocate the SRS harness (if so equipped) back to its original position.
