# NON COMPLIANCE RECALL

**Mack Trucks Inc.**  
Greensboro, NC USA

| Date | Number | Release | Page |
|---|---|---|---|
| 11.2019 | EC0022C | 01 | 1(16) |

## **Analysis & SCR Hardware Replacement, 11L - 1 box AN, CX, GR, GU.**

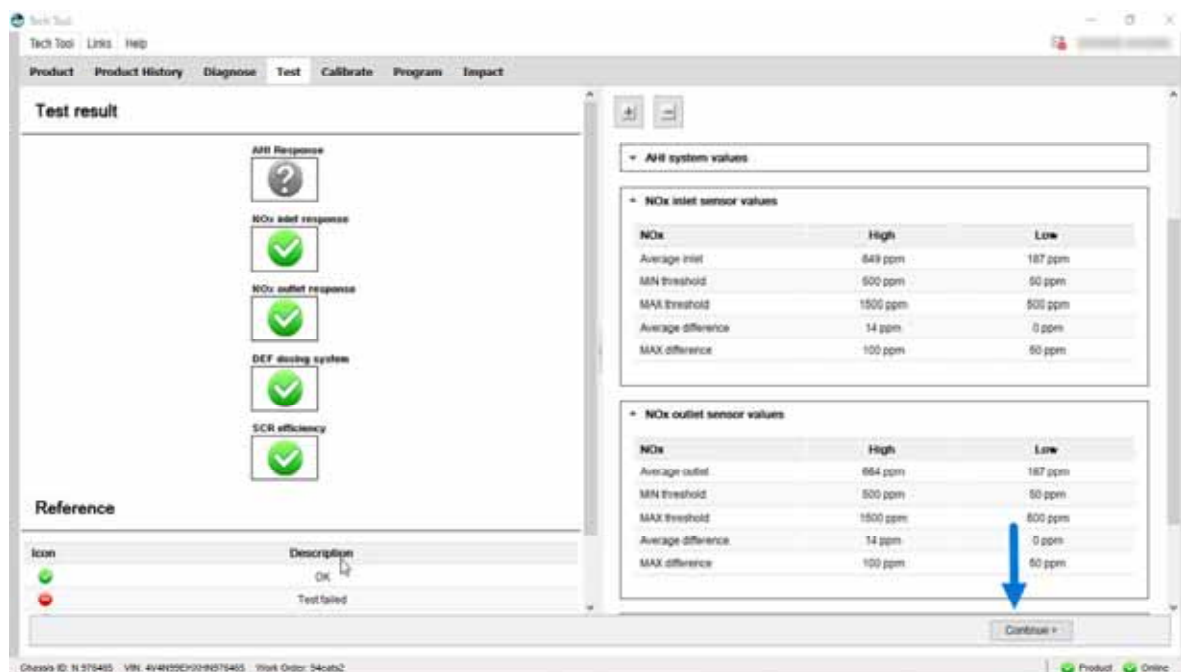
Wait for test to go through all phases of the operation. Note the blue indicator on the right will move through each phase.

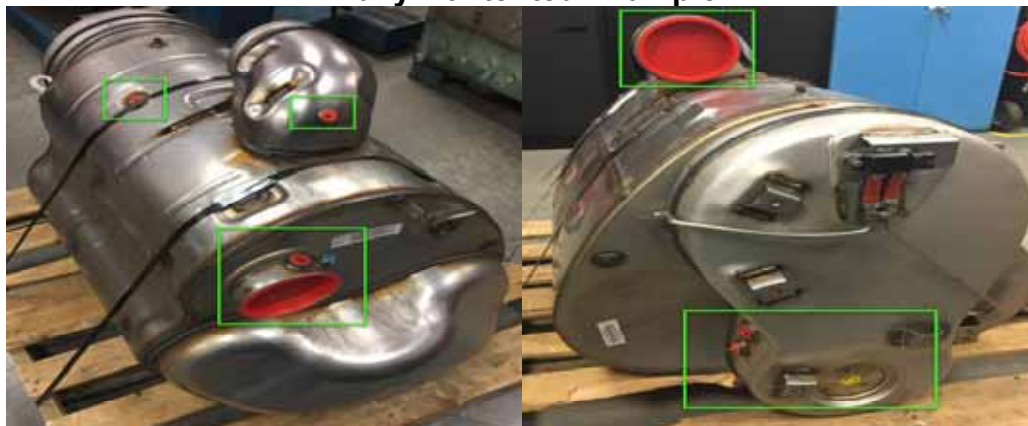
### Fully Contented Example

- 25. Ensure all plugs and caps supplied with the new SCR are reused and installed on returned part. Securely band SCR to Pallet.

| NOTE |
|---|
| All SCR openings must be sealed to eliminate contamination. If plugs and caps are damaged use water proof tape to cover the openings. |
