Technical Journal

Yellow stains at rear bumper and D-pillar

REF NO: TJ 35161.1.0	ISSUING DEPARTMENT: Technical Service	CAR MARKET: United States and Canada	
PARTNER: 3 US 7510 Volvo Car USA		ISSUE DATE: 2019-10-08	STATUS DATE: 2019-10-15
FUNC GROUP: 8612	FUNC DESC: Bumper, rear	Page 1 of 3

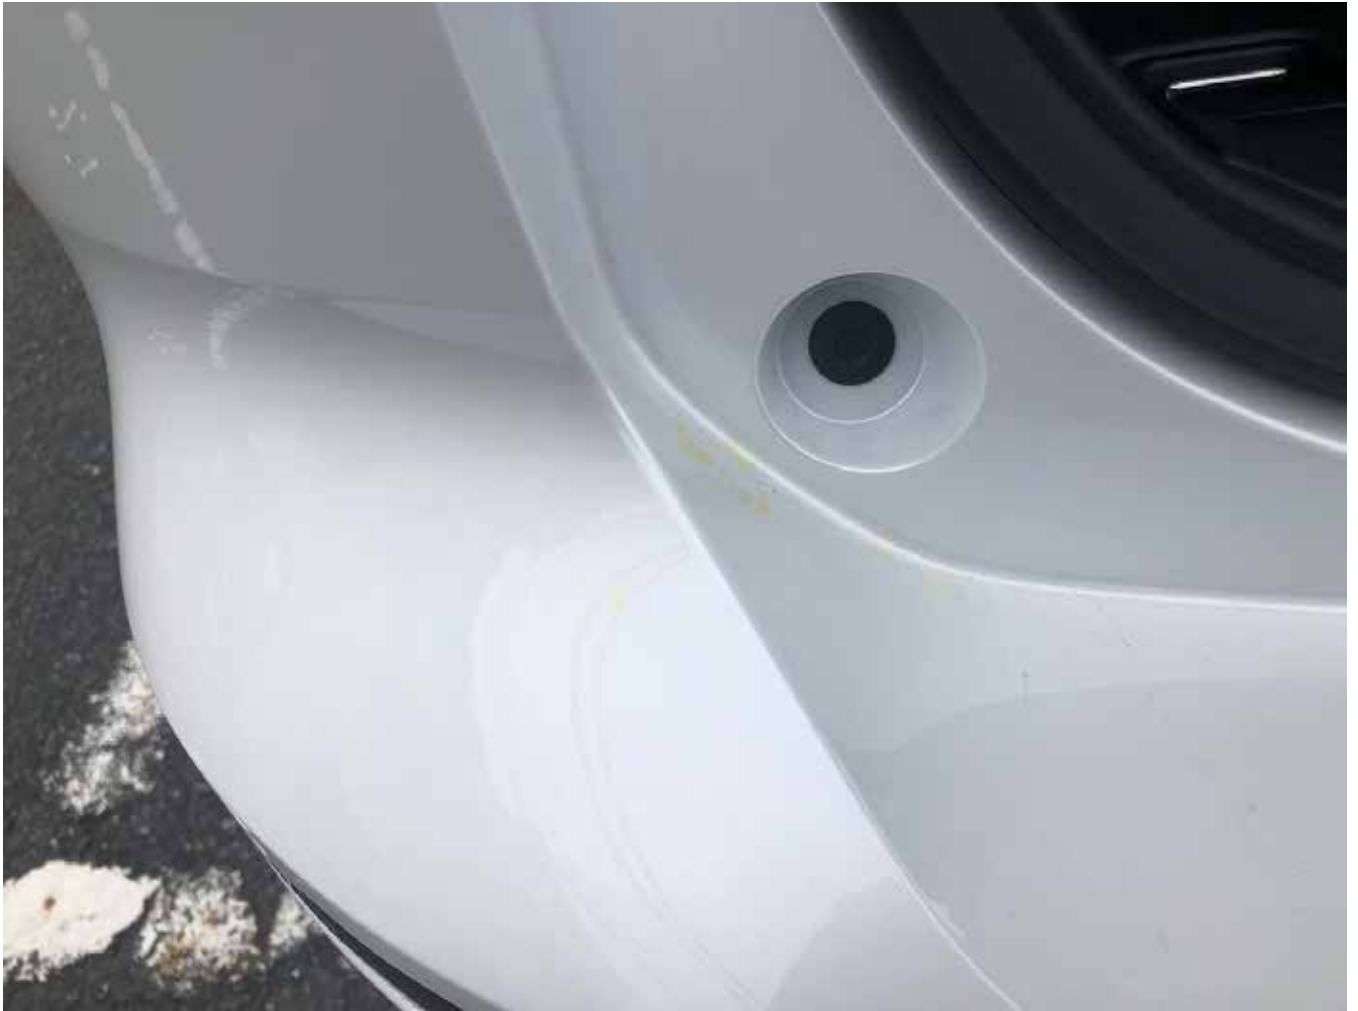
File Name	File Size
Yellow stain.jpg	0.1588 MB

If vehicle shows symptom to have yellow stains on rear bumper or D-pillar follow advice under “service”. See attachment for yellow stains

Only cars with power operated tailgate is affected, VDN L702.

Use clean hot water (90-95 degrees Celsius / 195 - 204 degrees Fahrenheit) and keep pouring over the yellow stains until the stains disappear (from 30 seconds up to 3 minutes).

Don't use a cloth or similar to wipe of the stains, just pouring water will remove them.

Note! Be careful due to the heat of water.
