Type: Satisfaction Campaign

Title: Sensor Protection Cap Install

Applicability: MY20 Revero GT Demos

The throttle body sensor connector under the engine cover has been issued a protective cap. The cap will prevent a sagging engine cover and protect the wiring. This applies to the vehicles listed below.

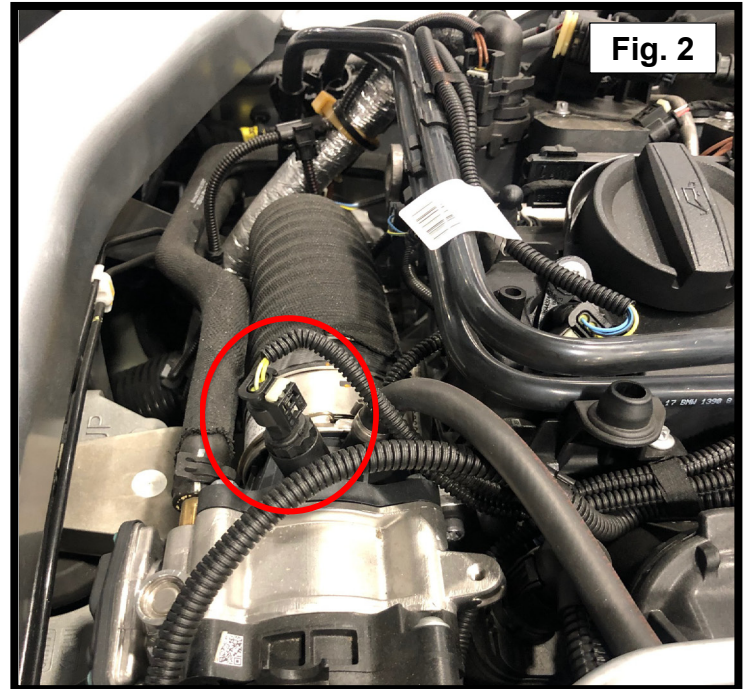
1. Open the hood, remove the engine cover.
Locate the connector indicated below (Fig. 2).

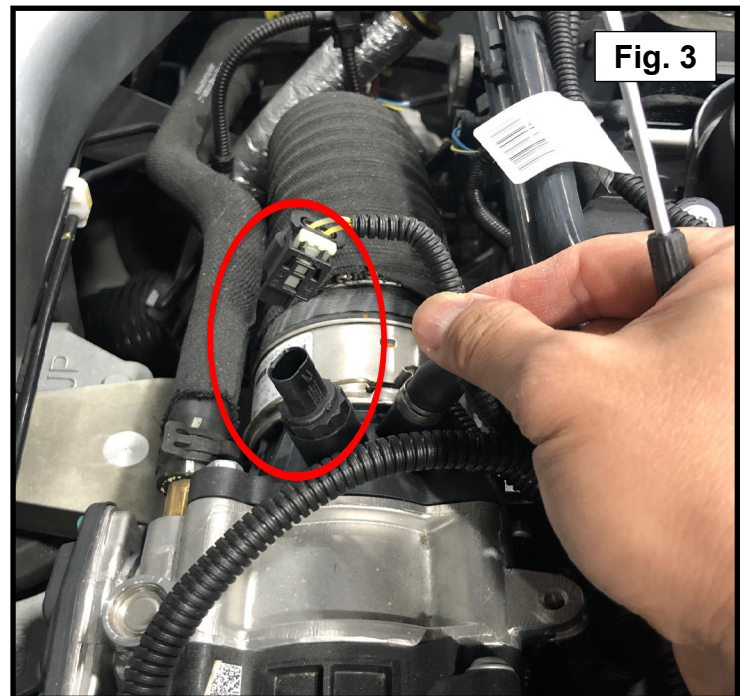
3. Remove the connector- pull up the white tab and
remove connector (Fig. 3).

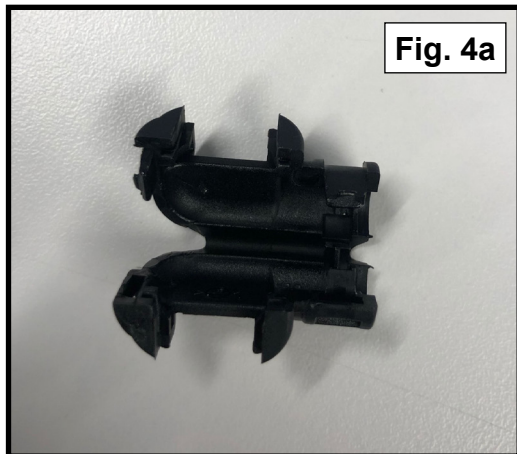
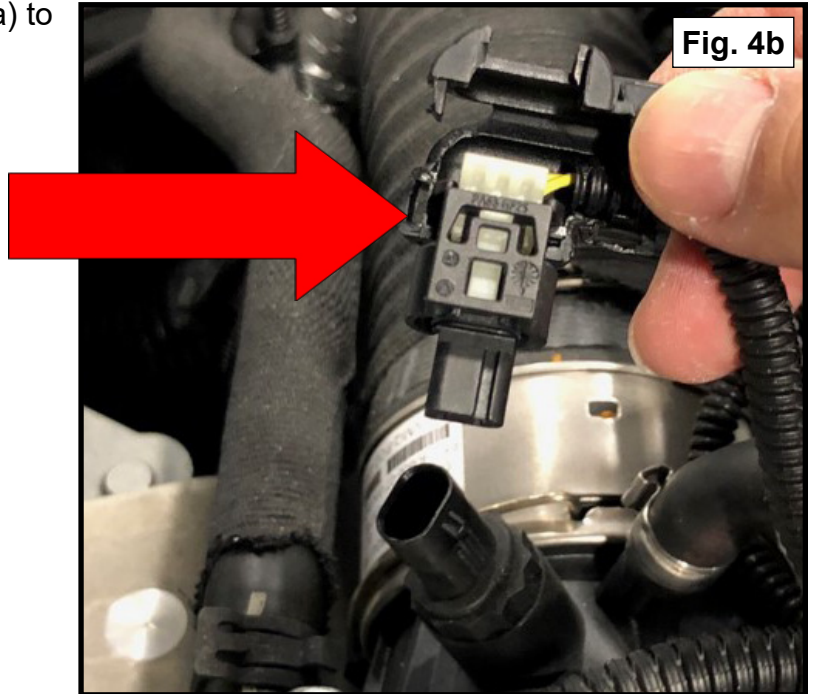
4. Add the protection cap (shown below Fig. 4a) to the connector (Fig. 4b). This clips around the connector in a clam-shell fashion.

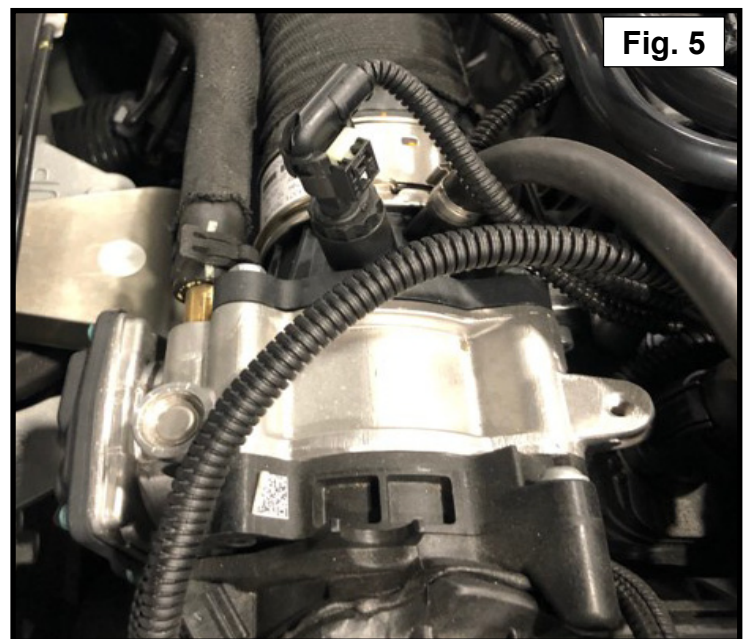
5. Connect this back to the sensor and push down the white tab. (Fig. 5). Reinstall the engine cover.
