# GRAND DESIGN TSB 19-005 HAPPIJAC® HINGE ISSUE

| TSB Number: | 19-005 | | |
| Product: | HappiJac® Bed Lift | | |

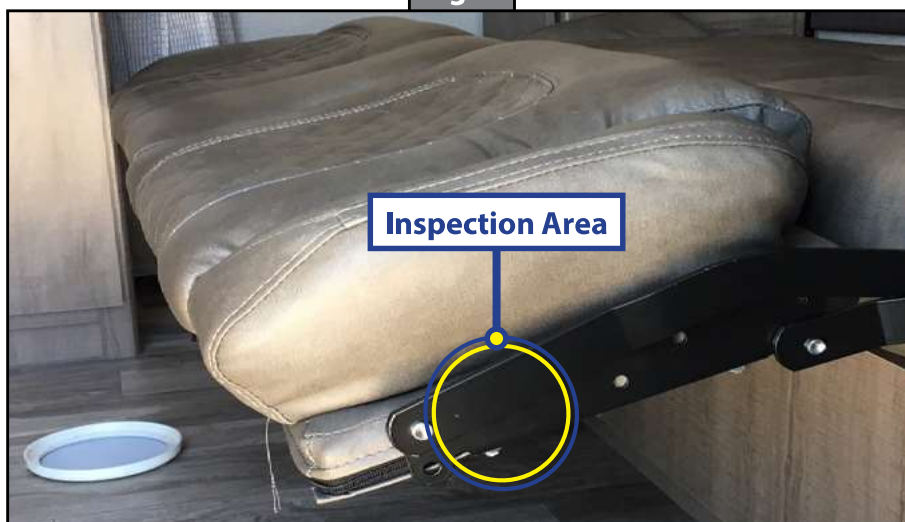
Fig. 1

The purpose of this document is to inspect and install, if missing, the stop bolts in the backrest portion of the convertible sofa/bed system installed on HappiJac Bed Lifts. Backrests missing these stop bolts may sag past horizontal when in the bed position (Fig. 1).

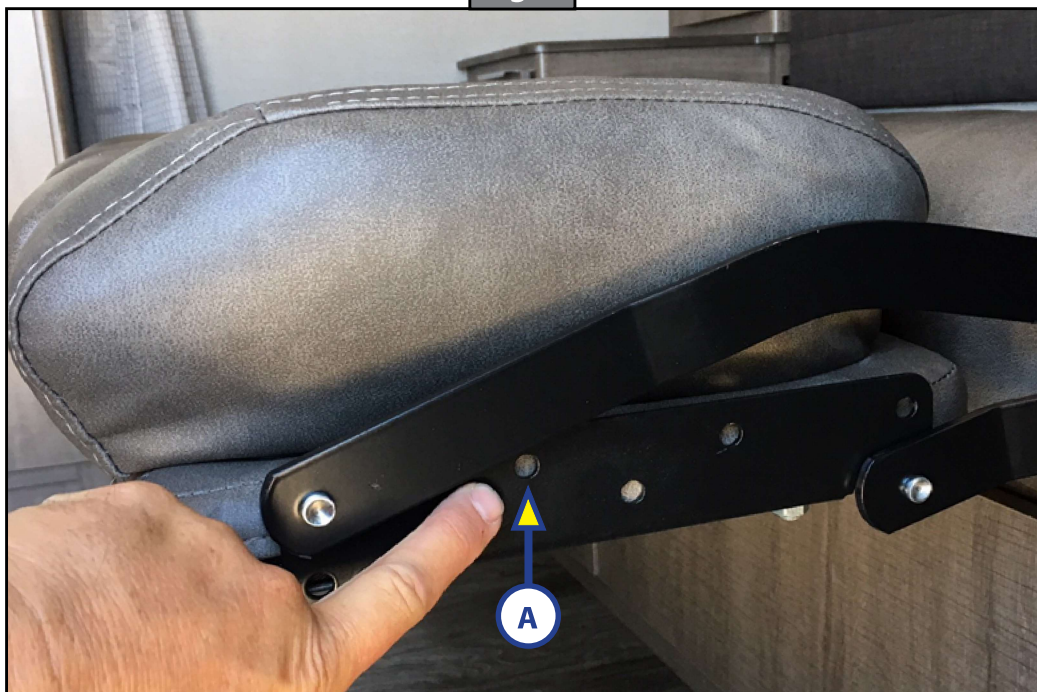
Fig. 2

Check both brackets securing the backrest for stop bolts. The stop bolts should be in the hole closest to the outside hinge when the system is in the bed position (Fig. 2A). If no stop bolts are found, go to Installation Instructions section.
