# Service Action

## Code: 60E2

**Subject** Front Sunroof Drain Cleaning & Modification

**Problem Description** In some sunroof-equipped vehicles, the front sunroof drains can become blocked with moist debris. If this happens, water could leak into the passenger compartment.

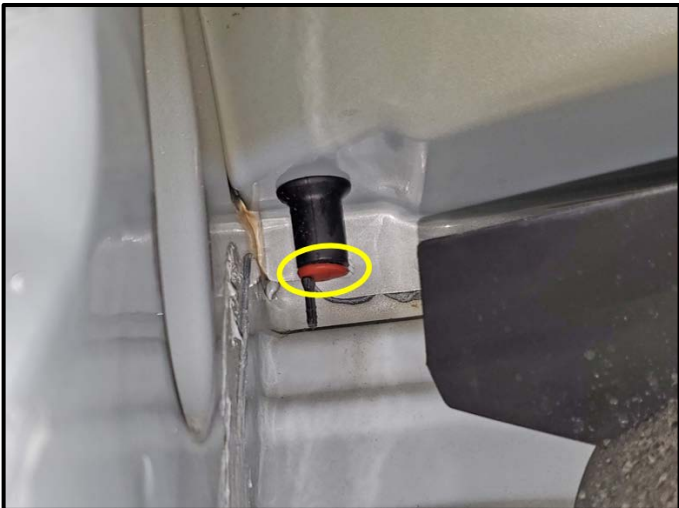
- Remove flaps from left front and right front sunroof drains.

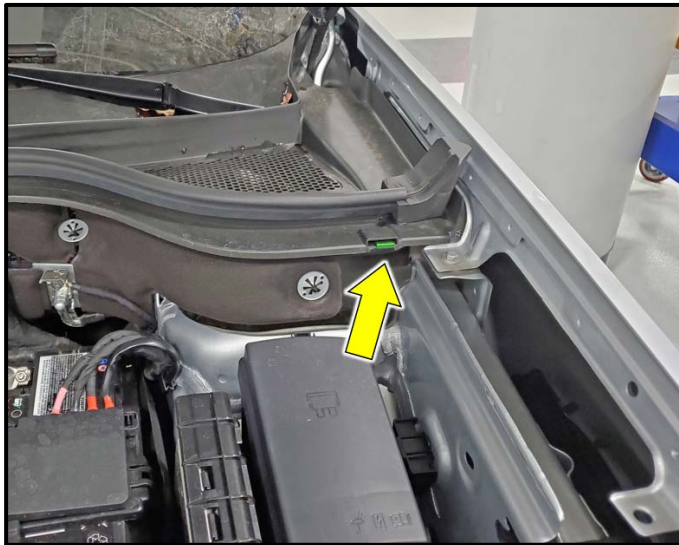
- Remove the outer most plenum chamber cover clip <arrow> on the left and right plenum chamber covers.

Left side shown. Procedure for right side is similar.

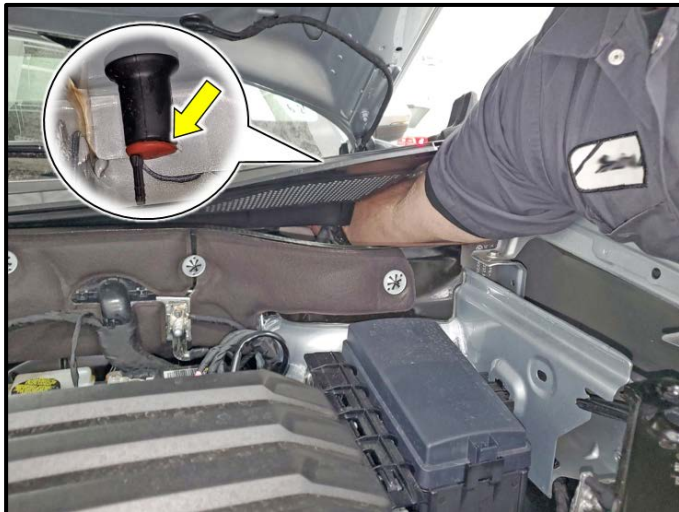
- Carefully lift the plenum chamber cover approximately 15 cm.
- Reach in along the outer edge of the plenum chamber (between the wiper transmission and the plenum chamber on the left side).
- Carefully remove the red sunroof drain flap <arrow> downward off the sunroof drain.
- Repeat on the opposite side.

When working during extreme temperatures, it is recommended that the vehicle be allowed to acclimate inside the shop to avoid temperature-related component damage/breakage. Damage to plenum chamber covers will not be covered under this action.

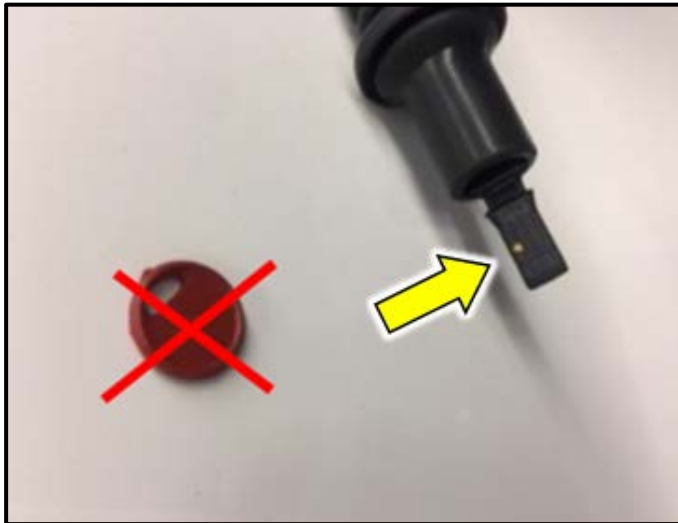
DO NOT remove the sunroof drain from the vehicle. The tab <arrow> on the sunroof drain remains on the sunroof drain. The red flap can be discarded.

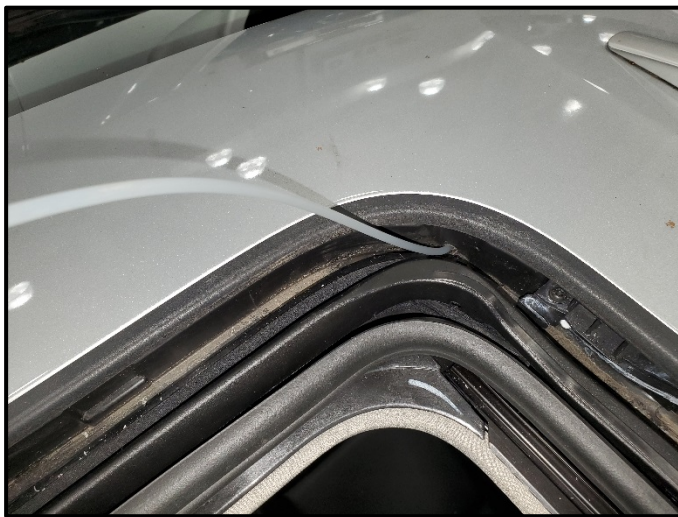
- Clean both front sunroof drains using the -VAS6620- (or equivalent).

DO NOT use extra force if resistance is encountered when using the -VAS6620-. Doing so could result in damaging the sunroof drain or disengaging the sunroof drain from the sunroof. Damage to the sunroof drain or time to reattach the sunroof drains to the sunroof will not be covered under this action.

The -VAS6620- will exit the sunroof drain tube in the plenum chamber after approximately 120 cm.

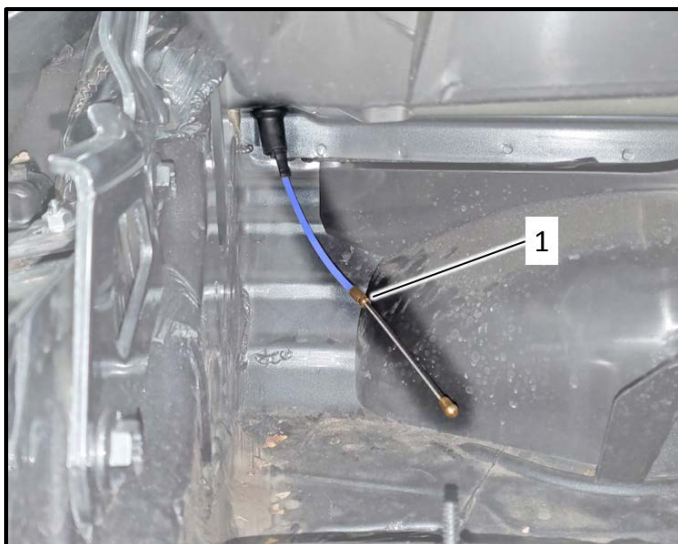
If the -VAS6620- cannot be removed out of the sunroof drain, the end of the tool <1> can be unscrewed and the tool can then be easily removed.

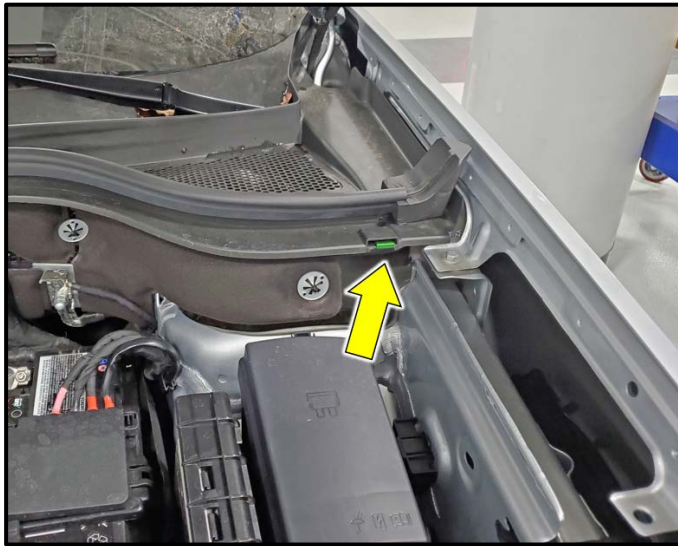
- Installation is the reverse order of removal.
- Ensure all seals are in place.
