Service Action

Code: 60E5

Subject Front Sunroof Drain Cleaning & Modification

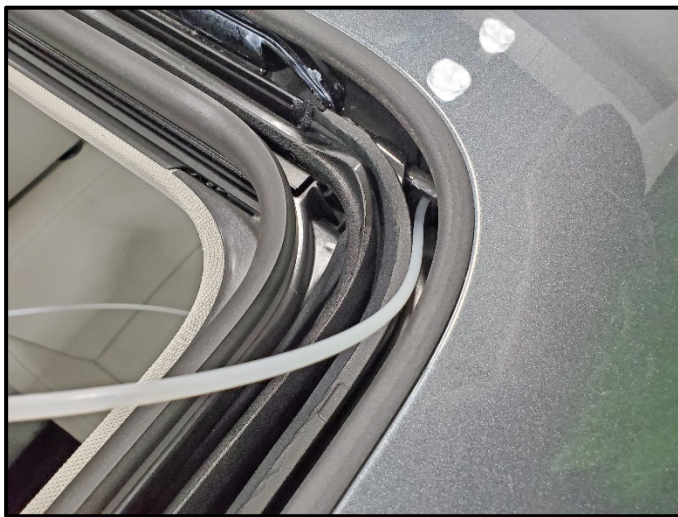
Clean the sunroof drains:

- Clean both front sunroof drains using the -VAS6620- (or equivalent).

DO NOT use extra force if resistance is encountered when using the -VAS6620-. Doing so could result in damaging the sunroof drain or disengaging the sunroof drain from the sunroof. Damage to the sunroof drain or time to reattach the sunroof drains to the sunroof will not be covered under this action.

The -VAS6620- will exit the sunroof drain tube in the plenum chamber after approximately 120 cm.

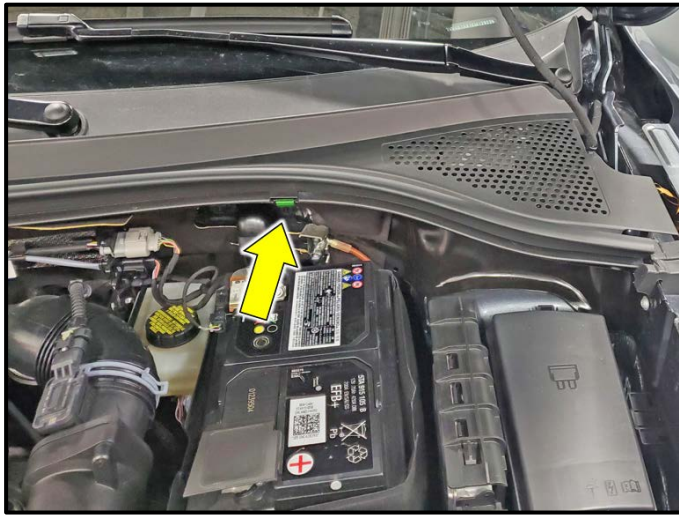
Reinstall the plenum chamber covers:

- Installation is the reverse order of removal.
- Ensure all seals are in place.
