NUMBER: 23-013-19 REV. A

Noise From A-Pillar or Floor Area During Turns or Body Movement

This bulletin involves inspecting and replacing the A-Pillar body mounts if needed.

2019	(DT)	RAM 1500 Pickup
2019	(DJ)	RAM 2500 Pickup
2019	(D2)	RAM 3500 Pickup

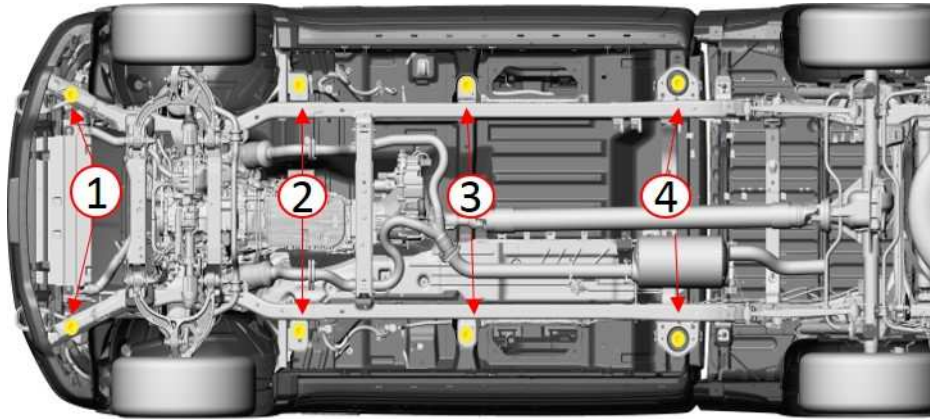
Fig. 1
Body Mount Locations

- 1 - Front Mounts
- 2 - A-Pillar Mounts
- 3 - B-Pillar Mounts
- 4 - C-Pillar Mounts

5. Remove all four (five for Mega Cab vehicles) cab mount bolts on the side that you will be working on first and **discard the old existing bolts. Do not reuse (Fig. 1)** .

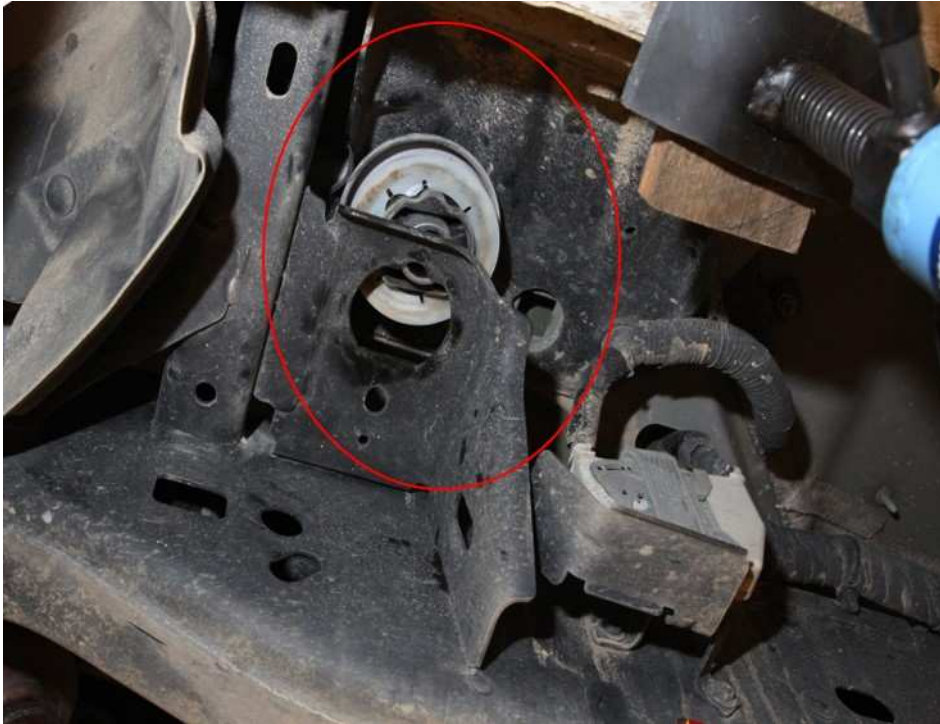
Fig. 3

Old A-Pillar Body Mount to be Discarded

7. Raise the cab of the vehicle using the jack stand supports equally and just enough to remove the A-Pillar body mount from the frame perch (Fig. 3) .

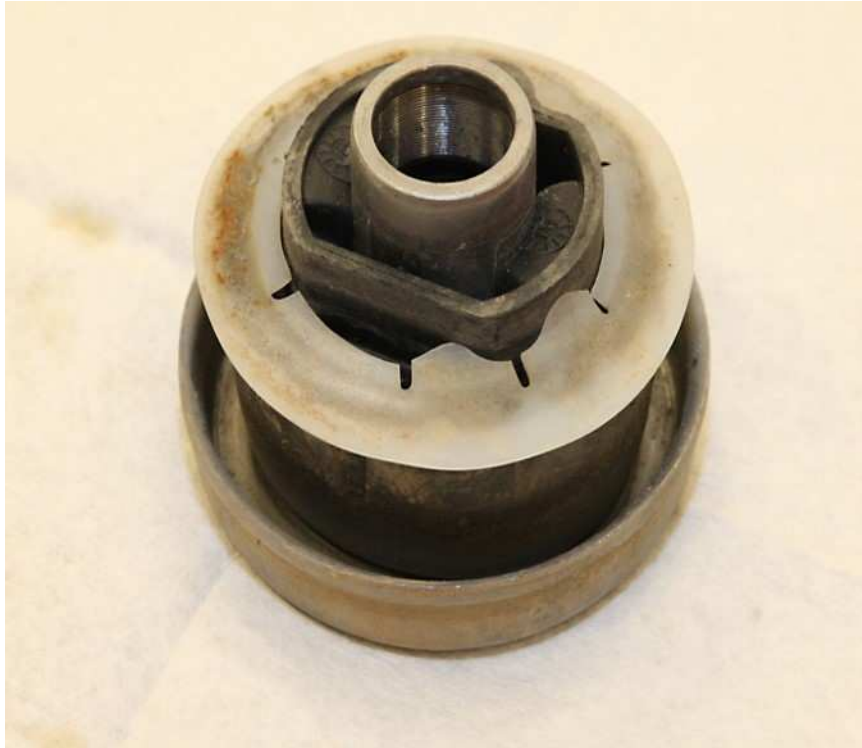
**Fig. 4
Discard Mount and Plastic Shim (DT Vehicles)**

NOTE: Discard the old mount and plastic shim (Fig. 4) (do not reuse) .

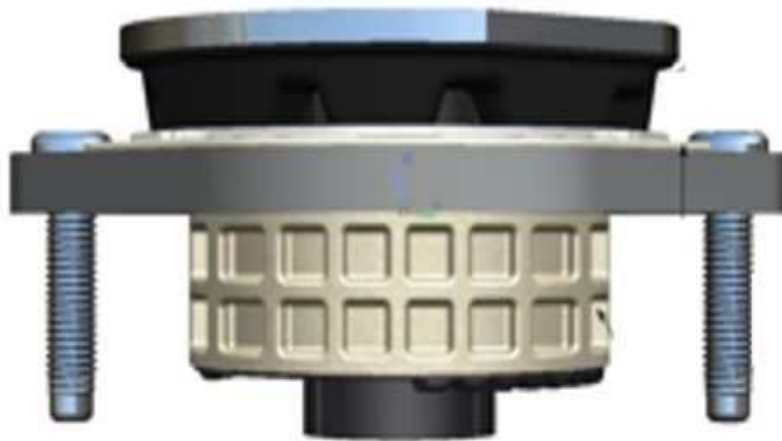
Fig. 6
New A-Pillar Body Mount (DJ & D2 Vehicles)
