Subject		Market
Body Electronics Inoperative - D/C Cut Fuse		USA
Service Category	Section	
Vehicle Interior	Meter/Gauge/Display	
Applicability		
2018-2020 LS500

2018-2020	LS500
-----------	-------

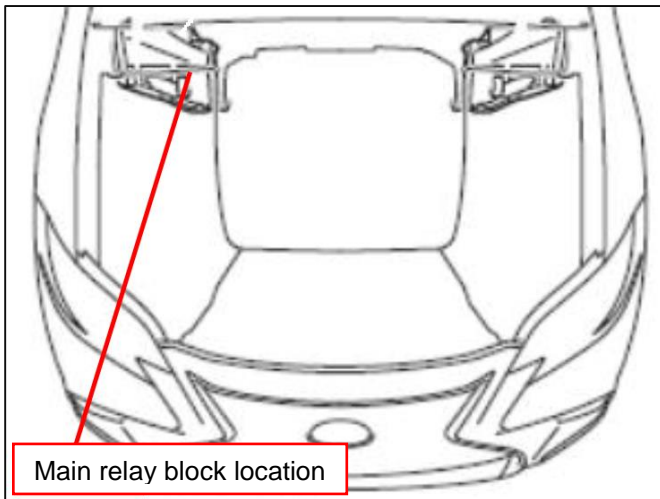
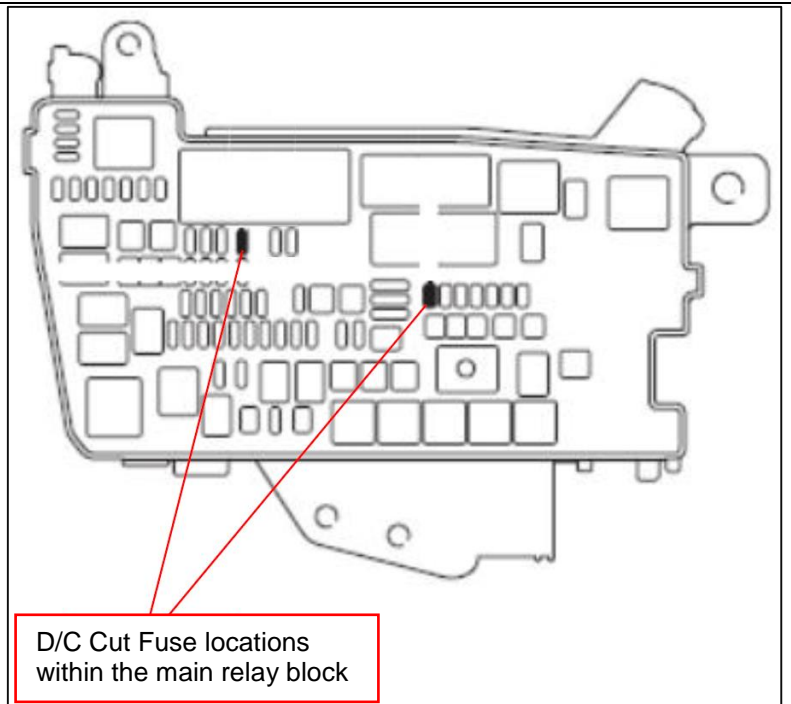
If the D/C Cut Fuses are not properly seated in the correct main relay block location, multiple body electronic systems can be affected. Some systems that may become inoperative or operate abnormally due to a loose or missing D/C Cut Fuse are listed below:

When diagnosing body electrical systems, such as the ones listed above, best practice is to confirm that the D/C Cut Fuses and other related fuses are checked for continuity, proper seating, and correct location.
