# Service Bulletin

Bulletin No.: 19-NA-255

**Subject:** Wax Coating on Frame Peeling, Metal Shows Corrosion/Rusting  
(U.S. and Canada Only)

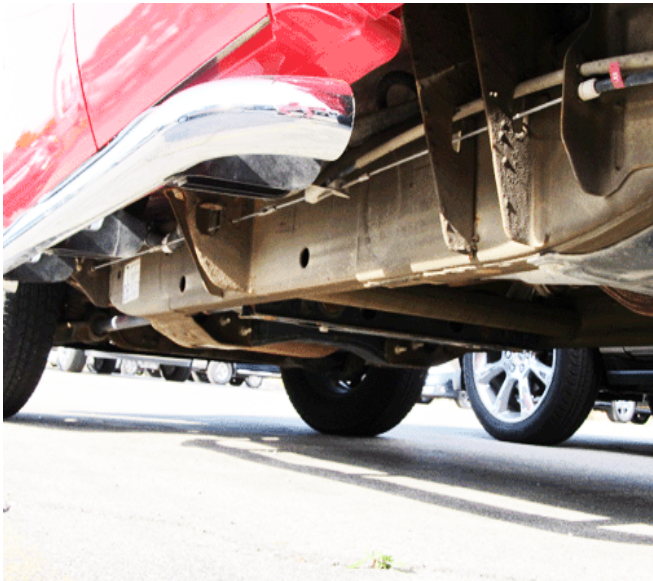
2708901

| Condition | <p>Some customers may comment that areas of the frame wax coating are peeling off and rust/corrosion is visible on the metal in these areas. Several examples of this condition are shown in each group of graphics below.</p> <p><b>Truck Example Photos</b></p> <div data-bbox="683 390 1331 966"></div> <div data-bbox="683 1010 1331 1581"></div> |

| <b>Cause</b> | The cause of this condition may be that the frame supplier may not have properly prepped the metal before the wax coating was applied. |

| <b>Correction</b> | <p><b>Note:</b> A combination of specialized metal coating products manufactured by Lloyds and Daubert have been found to be the most suitable products to provide corrosion control and protection to address this type of repair. Our recommendation is to prep the metal surface using *Lloyd's Pure Prep™ Metal Surface Preparation P/N 25418, then topcoat with both *Lloyds Kryptonite Metal Treatment P/N 36502 Life Long Rust Protection and *Daubert Non-Rust® P/N X-121B One Coat Rust Preventative Coating. It is strongly recommended they be applied according to the manufacturer's procedures.</p> <p>*We believe this source and their products to be reliable. There may be additional manufacturers of such products/materials. General Motors does not endorse, indicate any preference for, or assume any responsibility for the products or material from this firm or for any such items that may be available from other sources.</p> <p>Prep the frame and apply the Lloyds and Daubert coatings following the steps in the Service Procedure below:</p> |

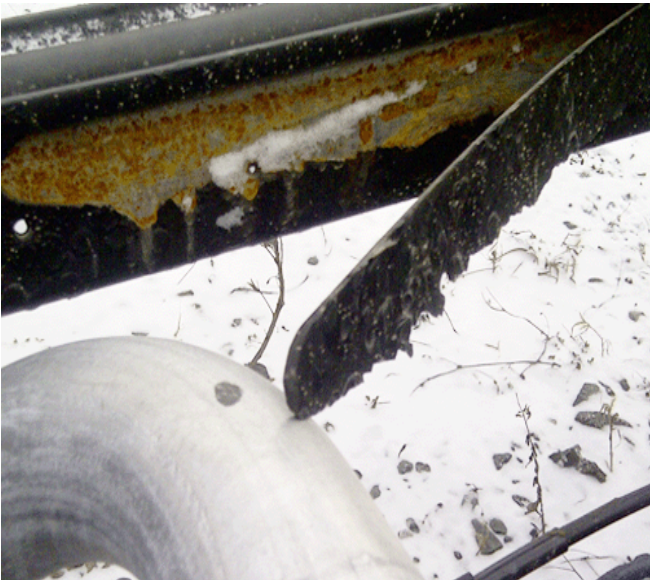
3396076

Van Example Photos

| | <div data-bbox="683 153 1333 728"> A close-up photograph of a dark metal beam. Several yellow paint markings are visible along the top edge of the beam. A black cable is attached to the beam with a metal bracket. The background is dark and out of focus.</div> <div data-bbox="1419 737 1484 758">3396078</div> <div data-bbox="683 772 1333 1348"> A close-up photograph of a metal beam, similar to the one above. A black cable is attached to the beam with a metal bracket. The surface of the beam appears to have some debris or peeling material. The background is light and out of focus.</div> <div data-bbox="1419 1356 1484 1377">3396079</div> |
