## Technical Service Bulletin

19-BD-011H

INSPECTION AND SERVICE GUIDE FOR DOOR TRIM  
REPLACEMENT

This bulletin provides information detailing the door trim replacement inspection and service guide.

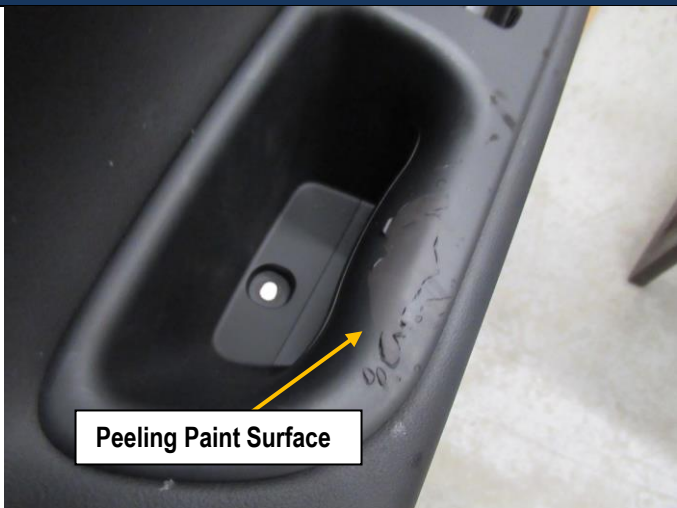
| CONDITION | PHOTO | REMARK |
|---|---|---|
| A26, A42, A25<br>Paint Peeling<br>Flaking | | <b>Inspection Method:</b><br>Inspect surfaces for flaking/peeling<br><br><b>Cause:</b><br>Door material degradation<br><br><b>Warranty:</b><br>Covered under warranty |

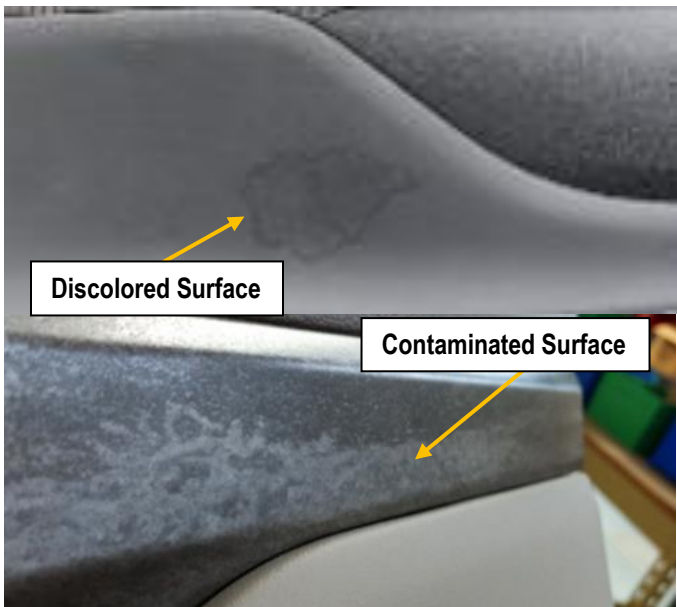
| CONDITION | PHOTO | REMARK |
|---|---|---|
| A43, A41<br>Discoloration<br>Contamination | | <b>Inspection Method:</b><br>Inspect surfaces for discoloration/contamination from foreign substances<br><br><b>Cause:</b><br>Cosmetic, liquid, cream, etc.<br><br><b>Warranty:</b><br><u>NOT</u> covered under warranty<br><br>Refer to TSB# 14-BD-001 for detailed cleaning procedures |

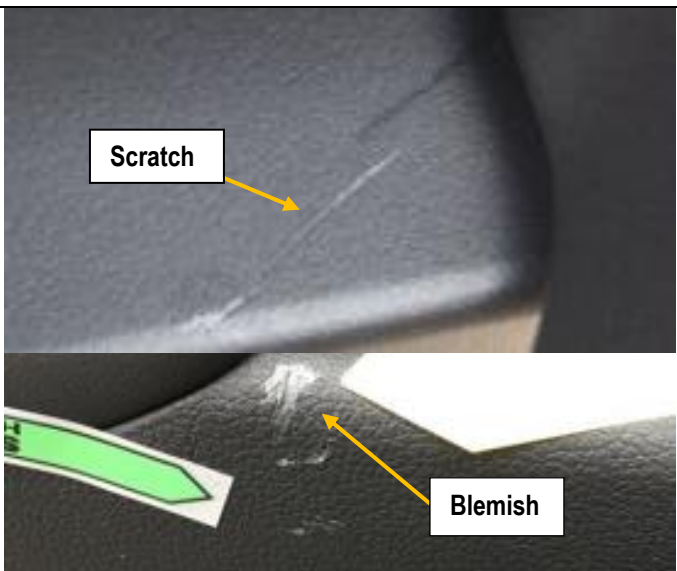
| CONDITION | PHOTO | REMARK |
|---|---|---|
| A32<br>Scratches<br>Blemishes | | <b>Inspection Method:</b><br>Inspect surfaces for scratches/blemish marks identified <b><u>after</u></b> retail delivery<br><br><b>Cause:</b><br>External wear and tear<br><br><b>Warranty:</b><br><u>NOT</u> covered under warranty |

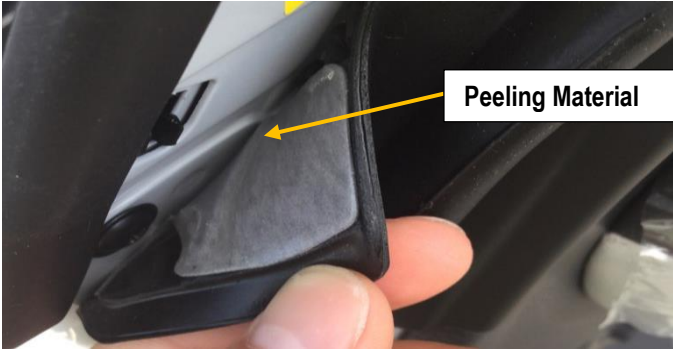
| CONDITION | PHOTO | REMARK |
|---|---|---|
| B12, B19<br>Material Pulling Apart | | <p><b>Inspection Method:</b><br/>Inspect surfaces for air pockets, detachments, or missing screws/welds</p> <p><b>Cause:</b><br/>Manufacturing</p> <p><b>Warranty:</b><br/>Covered under warranty</p> |

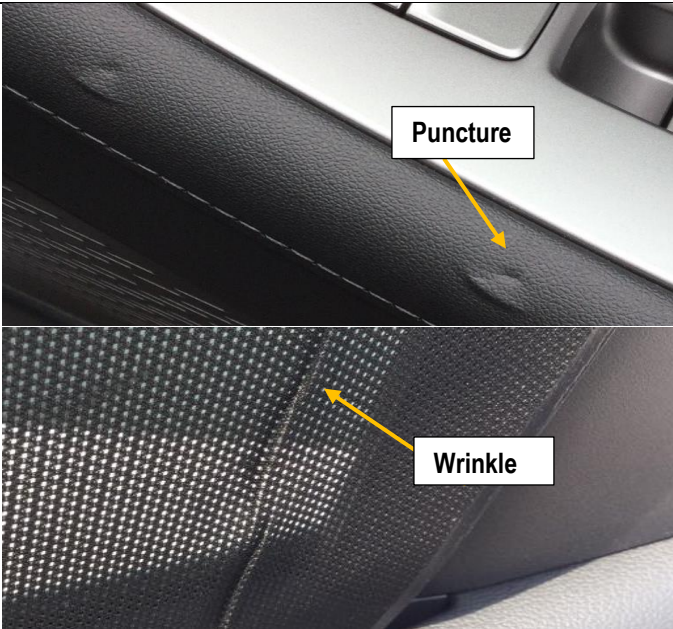
| CONDITION | PHOTO | REMARK |
|---|---|---|
| A33, A34<br>Wrinkle<br>Imperfection<br>Seam Loose<br>Protrusion | | <p><b>Inspection Method:</b><br/>Inspect surfaces for tears, punctures, or raised material</p> <p><b>Cause:</b><br/>External wear and tear</p> <p><b>Warranty:</b><br/><u>NOT</u> covered under warranty</p> |

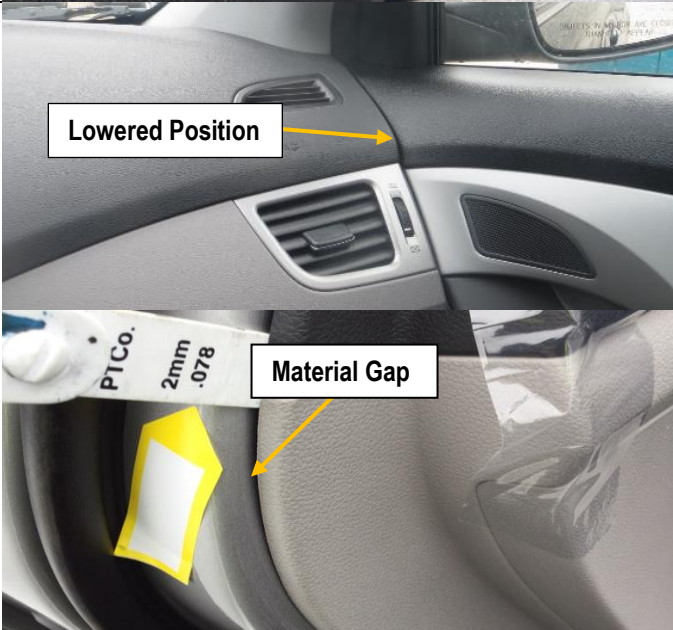
| CONDITION | PHOTO | REMARK |
|---|---|---|
| A31, A36, A37, B14,<br>B17, B18<br>Installation Gap<br>Wrong Position<br>Adjustment Error<br>Bending<br>Deformation<br>Distortion | | <p><b>Inspection Method:</b><br/>Inspect surfaces' attachment</p> <p><b>Cause:</b><br/>Manufacturing</p> <p><b>Warranty:</b><br/>Covered under warranty</p> |
