SIM 61 02 19

**SERVICE ACTION: F60 PHEV WIRING HARNESS EME**

The main wiring harness near the Electrical Machine Electronics (EME) connector may chafe on the power electronics or E-machine/ connector under certain circumstances.

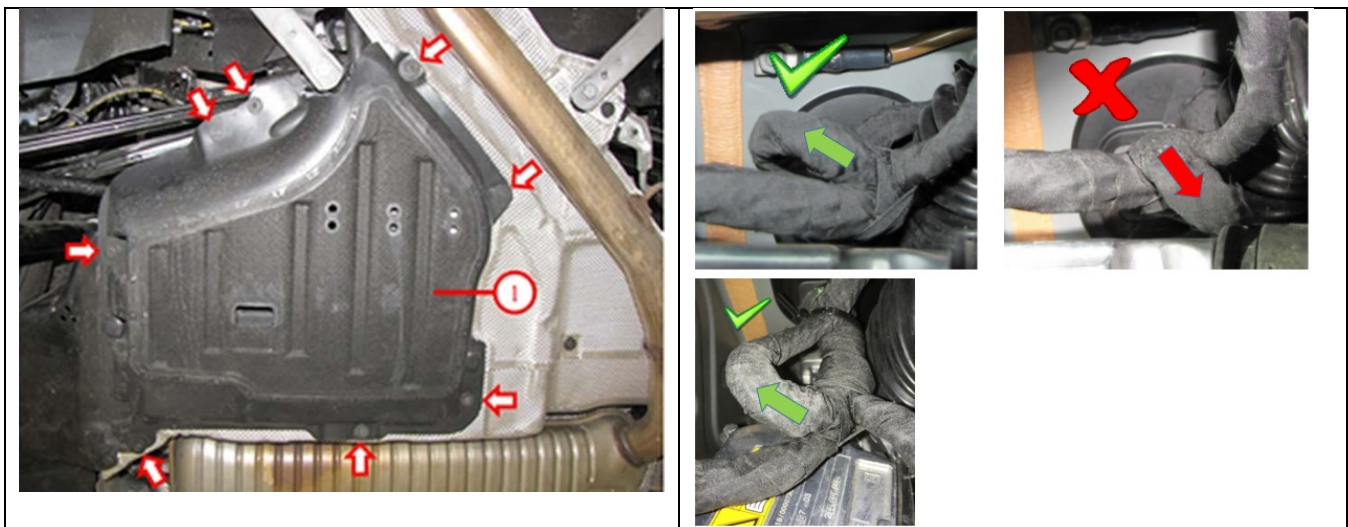
If there are chafe marks on the wiring harness (red arrow) per the examples below; the harness must be repositioned and repaired.

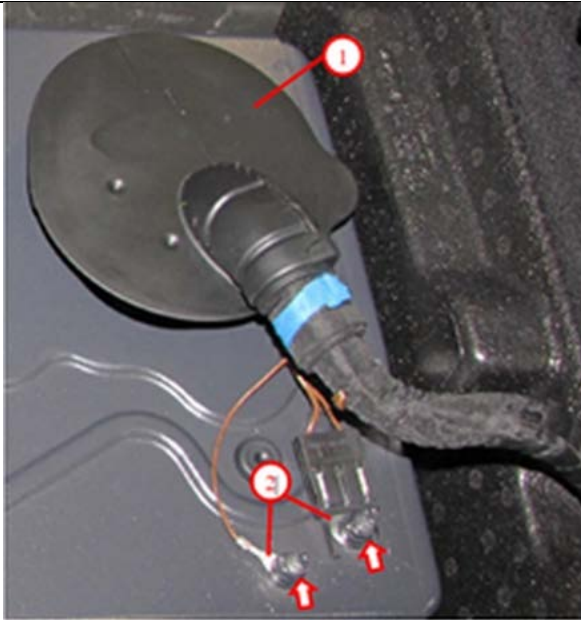
7. Remove the ground connection nuts (arrows).

8. Remove the ground connections (2)

**Effort is required to remove the luggage compartment pass through rubber grommet (1).**

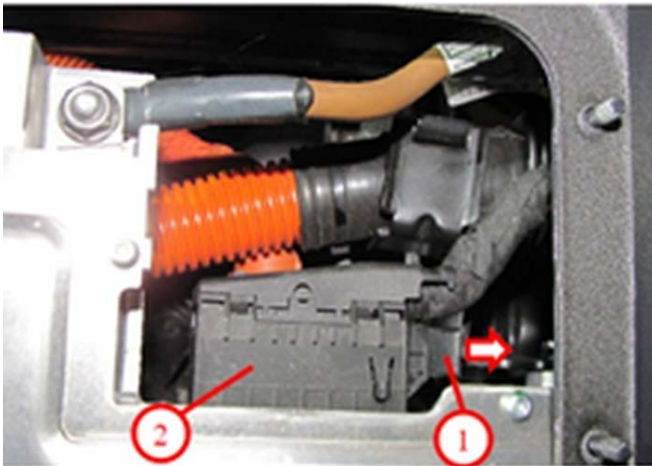
10. Open EME 12V connector clip (1) in the direction of arrow.

11. Release the 12 V EME connector (2).

12. Close the clip (1) again.

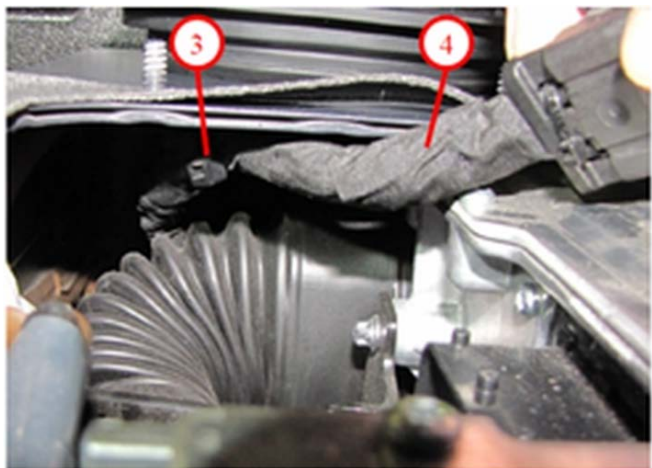
13. Position the wiring harness (4) as indicated.

14. Carefully disconnect the cable tie (3).

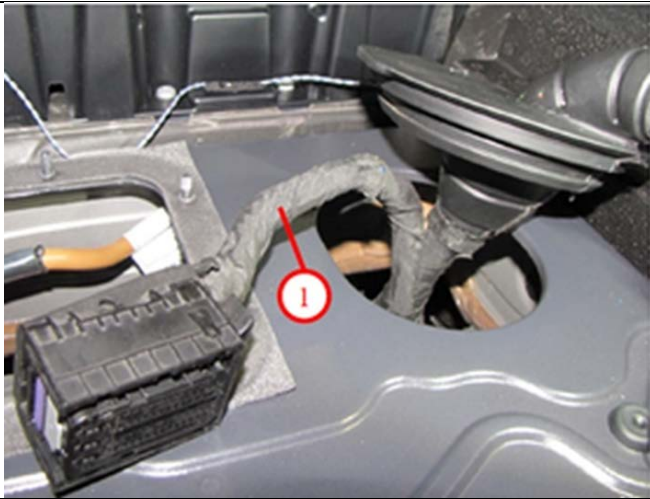
15. Carefully pull the wiring harness (1) out of the wiring harness luggage compartment pass through.

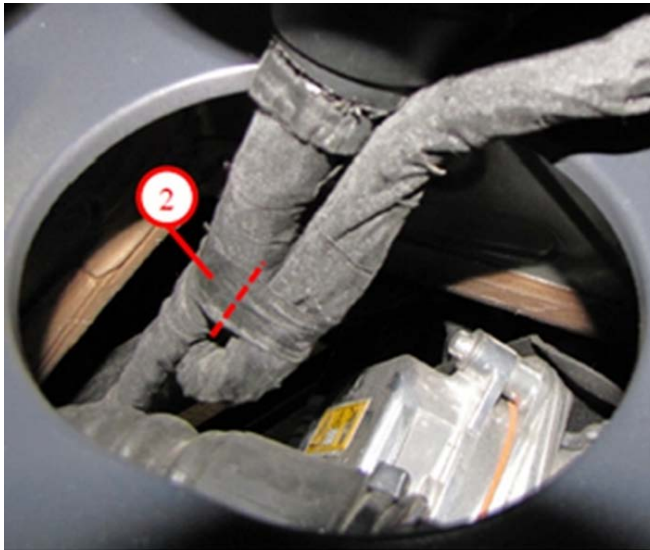
16. **Carefully** cut through the insulating tape (2), on the dotted line as illustrated.

**Do not damage the wiring harness!**

17. Remove the insulating tape (2).

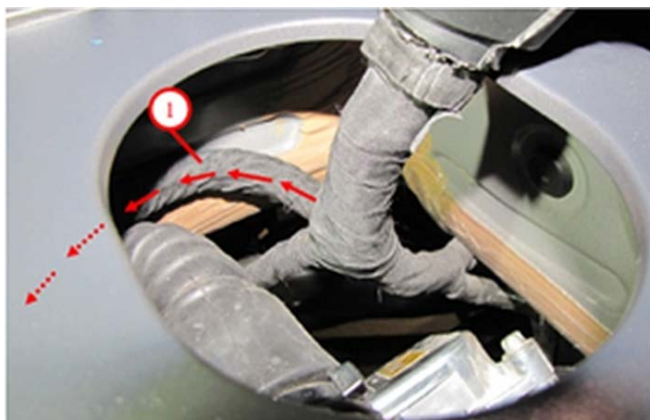
18. Install the wiring harness (1) correctly as indicated

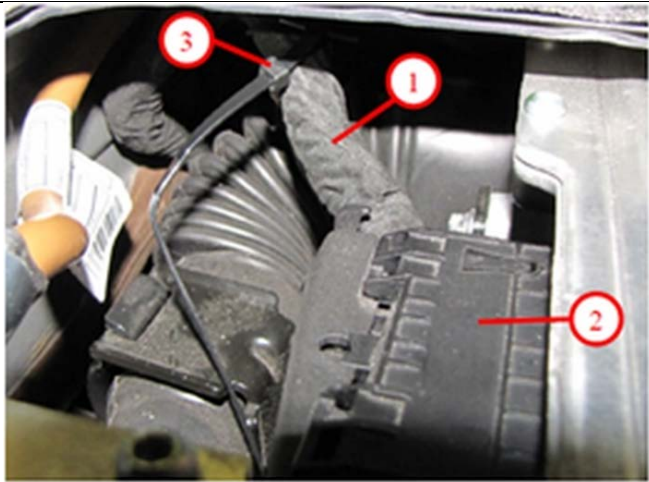
19. Close the wiring connector (2).

20. Mount the wiring harness (1) with the cable tie (3).

**Risk of damage!**  
**Do not apply the cable tie (3) too tightly!**

21. Remove the excess length from the cable tie (3).

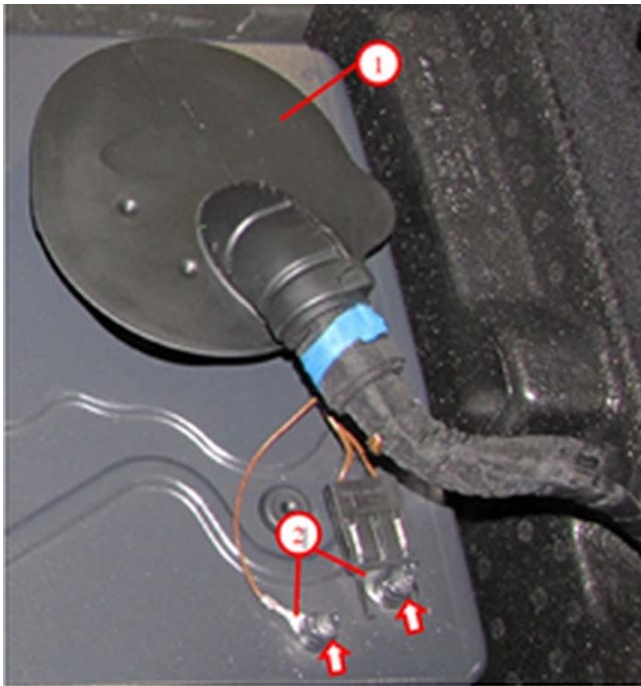
22. Position the wiring harness pass through grommet (1) correctly and firmly press on to the luggage compartment floor panel.

23. Verify that the grommet (1) is installed correctly.

25. Position the grounding connections (2).

26. Torque the grounding connections point nuts (arrows) to 8 Nm.

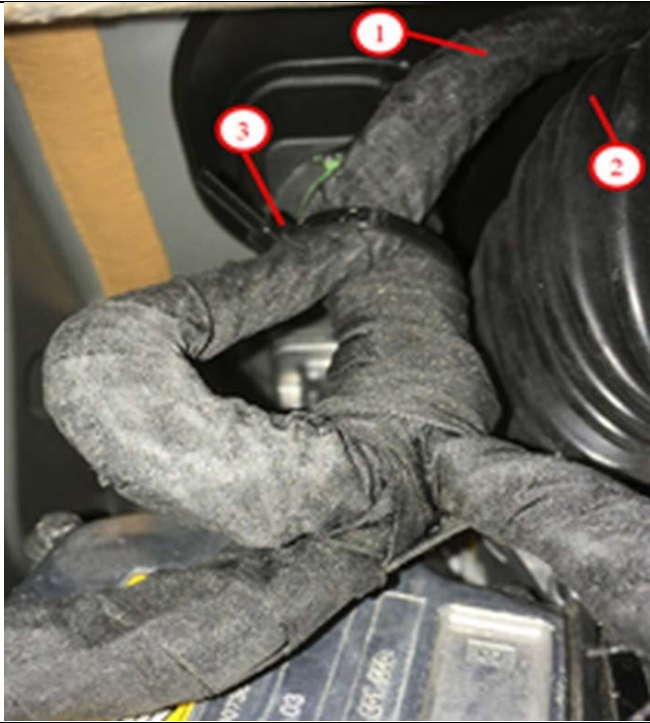
27. Elevate the vehicle.

28. Install the wiring harness (1) as indicated in such a way that the wiring harness (1) does not touch against the grommet (2).

29. Mount the wiring harness (1) as indicated with the cable tie (3).

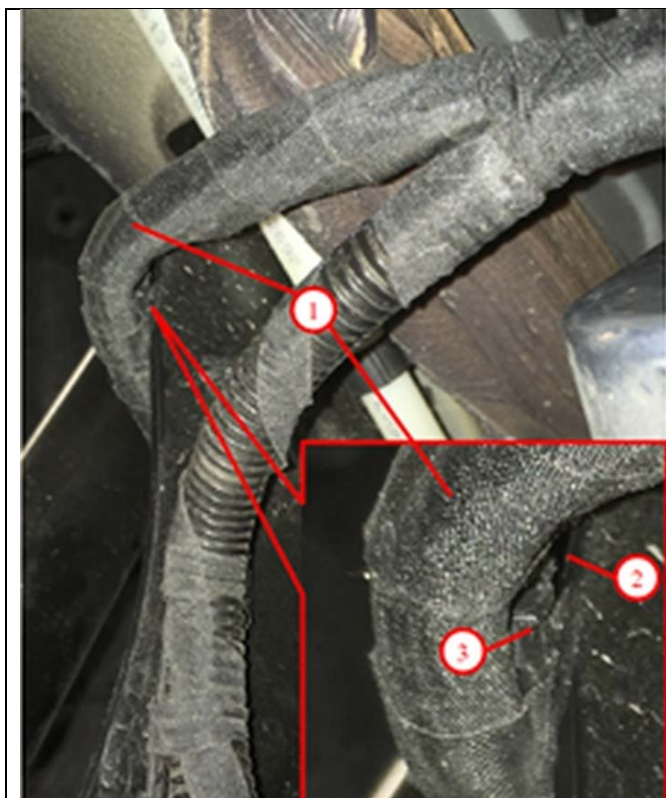
**Risk of damage!**

**The wiring harness (1) must not be at the edge (2)!**

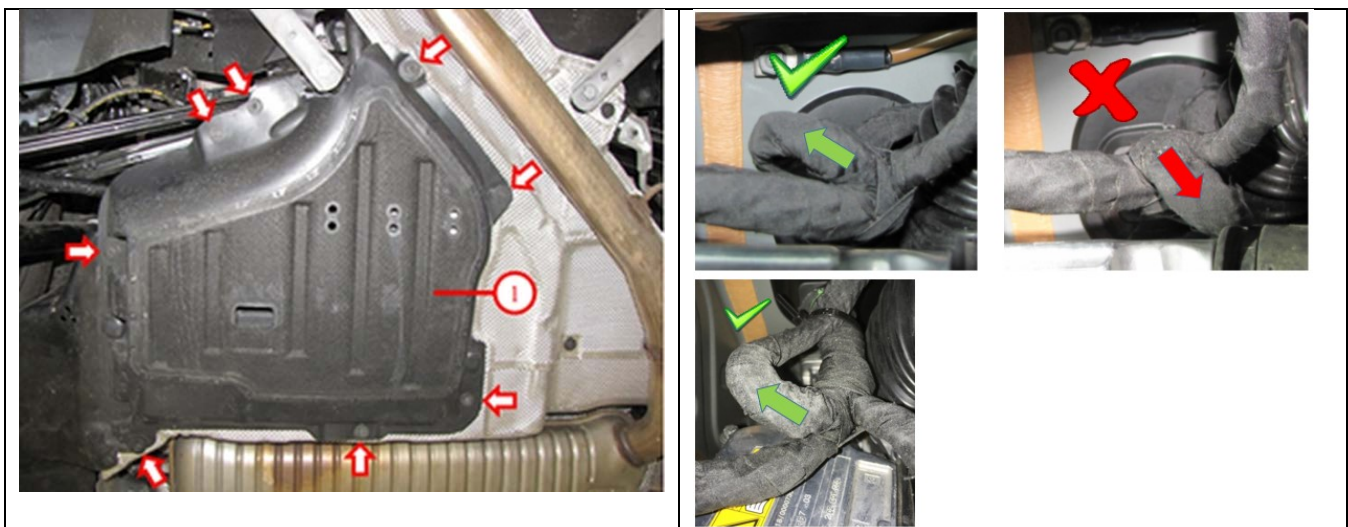
If there are chafe marks on the wiring harness (red arrow) per the examples below; the harness must be repositioned and repaired.

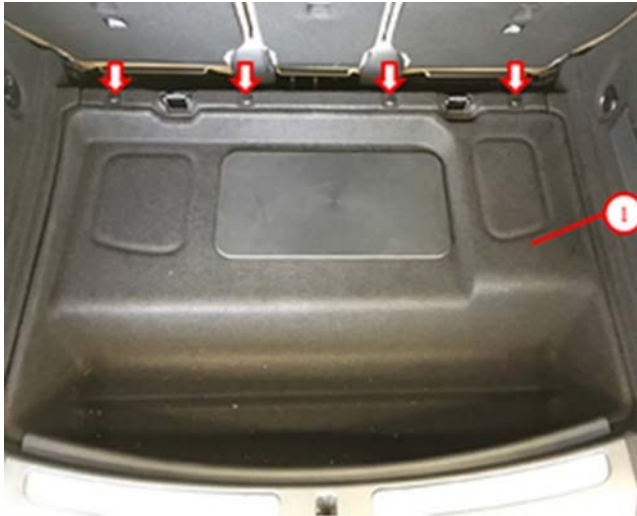
Luggage compartment trim panel (1)

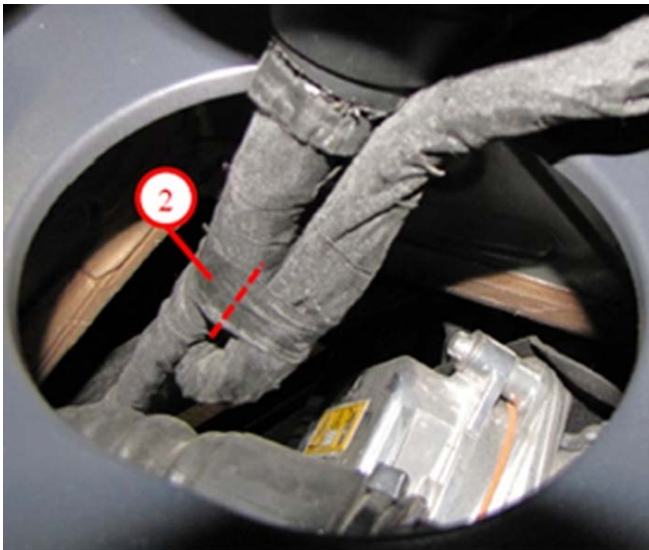
15. Carefully pull the wiring harness (1) out of the wiring harness luggage compartment pass through.

16. **Carefully** cut through the insulating tape (2), on the dotted line as illustrated.

17. Remove the insulating tape (2).

18. Install the wiring harness (1) correctly, as indicated.

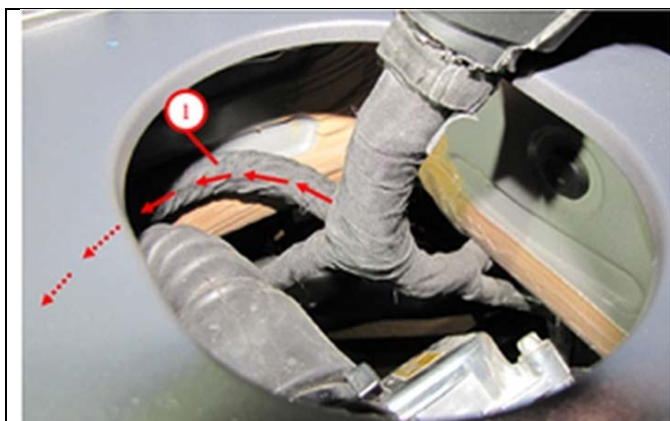
19. Close the wiring connector (2).

20. Mount the wiring harness (1) with the cable tie (3).

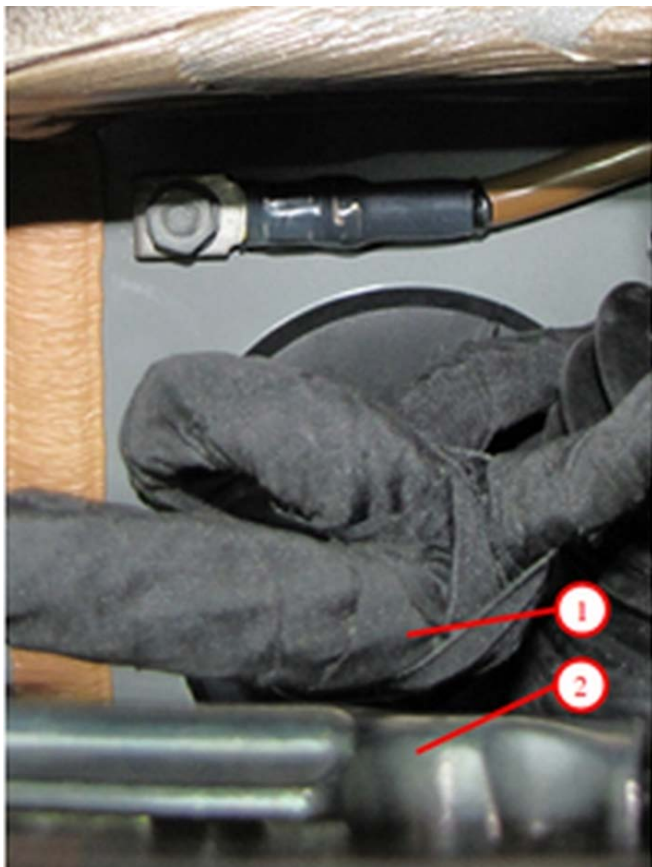
**28 Wrap the wiring harness (1) in the damaged area (4) with several layers of Fabric tape.**

29 Install the wiring harness (1) as indicated in such a way that the wiring harness (1) does not rub against the grommet (2).

30 Mount the wiring harness (1) as indicated, with cable tie (3).

31. Check the wiring harness routing and installation arrangement as illustrated.

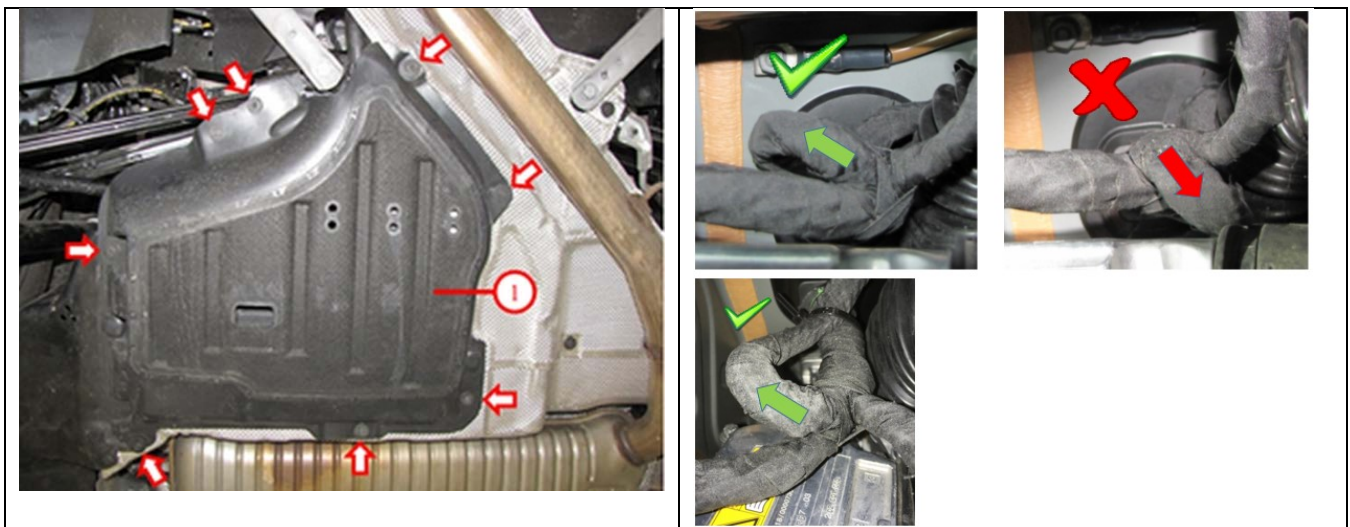
If there are chafe marks on the wiring harness (red arrow) per the examples below, the harness must be repaired.

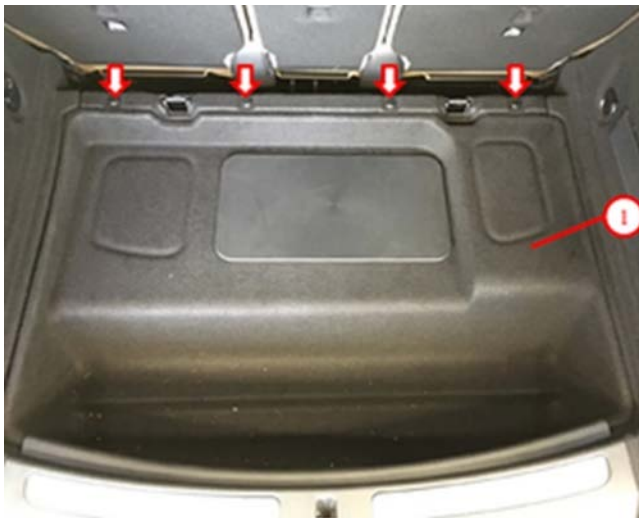
F60 PHEV - luggage compartment felt trim panel (1)

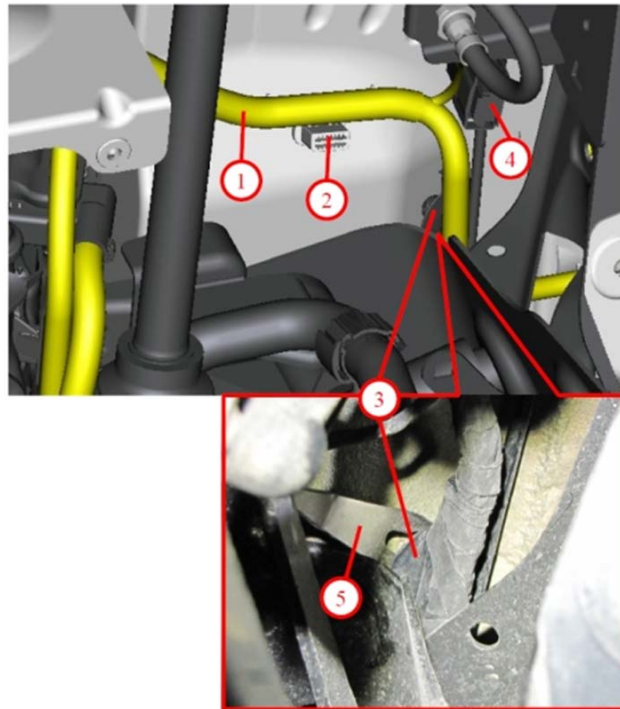
F60 PHEV - underbody view of the wiring harness (1) routing and attachment points near the high voltage battery area.

**15.1. Wiring harness (1)** - runs over the rear axle to the high voltage battery.

- Release the mounting (2).
- Release the clip (3) (over the rear axle) with the clip lifter tool (5).
- Release the plug connection (4).

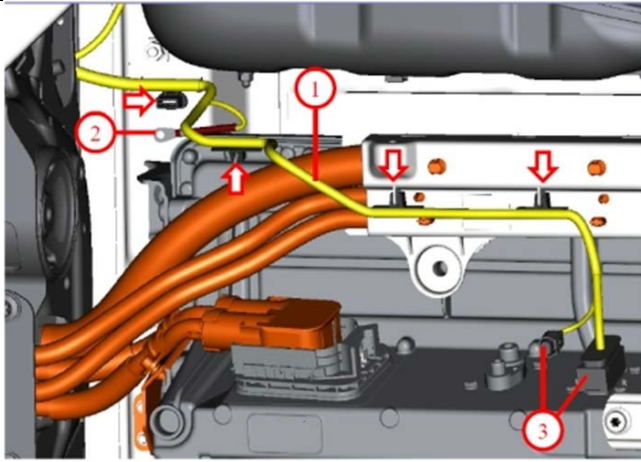
F60 PHEV - underbody view of the wiring harness (1) routing and attachment points near the high voltage battery area.

#### Wiring harness (1) continued:

- Undo nut (2).
- Remove the grounding cable.
- Disconnect the plug connections (3).
- Release the mountings (arrows).

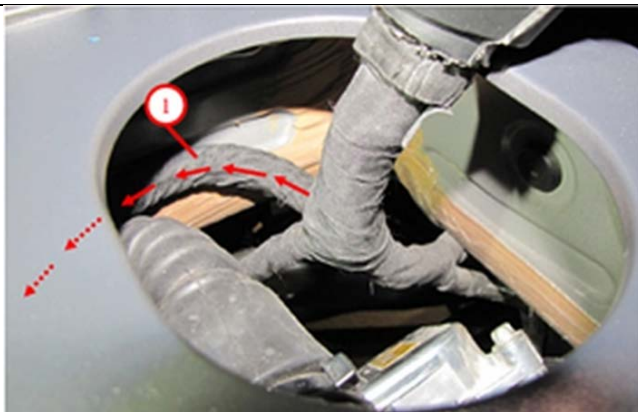
- 30.2 Insulate the crimp connection points with watertight heat-shrink tubing.

- 30.3 Wrap the wiring harness (2) with Fabric tape.

31. Install the wiring harness (1) correctly as indicated.

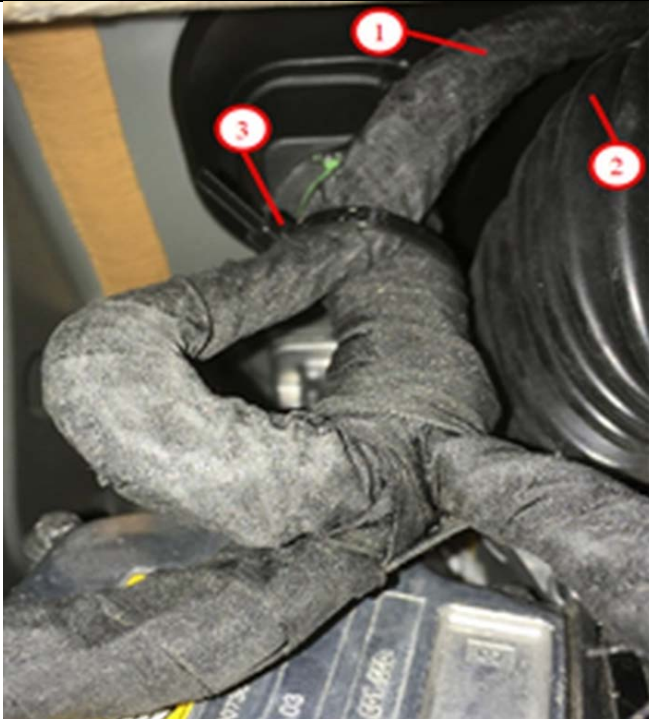
35. Position the wiring harness pass through grommet (1) correctly and firmly press on to the luggage compartment floor panel.
36. Verify that the grommet (1) is installed correctly.
37. If necessary, press on the grommet (1) to ensure proper installation.
38. Position the grounding connections (2).
39. Torque the grounding connections point nuts (arrows) to **8 Nm**.

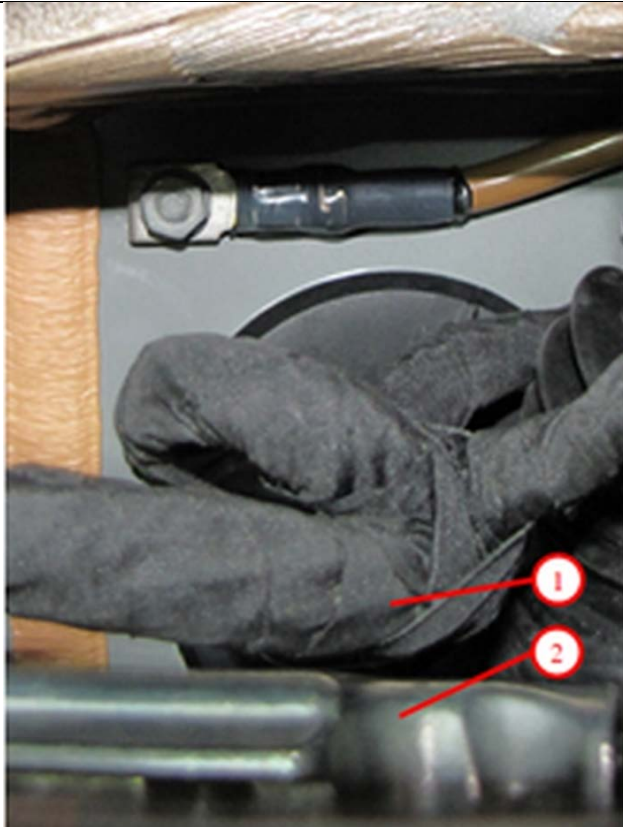
40. Elevate the vehicle.
41. Install the wiring harness (1) as indicated in such a way that the wiring harness (1) does not rub against the grommet (2).
42. Mount the wiring harness (1) as indicated with the cable tie (3).

43. Check the wiring harness routing and installation arrangement.
