Service Alert

GUIDE LINES AND PHOTOS TO DETERMINE IF FLUID/OIL SEEPAGE
OR LEAK IS SEVERE ENOUGH TO REQUIRE WARRANTY REPAIR
OR TO CLEAN AND MONITOR

Service Alert No.: SA-053/19

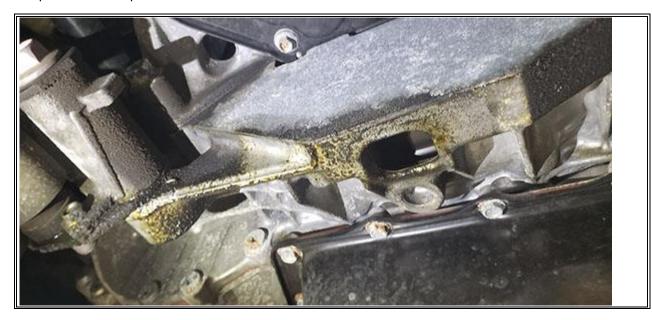
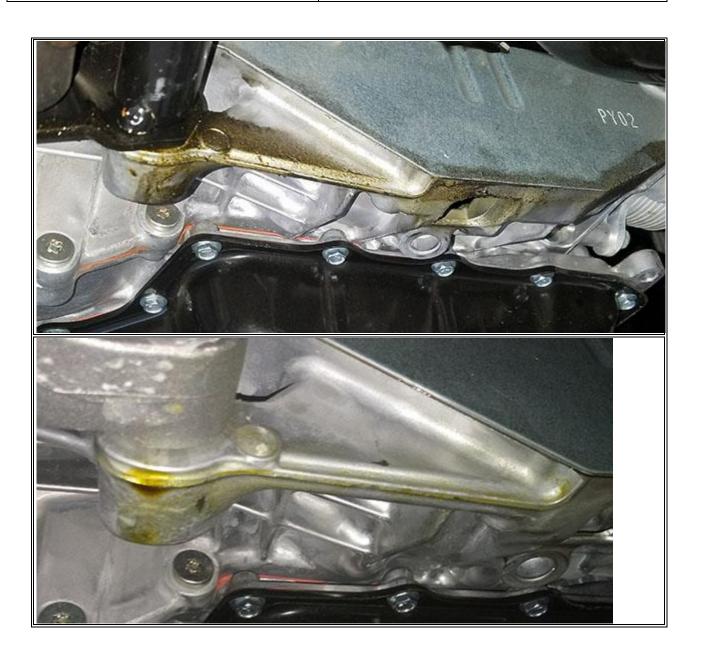
Examples of residue or seepage that may not be considered a leak and that may not require repair based on splash shield inspection.

- If there are a few drips or the fluid residue has dried up, no repair is needed. Clean up the area and monitor the condition at the next service.
- If the fluid residue is wet, drip tracking along the surface or dripping on the ground, a repair is needed.

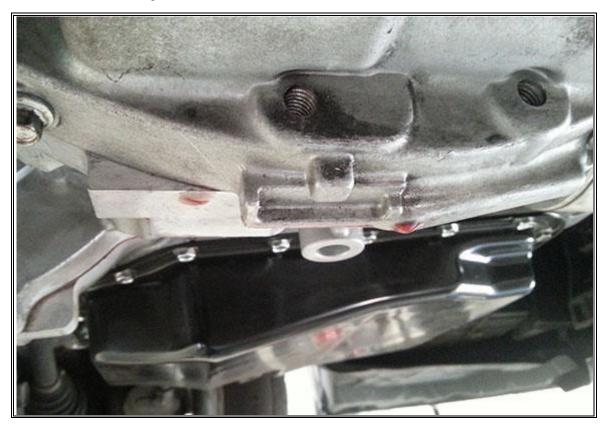
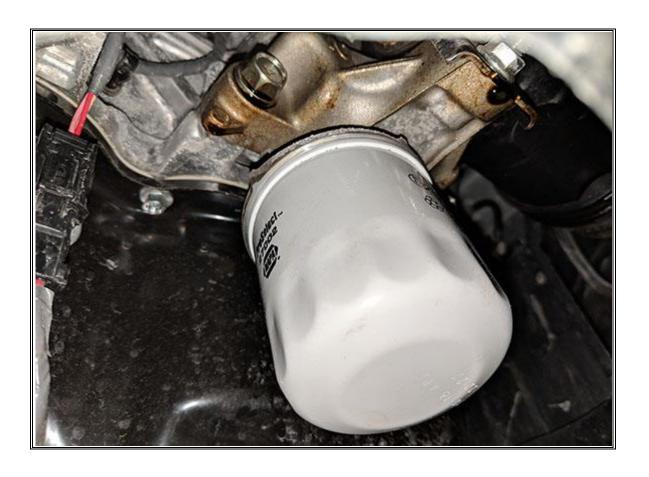
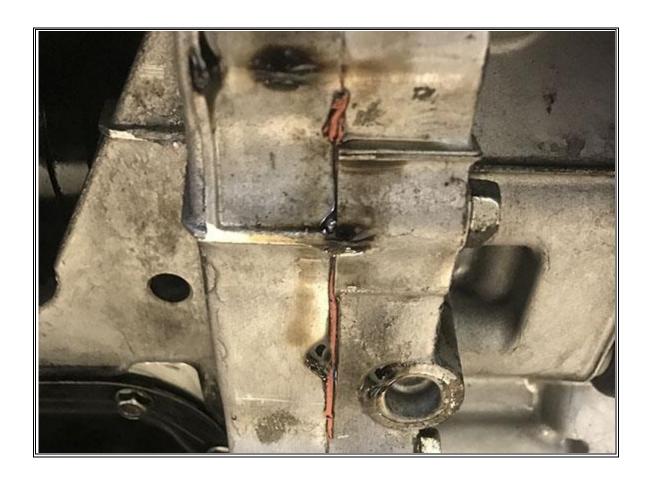
Examples of a leak that may require repair based on splash shield inspection or if the customer states there is a fluid/oil leak on the ground.

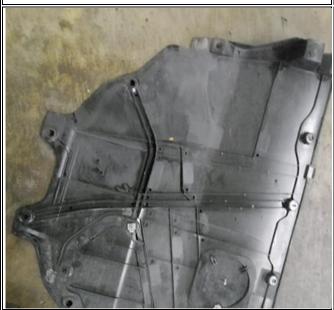
If a few drips are present or none at all, no repair is needed.

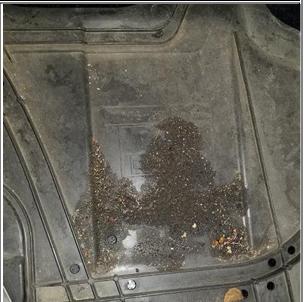
If the residue is dried up and nothing is wet, no repair is needed.
