## Dash Center Vent Damaged/Broken

| Topic number | LI83.10-N-067607 |
| Function group | 83.10 Ventilation |
| Validity | Metris 447.603/.703<br>Sprinter 906.xxx<br>Sprinter 907.xxx |

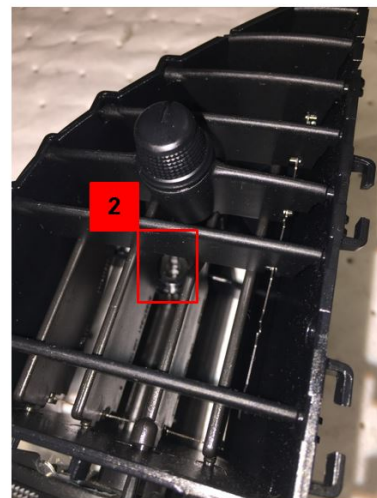
Center Vent Damage.  
JPG:

Center air vent with broken fins and knob controls are a result of improper operation, abuse, or incidental damage.

(1) Parts missing / (2) adjustment knob not attached

Replacement of the air vent.

Note: Replacement parts and labor are not covered under warranty. Please refer the customer to the owners manual section "Adjusting the air vents" for coaching.

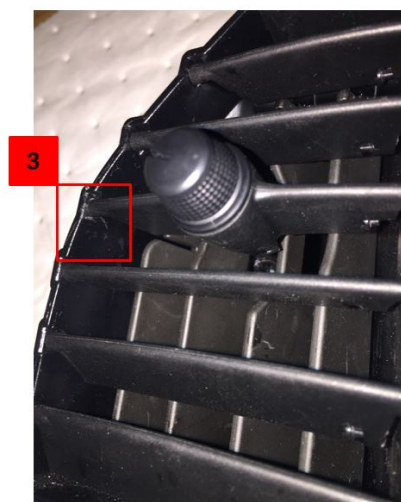
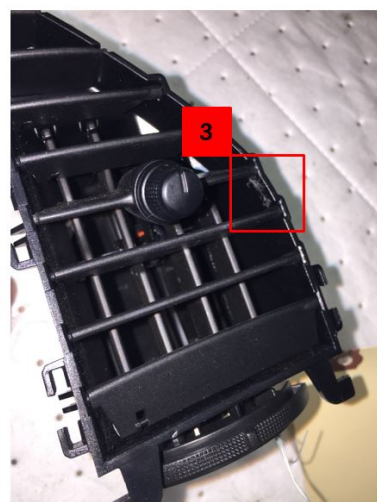
Center Vent Damage 2.  
JPG:

(3) Scratches caused by loose parts
