Product Upgrade Bulletin 191010REV

UPGRADE BULLETIN:
191010REV

PRODUCT(S) AFFECTED:
American Eagle, equipped with Option 455, Foil Cabinetry and having the microwave installed below a cabinet

SUBJECT:
Shimming the Microwave Mounting to Improve Ventilation

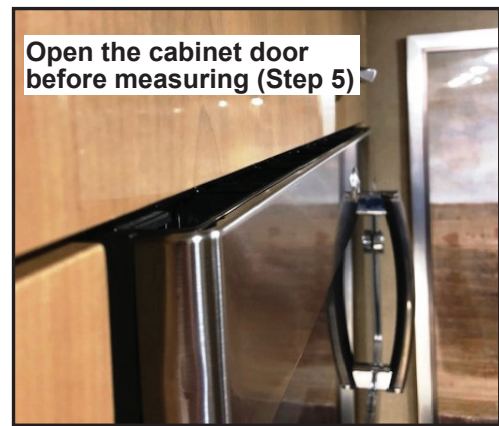
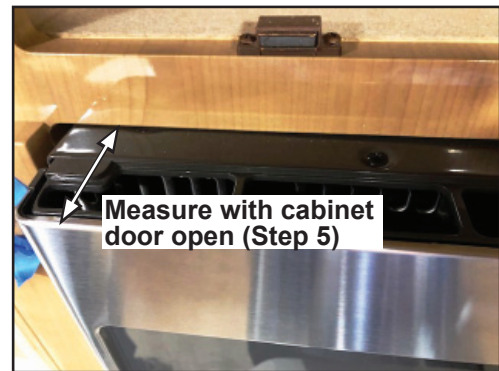
On motorhomes affected by this Product Upgrade, the microwave, mounted below a cabinet, has insufficient venting. This can allow moisture to collect and condense on the cabinet front.

5. With the cabinet door open, measure the distance between the front face of the cabinet (above the microwave) and the front face of the microwave's door. If it is less than 3", the microwave's rear mounting bracket should be shimmed with plywood to allow clearance for proper venting. Refer to the photos in Figures 1 and 2 for examples of a microwave that needs shims added to its rear bracket mounting surface to allow its proper ventilation.

If shimming the microwave's rear mounting bracket is necessary to achieve clearance for proper ventilation, take several clear photos of the installation and attach them to a draft claim in the dealer warranty portal (A.D.N.). Also, call American Coach dealer technical support for confirmation to proceed with repairs.

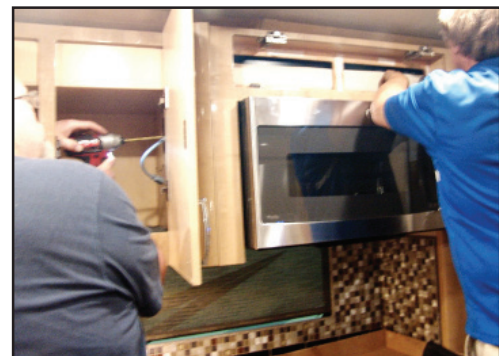
8. Place a thick piece of cardboard over the cooktop to protect it while repairs are performed.
9. Open the door of the upper cabinet to the left of the microwave. Move the grommet aside to expose the hole for the microwave cord and plug. See Figures 3 and 4.

11. **Have an assistant help hold the microwave while it is being uninstalled to avoid dropping it or causing damage.** First, remove its mounting fasteners. Referencing the photo in Figure 3 on the previous page, remove one screw on the side of the microwave (access this screw by opening the cabinet at left). Remove the 3 additional screws from the top of the microwave. Next, carefully remove the microwave from its mounting bracket. Set the bracket and mounting screws aside for later reinstallation.

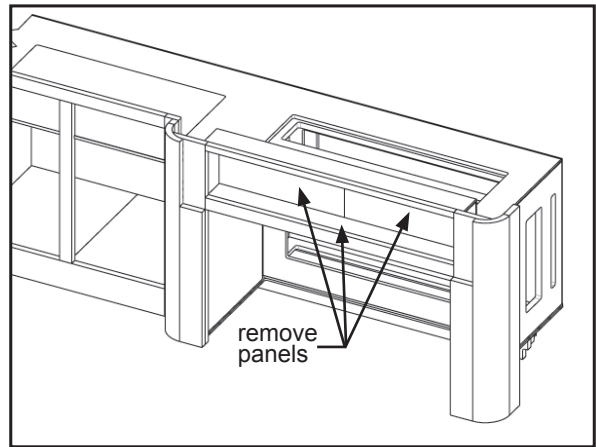
Figure 5

10. Remove the panels from inside the cabinet over the microwave by removing the panel screws. Retain screws for reinstallation. The microwave mounting screws should now be visible - **do not** remove them yet. See Figure 5.

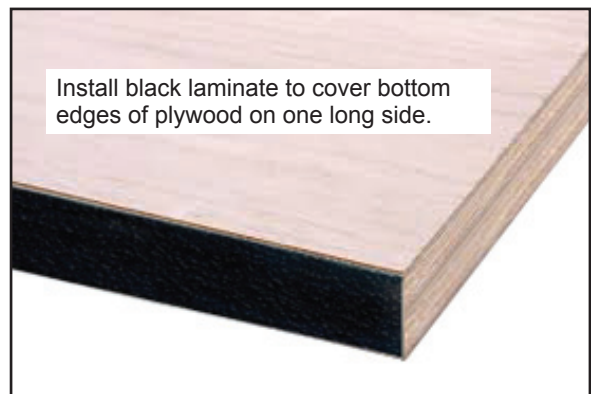
Figure 6

14. Obtain a new piece of black laminate and use contact cement to affix it to one of the long edges of the newly joined pieces of plywood. Use a roller to ensure the laminate properly adheres to the plywood. See Figure 6.

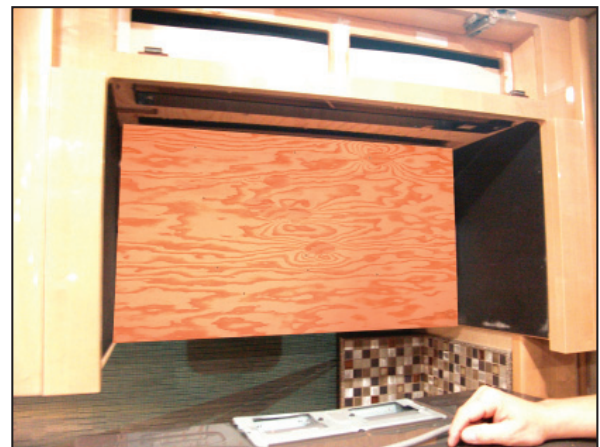
Figure 7

15. Use 2" long self-tapping screws to mount the new plywood pieces directly over the original plywood backing for the microwave, creating a 1 1/2" shim that will position the microwave outward, allowing it to properly vent. Refer to Figure 7.

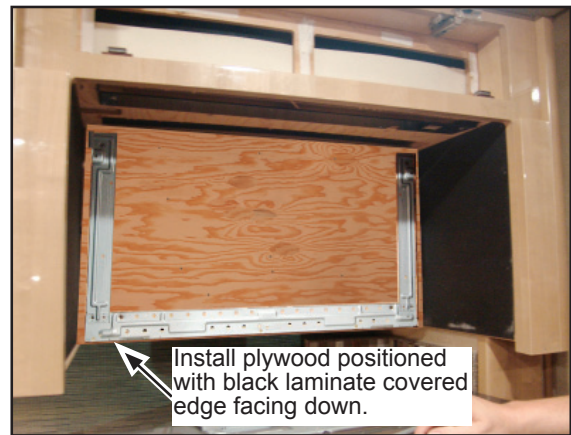
Figure 8

16. Reinstall the microwave mounting bracket using the original screws. The bracket should be aligned with the bottom of the plywood and centered horizontally, as shown in Figure 8.
17. Reinstall the microwave onto its mounting bracket using the original screws. Ensure the power cord is routed through the opening in the side of the cabinet when reinstalling the microwave.
18. Cover the opening for microwave's power cord using the original grommet. Plug the power cord back into the electrical outlet. Refer to Figure 8.
19. Reinstall the panels (removed in Step 10) in the cabinet above the microwave.
20. Return any contents removed from the microwave back into place and close its door.
21. Clean up the area and close the doors for the cabinets.
