Technical Service Bulletin

10 Engine cover is loose or rattles

10 19 17 2057260/2 December 20, 2019. Supersedes Technical Service Bulletin Group 10 number 19-16 dated November 19, 2019 for reasons listed below.

Model(s)	Year	VIN Range	Vehicle-Specific Equipment
RS4, RS5	2018 - 2020	All	Not Applicable

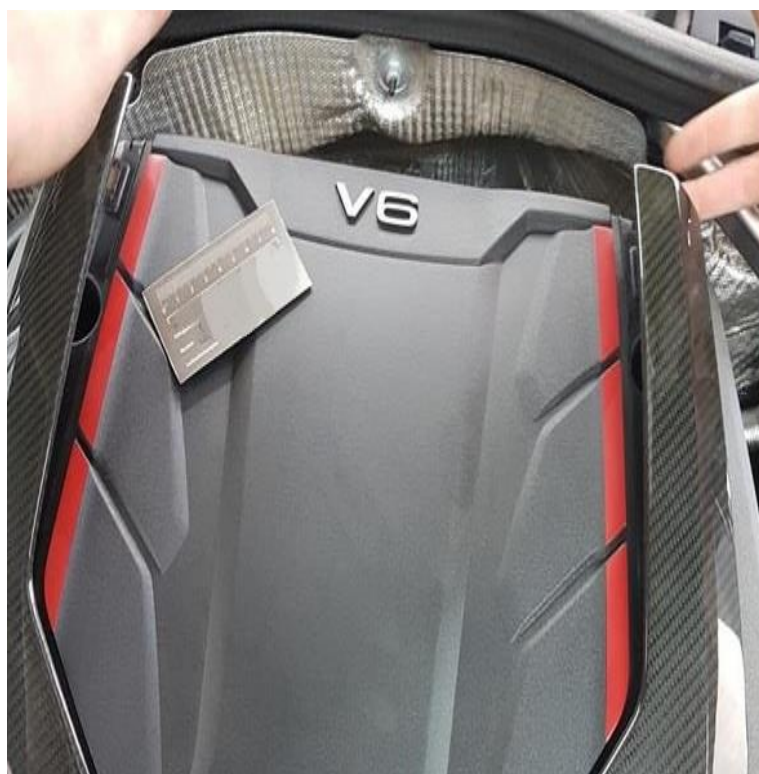
- Rattling noises from engine compartment and the trim panel comes off engine compartment cover (Figure 1).

Figure 1. Engine compartment cover.

Optimized bonding.

Bond the engine compartment cover and the trim panel as described below:

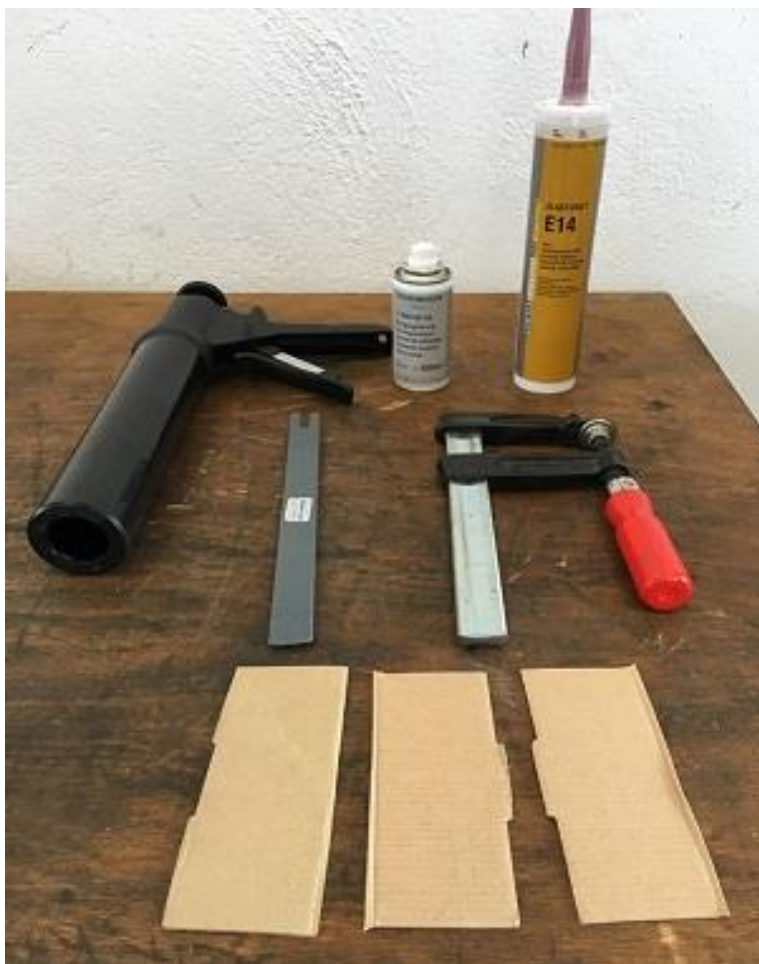
Required Shop Tools (Figure 2):

- Plastic wedge
- Adhesive tape
- Cleaning solution G 065 567 A2
- Cartridge press
- Elastosil silicon rubber E14 RTV-1 Brand Wacker
- Cardboard
- Screw clamp

Figure 2. Required tools.

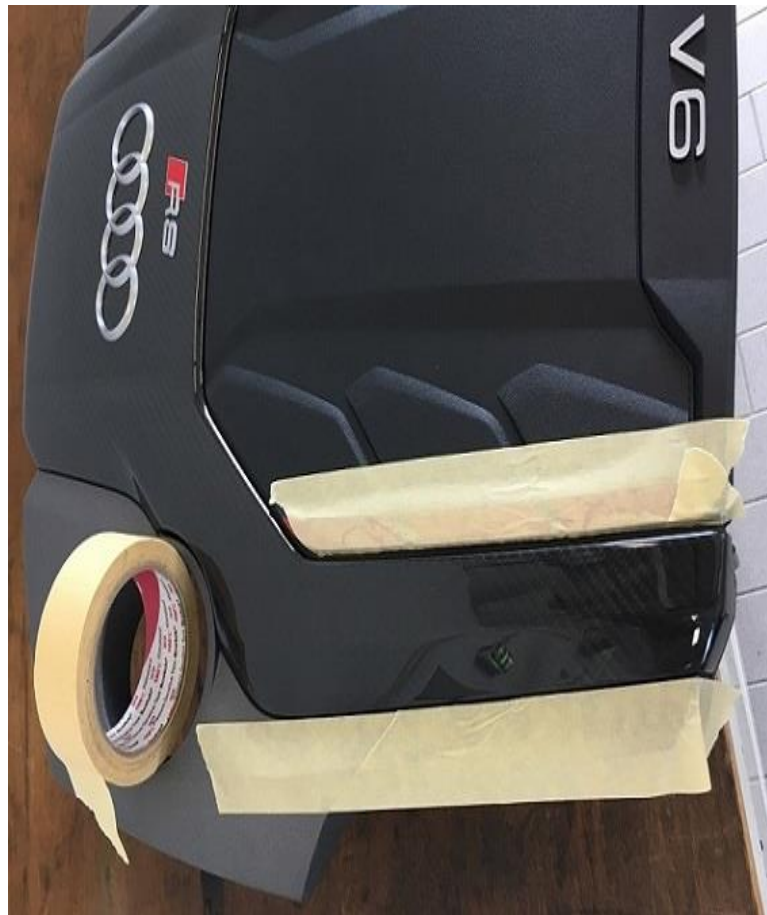
Figure 3. Masking the engine compartment.

1. Mask the engine compartment cover in the area of the trim panel (Figure 3).

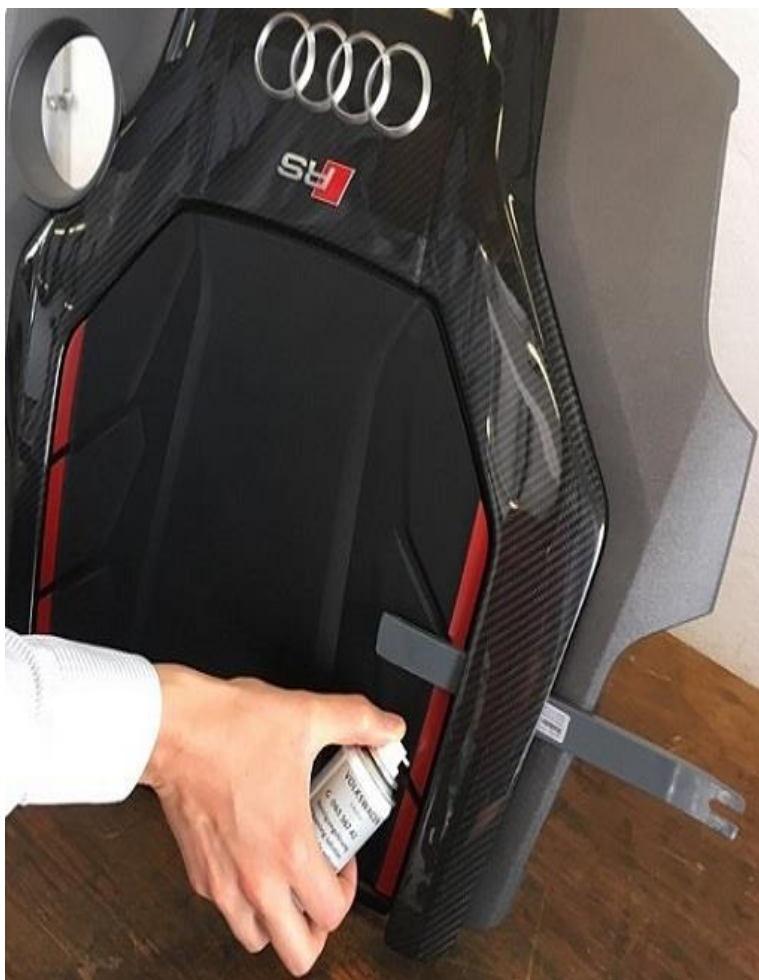
Figure 4. Lift the trim panel and clean.

2. Carefully lift the trim panel with a plastic wedge and clean the bonding surfaces (Figure 4).

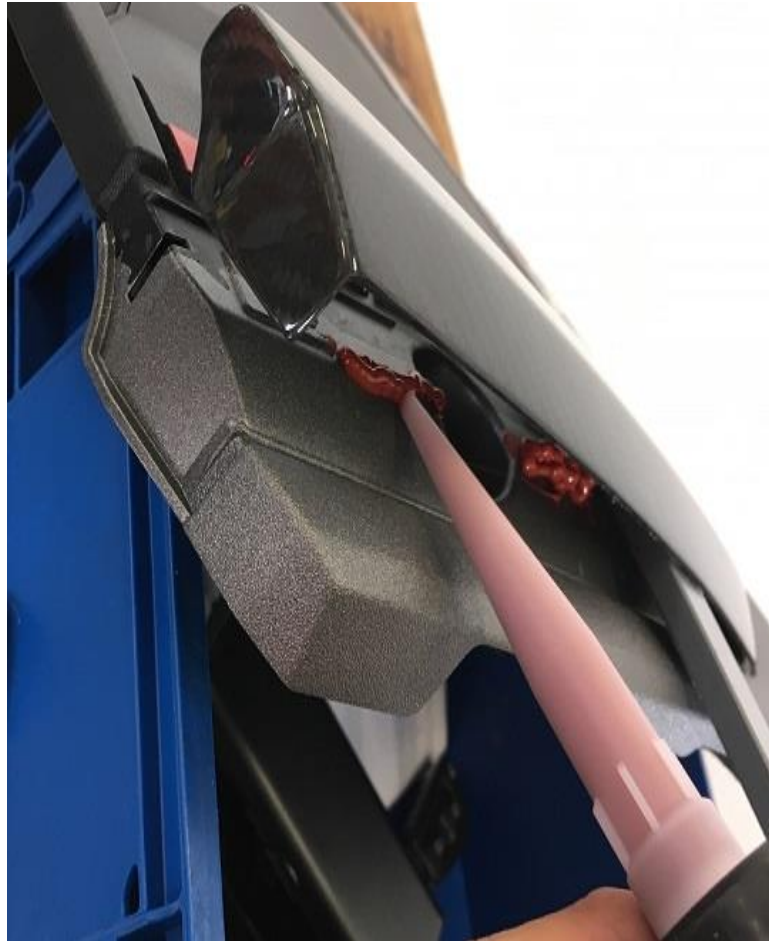
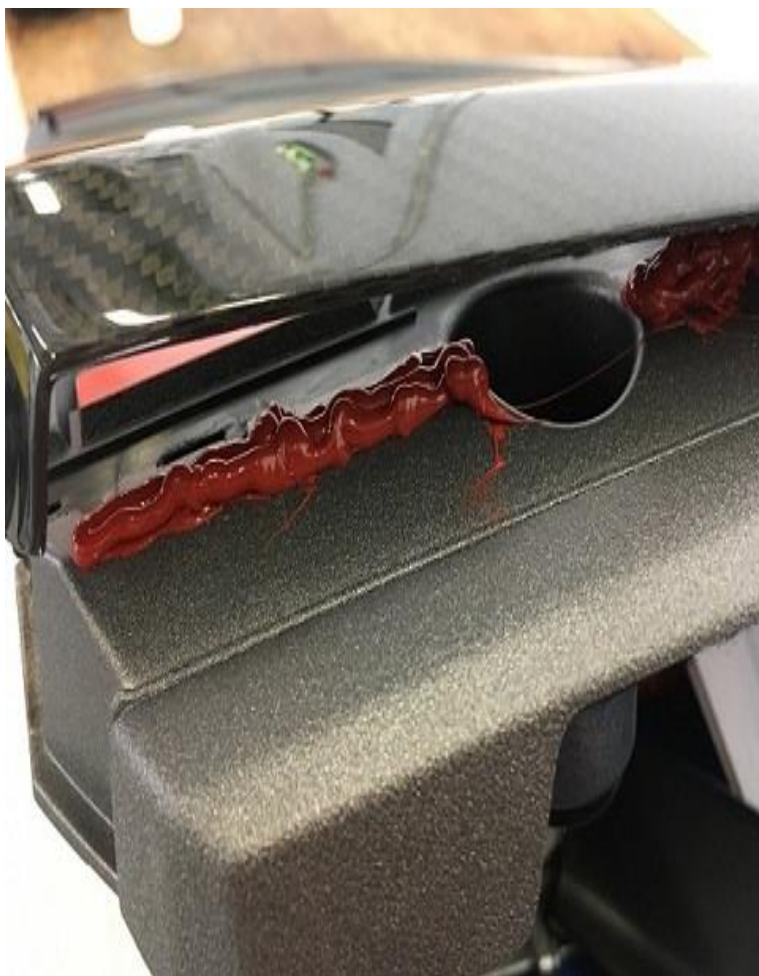
Figure 5. Applying adhesive.

Figure 6. Applying adhesive.

3. Apply the adhesive generously on the middle edge of the two surfaces below the trim panel (Figure 5 – 6).

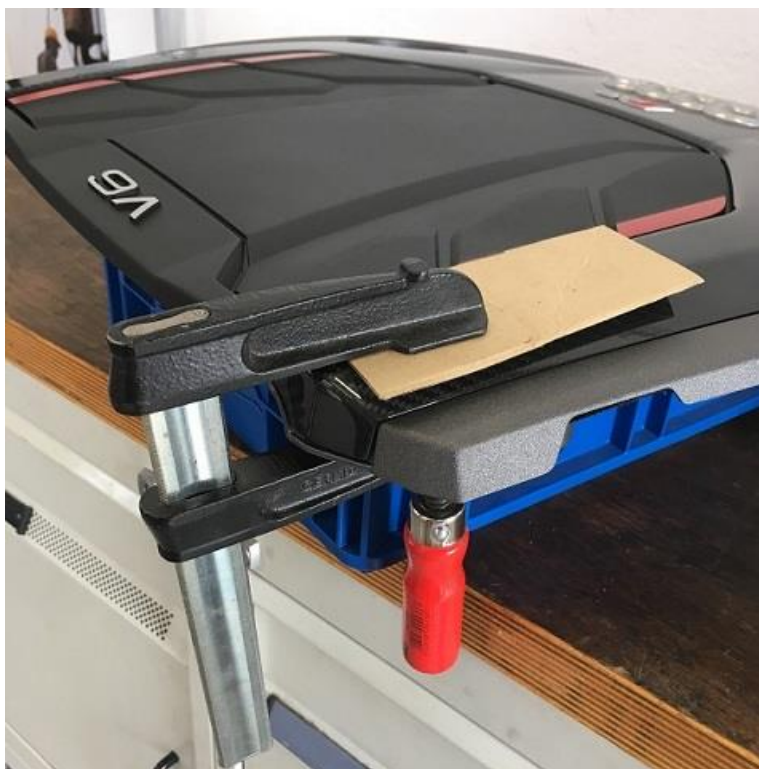
Figure 7. Put the cover in position and clamp together.

4. Put the trim panel and the engine compartment cover in position with a screw clamp and let the adhesive harden for 4 hours (Figure 7).
