**Document ID:** IK0500038

**Title:** Steering Shake, Shimmy, Shudder, Steering Vibration

**Applies To:** Prostar/Lonestar and LT/RH with 14k front weight rated axles and below

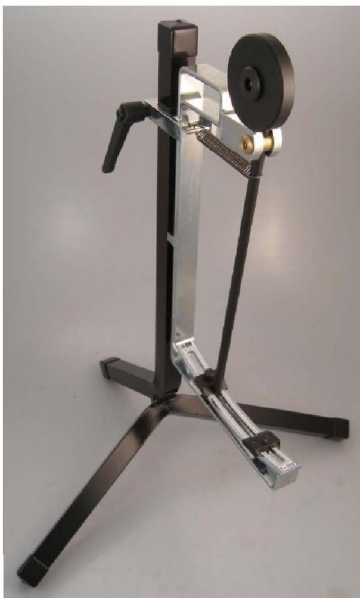
Measure lateral and radial run out on all tires using the tire runout gage RN 4532000. [Tire Runout Gage Instructions Navistar PN 4532000](#)

All other vehicles: lateral and radial run out must be below .065".

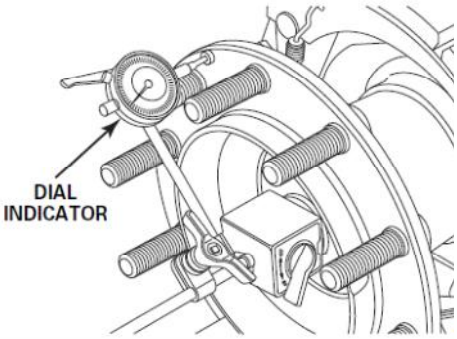
Step	Action	Decision
4	<p><b>DIAGNOSTIC: Wheel Bearing End Play</b></p> <p>Measure wheel bearing for excessive end play</p> <p>Use a dial indicator to verify acceptable endplay of 0.001"-0.005".</p>

<p>DIAL INDICATOR</p> <p>Is wheel bearing end play in spec?</p>	<p><b>Yes:</b> Please proceed to step 5.</p> <p><b>No:</b> Replace or adjust the wheel bearings as needed and proceed to step 5.</p> <p>Refer to <a href="#">ConMet Service Manual</a></p>

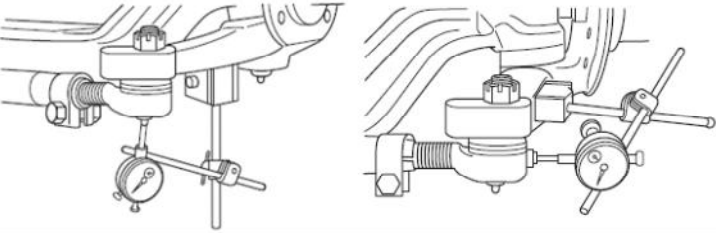
<p>Use a dial indicator and measure the vertical and horizontal end play of the tie rod ends and drag link ends.</p> <p>Spec: less than 0.030 inches.</p> <p>Are the drag link and tie rod ends within specification?</p>	<p><b>Yes:</b> Please proceed to step 6.</p> <p><b>No:</b> Replace the drag link and tie rod ends as needed and proceed to step 6.</p>

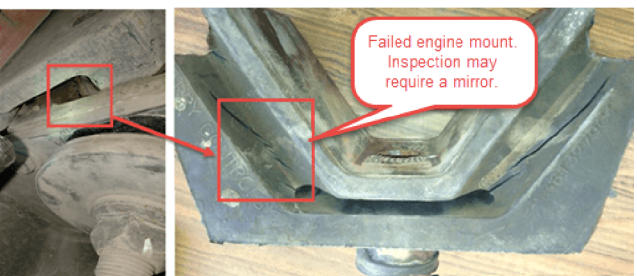
Step	Action	Decision
6	<p><b>DIAGNOSTIC: Spring Hangers, Cab Mounts, Engine Mounts and Frame Fasteners</b></p> <p><b>NOTE:</b></p> <p>The rear engine mounts on X15 powered vehicles need to be replaced regardless of condition, if it was not built with 1664729C7 - Refer to Service Parts Information</p> <p>Inspect the spring hangers, shackles, and bushing for looseness, play and fastener torque.</p> <p>Inspect cab and engine mounts for excessive wear, being degraded and/or looseness.</p>

<p><b>Yes:</b> LT/RH refer to <a href="#">0000885380</a></p> <p>Prostar/LoneStar refer to <a href="#">0000863170</a></p> <p>Repair, torque, or replace fasteners and suspension components as needed and proceed to step 7.</p> <p><b>For A26 powered LT, the rear engine mounts should be replaced with a new part from the parts catalog if damage is found.</b></p> <p><b>For X15 powered LT, the rear engine mount should be replaced with 1664729C7 regardless if damage is found.</b></p> <p><b>No:</b> Please proceed to step 7.</p> <p><b>For X15 powered LT, the rear engine mount should be replaced with 1664729C7 regardless if damage is found.</b></p>

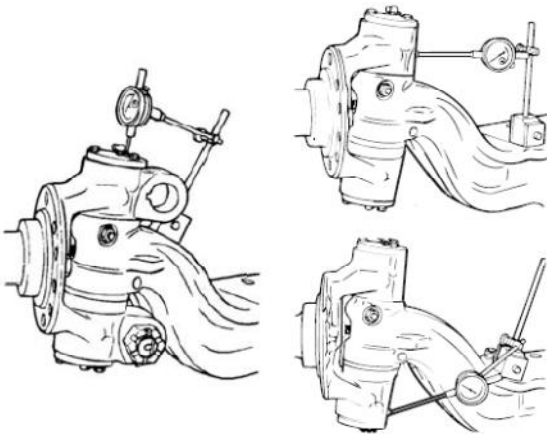
Step	Action	Decision
9	<p><b>DIAGNOSTIC: King Pin Vertical and Horizontal play</b></p> <p>Measure the king pin for excessive vertical horizontal end play.</p>

<p>Confirm the type of axle installed and use a dial indicator to verify acceptable play per supplier's specifications.</p> <p>Meritor: <a href="#">MM-2</a></p> <p>Dana: <a href="#">AXSM-0038</a></p> <p>Hendrickson: <a href="#">17730-252</a></p> <p><b>Is King pin play out of specification?</b></p>	<p><b>Hendrickson:</b></p> <p><b>Yes:</b> Install high friction composite kingpin service kit H60961628 per Hendrickson manual <a href="#">59310-011</a>.</p> <p><b>No:</b> Install the high friction composite kingpin bearing only kit H60961629. If the service kit is not available, install the steering stabilizer H60961167 can be installed in its place per the below resolution.</p> <p>Proceed to step 10</p> <p><b>Dana:</b></p> <p><b>Yes:</b> Install a king pin service kit and the high friction composite king pin kit 2520702C9.</p> <p><b>No:</b> Install the high friction composite king pin kit 2520702C91. If the service kit is not available, install the steering stabilizer H60961167 can be installed in its place per the below resolution.</p> <p>Proceed to step 10</p> <p><b>Meritor 12K:</b></p> <p><b>Yes:</b> Install high friction composite kingpin service kit 2519548C91 per <a href="#">TP1873</a>.</p> <p><b>No:</b> Install the high friction composite kingpin bearing only kit 2520213C91. If the service kit is not available, install the steering stabilizer H60961167 can be installed in its place per the below resolution.</p> <p>Proceed to step 10</p> <p><b>Meritor 13/14K:</b></p> <p><b>Yes:</b> Install high friction composite kingpin service kit 2519476C91 per <a href="#">TP1873</a>.</p> <p><b>No:</b> Install the high friction composite kingpin bearing only kit 2520212C91. If the service kit is not available, the steering stabilizer H60961167 can be installed in its place per the below resolution.</p> <p>Proceed to step 10</p>

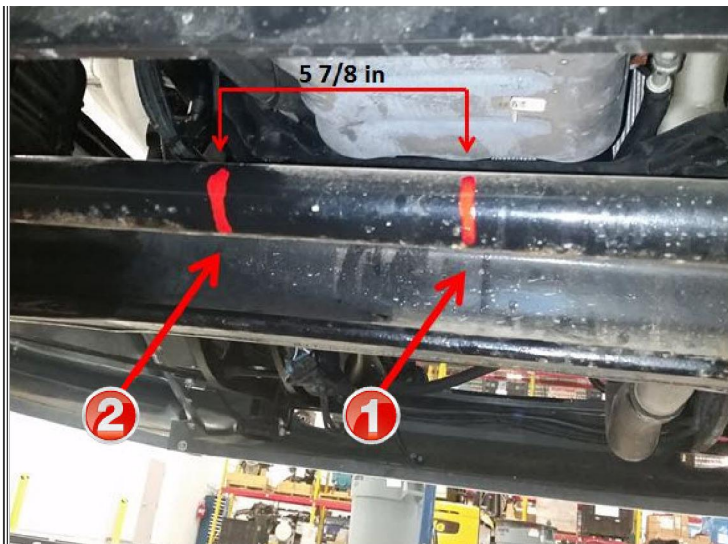
**Figure 3: Tie rod assembly**

7. From the tie rod assembly centerline, make a second mark  $5 \frac{7}{8}$ in towards the driver's side per figure 3. This will be the mounting location of the tie rod mounting plate.

Item 1: Tie rod assembly centerline (first mark)  
 Item 2: 5 7/8 from tie rod assembly centerline (second mark)

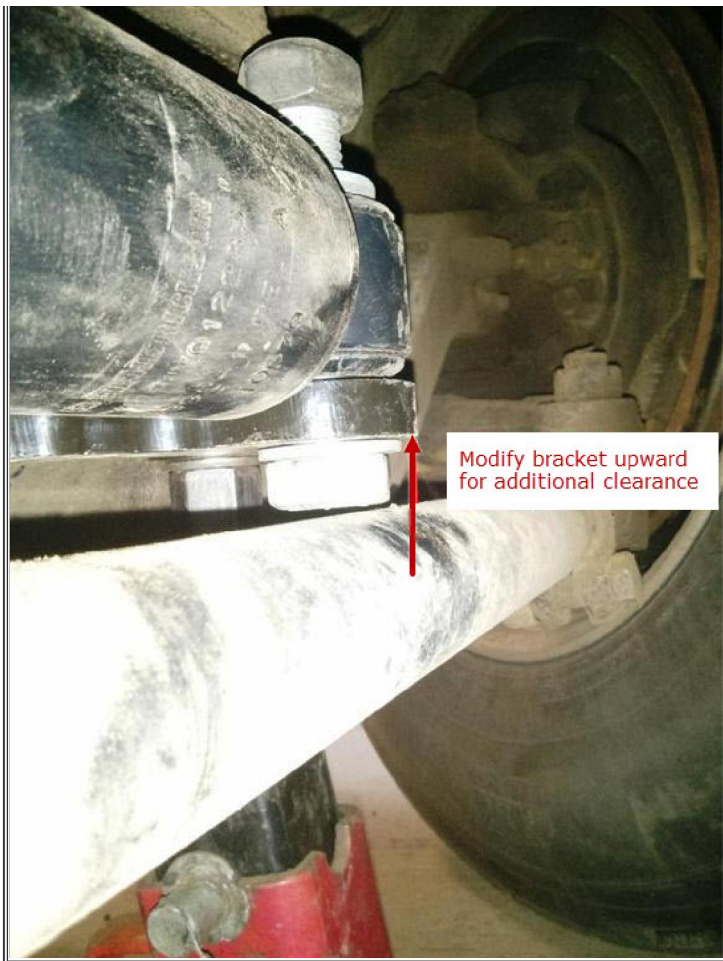
**Figure 4: Tie rod tube to mount clearance**

9. Ensure proper clearance between the tie rod tube and the shock mount at the U-bolt per figure 4. If required modify the mounting bracket to provide the needed clearance.
10. Before returning the truck to service, the steering system MUST be tested through its full range of travel. Any binding or contact at any point must be repaired before releasing the vehicle.
