TECHNICAL SERVICE BULLETIN

Vista Roof - Rattle And/Or Squeak Noise While Driving With Roof Opening Panel Closed

19-2374
13 December 2019

Ford 2015-2019 F-150
2017-2019 F-Super Duty
2018-2019 Expedition
Lincoln 2018-2019 Navigator

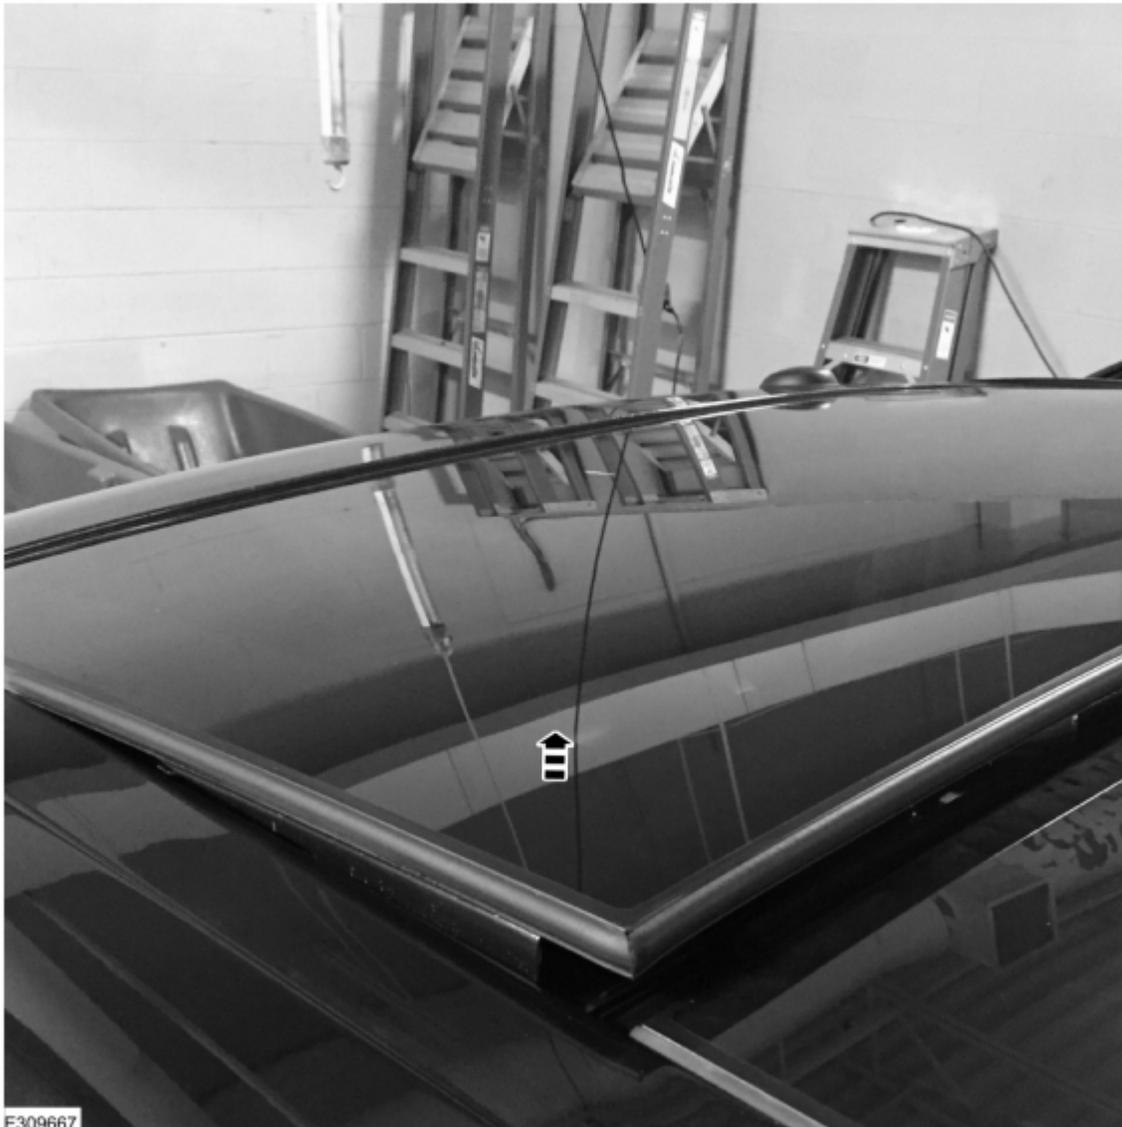
Figure 1

1. Position the glass panel to the vent position. (Figure 1)

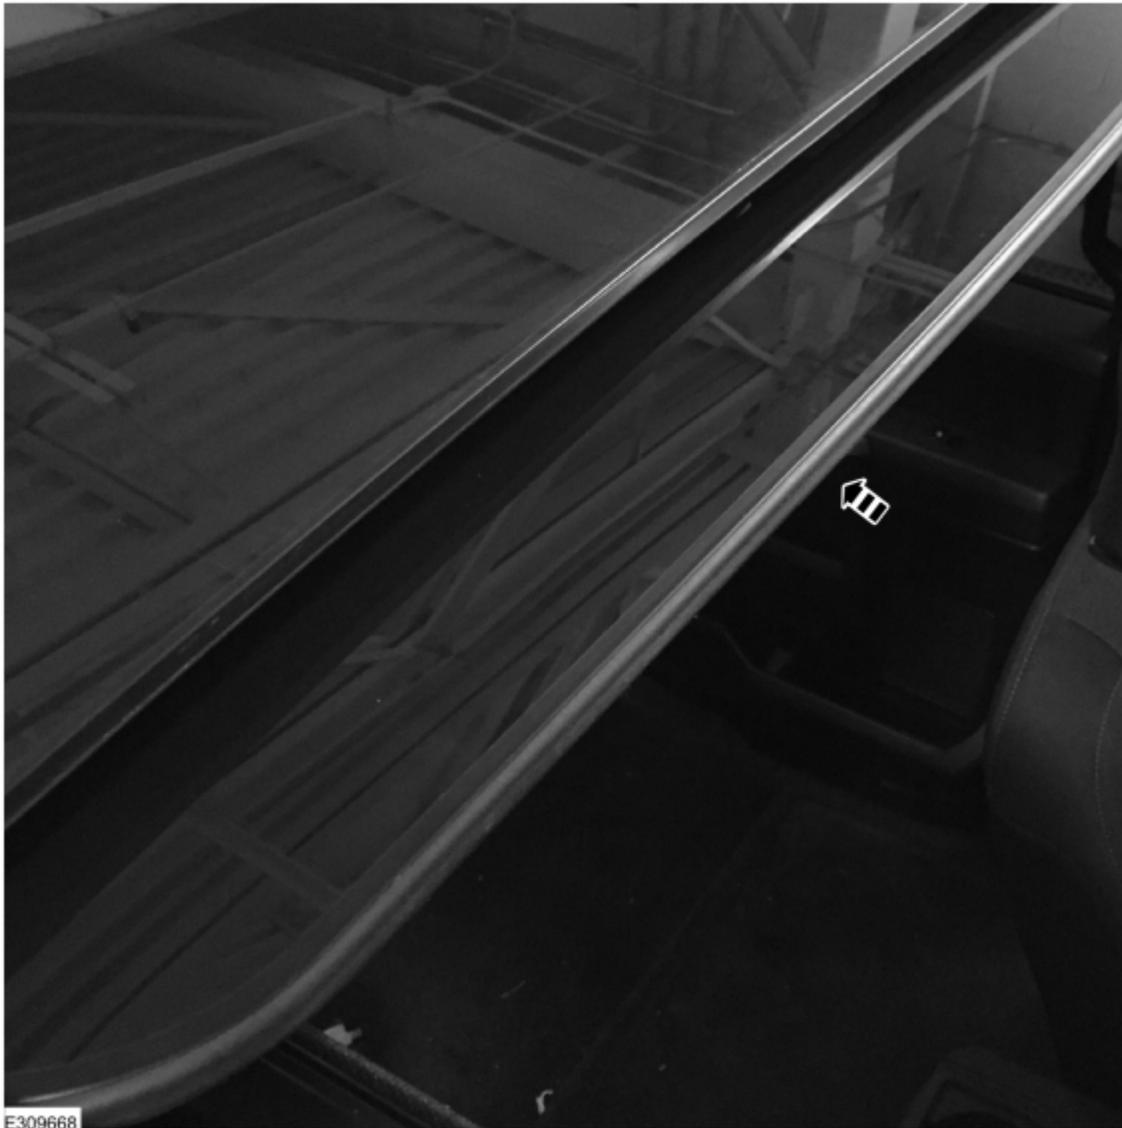
Figure 2

2. Clean the rear and side rubber seals of the movable glass panel with isopropyl alcohol or equivalent.
3. Clean the exposed sheet metal of the roof opening with isopropyl alcohol or equivalent.
4. Position the glass panel to the fully open position. (Figure 2)

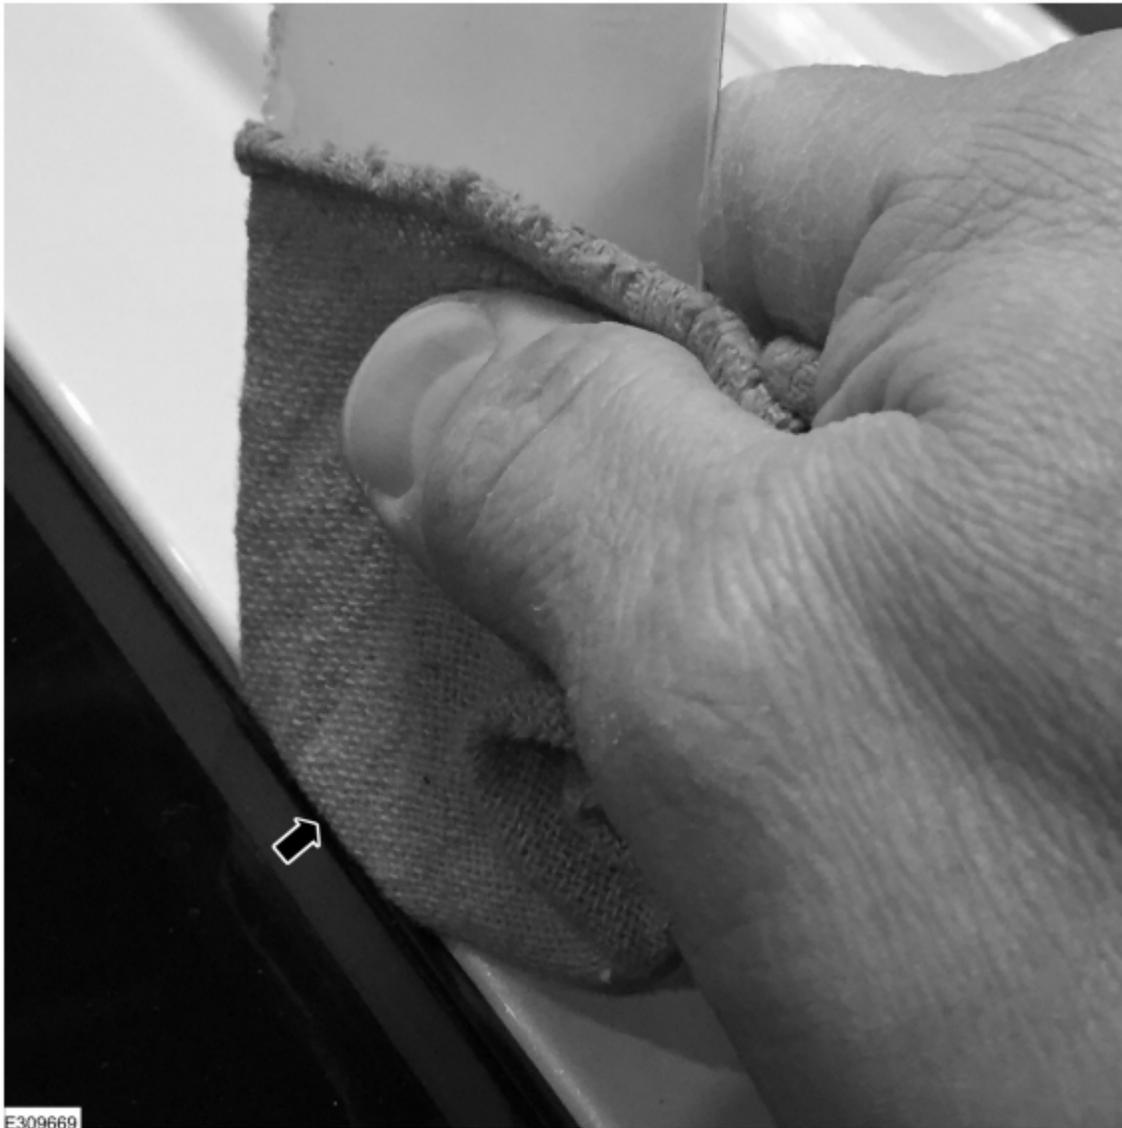
Figure 3

5. Clean the remaining front rubber seal area of the movable glass panel with isopropyl alcohol or equivalent.
6. Clean the remaining exposed sheet metal of the roof opening with isopropyl alcohol or equivalent.
7. Apply isopropyl alcohol or equivalent onto a clean cloth and insert it between the rear fixed glass panel rubber seal and the roof opening sheet metal. (Figure 3)
 - (1). Folding the cloth over a flexible piece of plastic such as an old credit card or a thin piece of plexiglass will assist in the cleaning process.
 - (2). Slide the isopropyl alcohol soaked cloth around all sides of the fixed panel glass and rubber bulb seal.

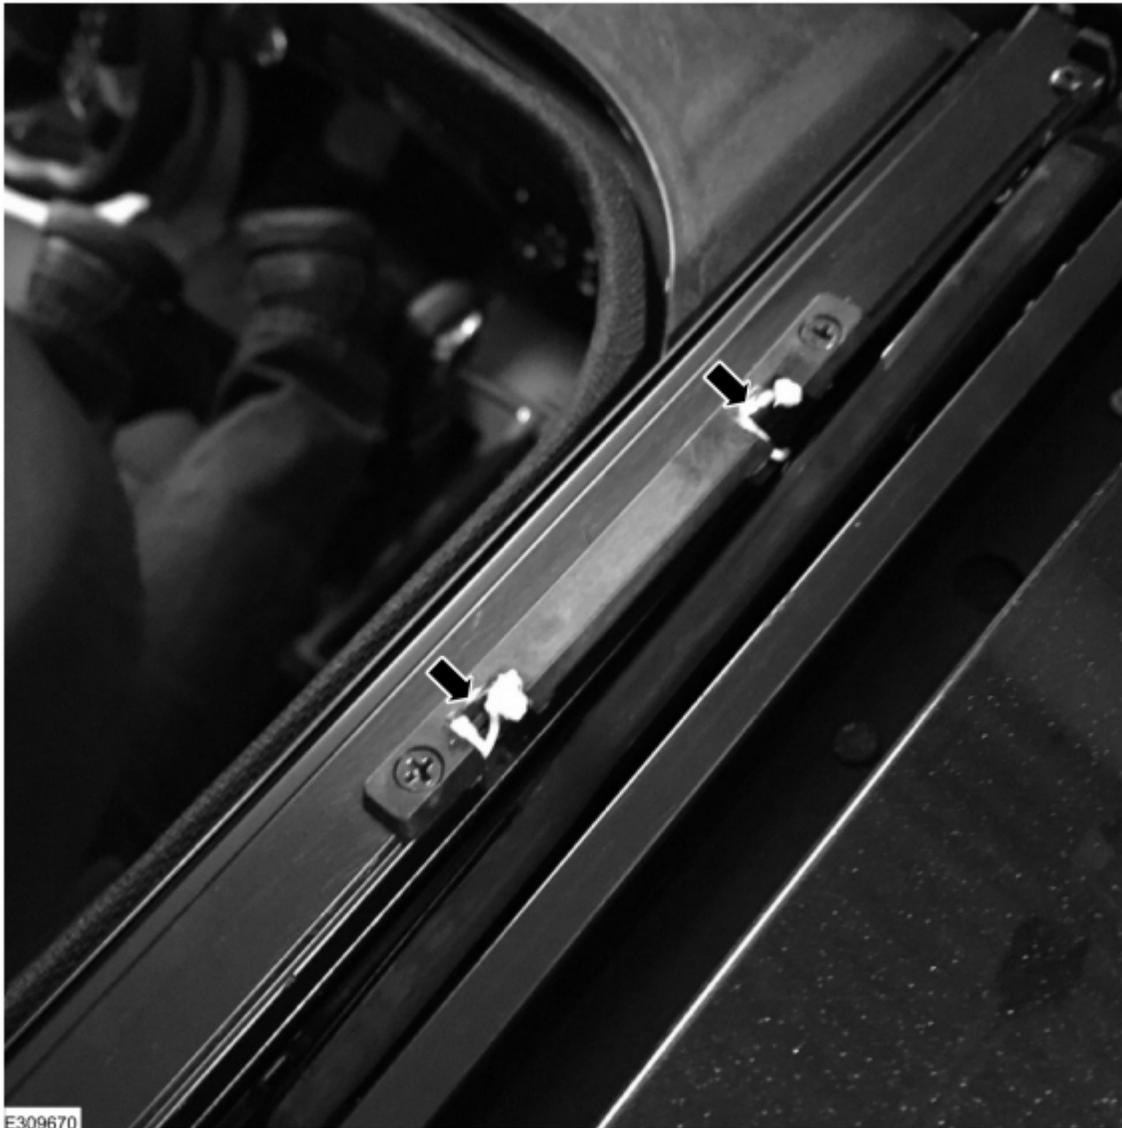
Figure 4

9. Hold the wind deflector down and apply Krytox® Grease to both openings of the left and right front set plates. (Figure 4)
