Technical Service Bulletin

Topic	Air spring fault finding
Market area	Bentley: worldwide (2WBE)
Brand	Bentley
Transaction No.	2053492/5
Level	EH
Status	Released for publishing
Release date	Dec 16, 2019

The front and/or rear suspension appears to have dropped.

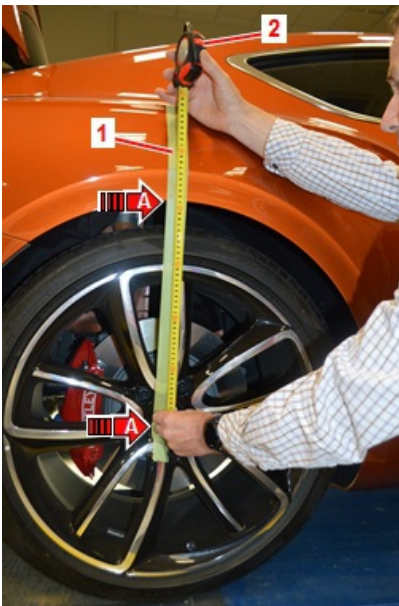
Figure 1

Adhere strips of masking tape (1) from the centre of each wheel to the highest part of the wheel arch as shown, making sure they are applied taut.

Using a tape measure (2), also measure and take note of the ride heights (A-A) at all four corners of the vehicle. See Figure 1.

Leave the vehicle overnight and again measure the ride heights (A-A) at all four corners of the vehicle. Compare these values with those taken previously.

If there is **NO** difference in ride heights, and the strips of masking tape are still 'taut' then no air leak is present. Please explain to the customer the long term storage or changing climate conditions would cause a drop in ride height which is normal. As soon as the vehicle is started, the compressor will level the vehicle automatically. No further action is required.

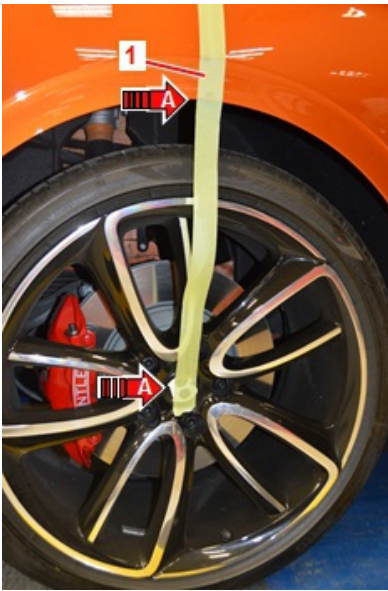
Figure 2

If there **IS** a difference in ride heights, and the strips of masking tape (1) have 'sagged' (shown in Figure 2), then refer to the following leak finding procedures below.

It should be noted that if these checks involve a claim through warranty then photographic evidence of the vehicle sagging and air leak should be included.

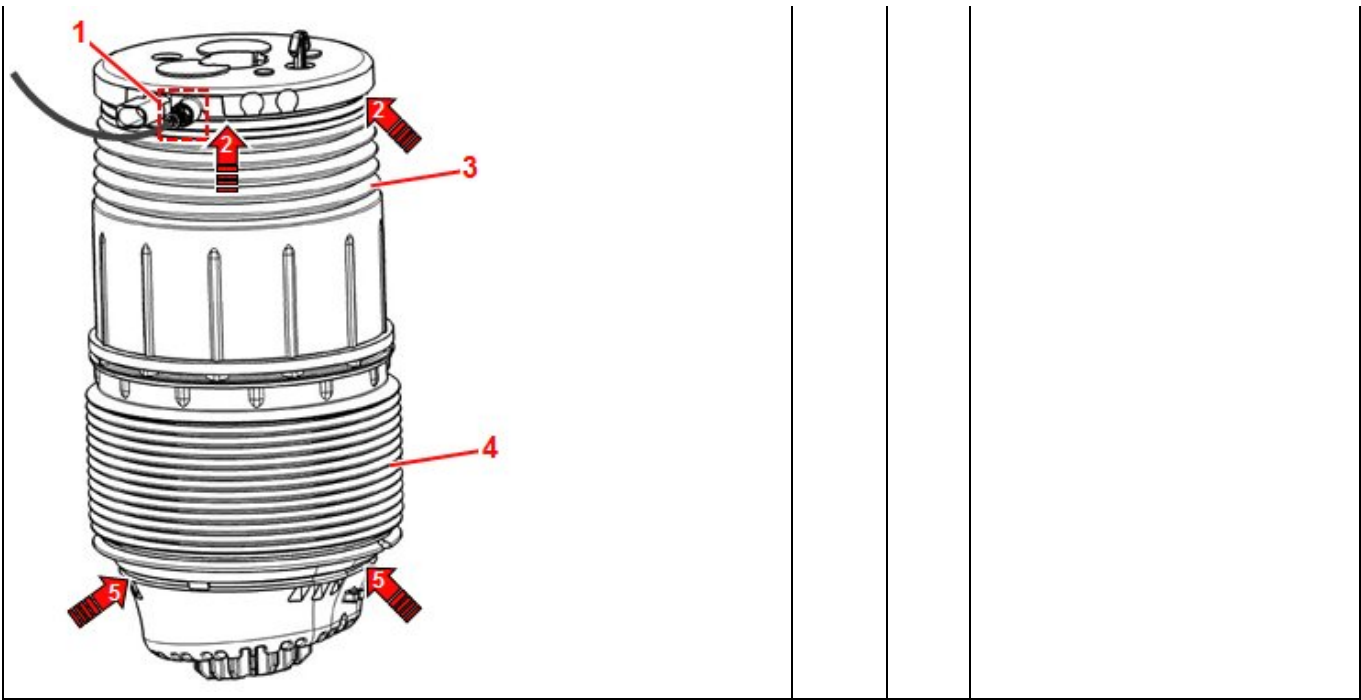
Rear air spring check points – New Continental GT

Check	Yes	No	Comments
Air feed pipe connection (1) Top of air spring (2) Air spring gaiter condition (3 & 4) Lower area of air spring (5)
