LTB01230NAS2

TECHNICAL BULLETIN

Third Row Seat(s) Not Latching in the Upright Position

MODEL:	MODEL YEAR:	VIN:	APPLICABILITY:
Discovery (LR)	2017-2018	000004-073436	Vehicles With: 7 Seats

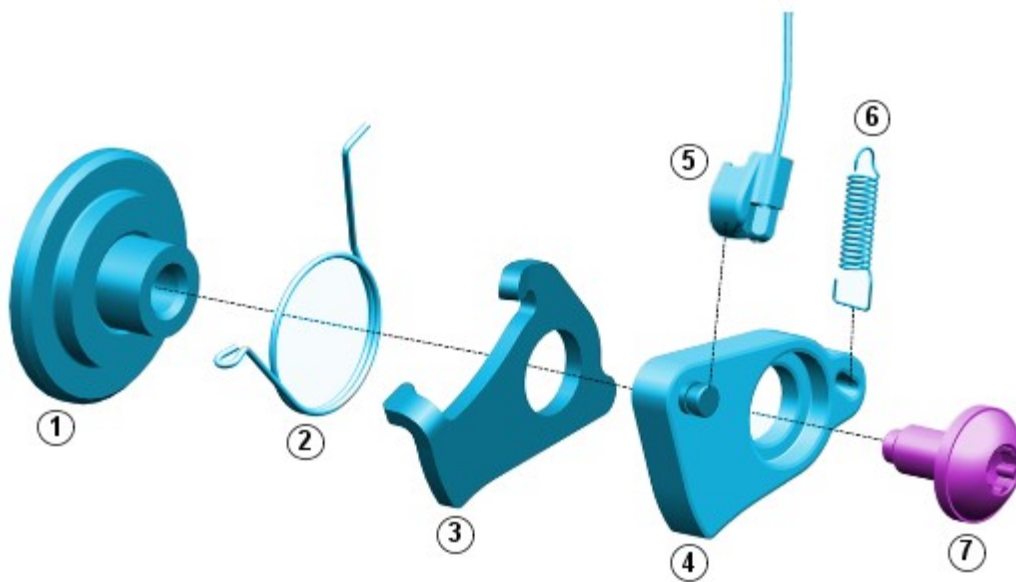
E231098

Component overview:

- **1.** Boss
- **2.** Free play spring
- **3.** Free play cam
- **4.** Crash lock
- **5.** Bowden cable
- **6.** Crash lock spring
- **7.** Fastener

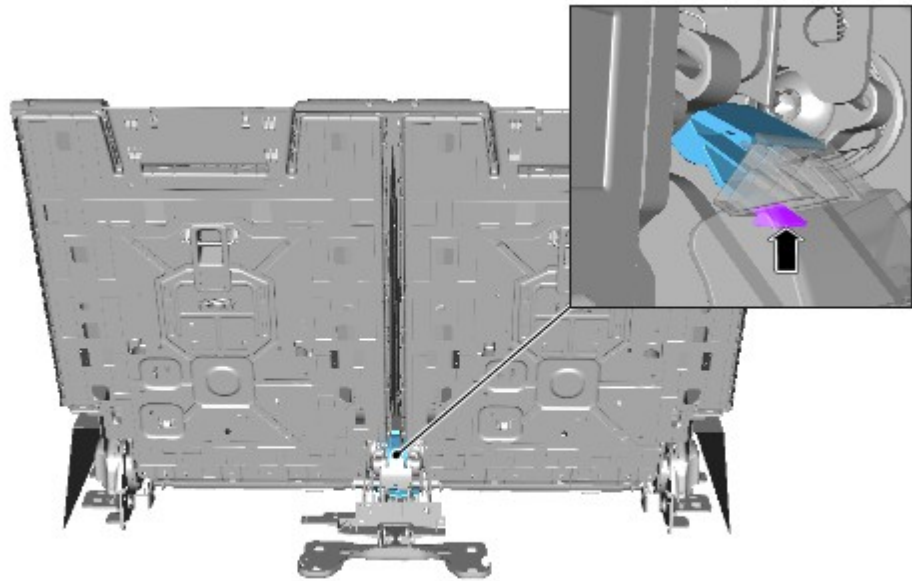
E231095

Do not attempt to fully remove the trim at this point.

Release the trim tab only.

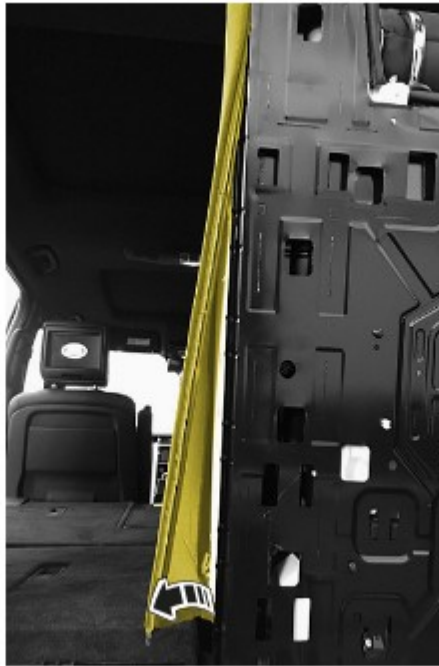
E231598

Do not fully remove.

Unclip the backrest seat trim for access only.

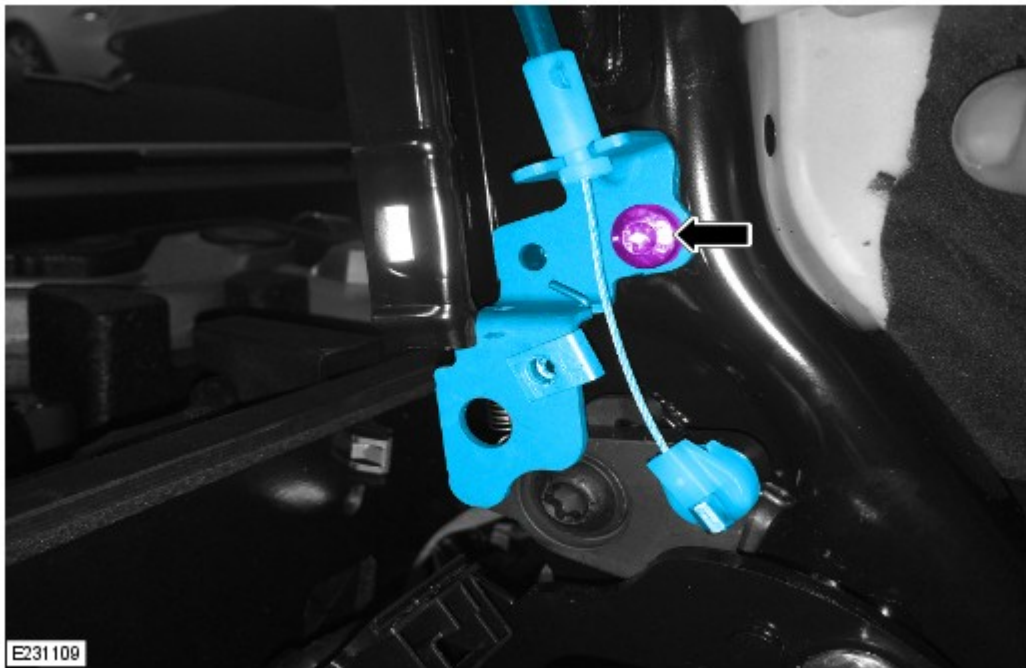
Do not remove the bowden cable from the plastic fixing on the bracket.

Remove the bowden cable bracket securing bolt.

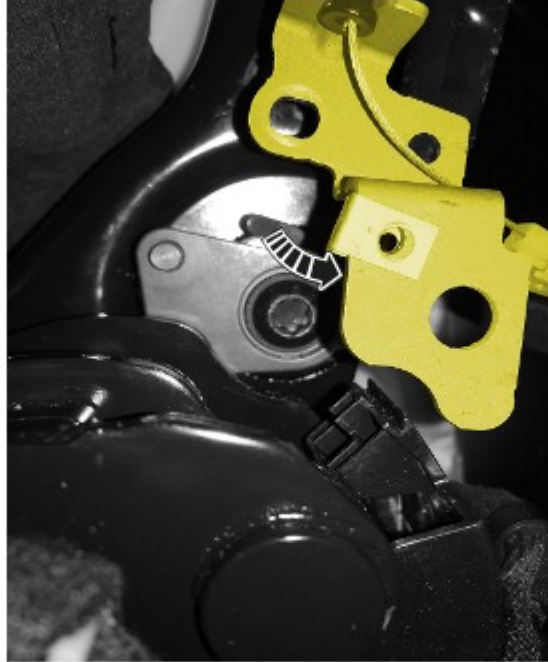
E231601

The bowden cable bracket is held under tension by the freeplay cam spring.

Compress the free play spring to allow movement of the bracket and position to allow access to the crash lock securing bolt.

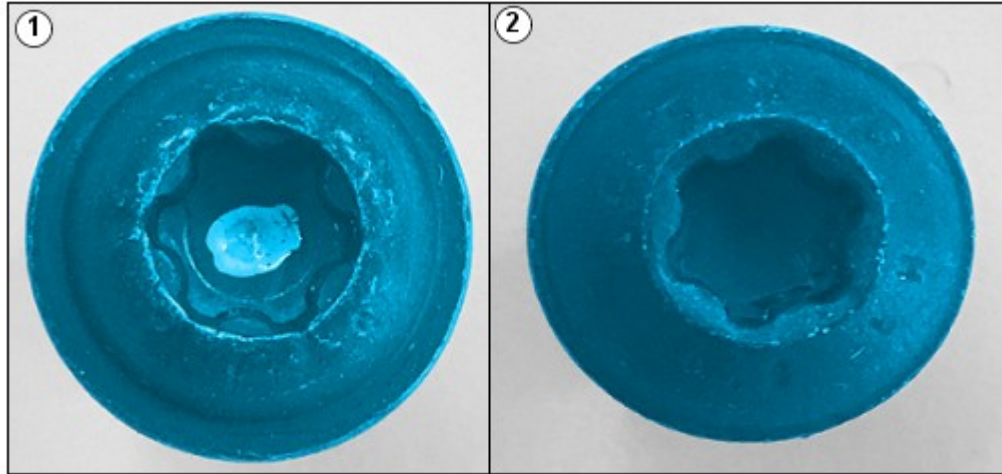
E231102

You must identify the type of crash lock securing bolt used.

Identify the type of crash lock securing bolt used:

- **1.** Right hand thread - Large flat flange around the head of the bolt.
- **2.** Left hand thread - Small flange around the head of the bolt.

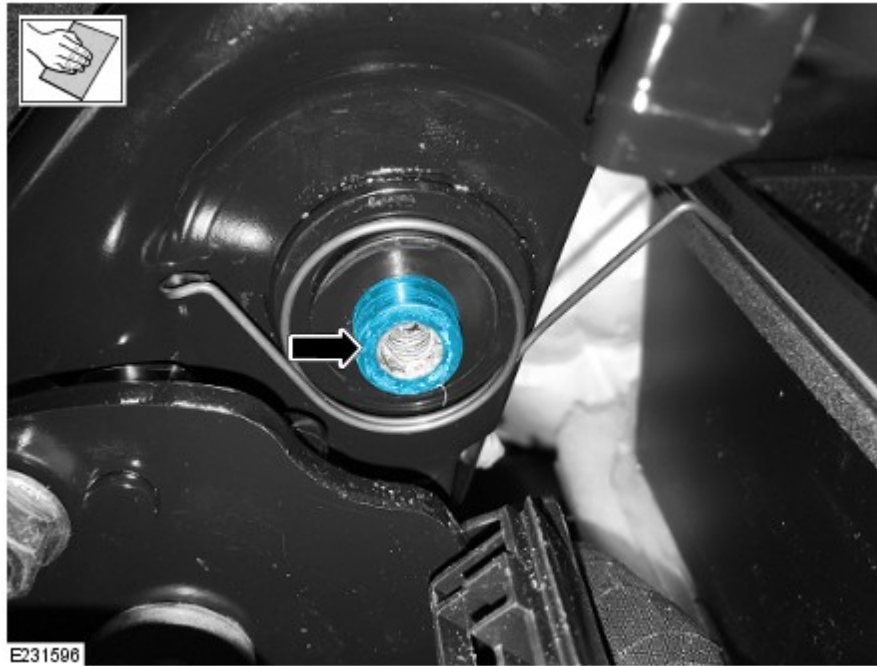
Debris in the latch, limiting operation.

Clean the area highlighted using **ONLY** the Scotch-Brite™ supplied within the kit.

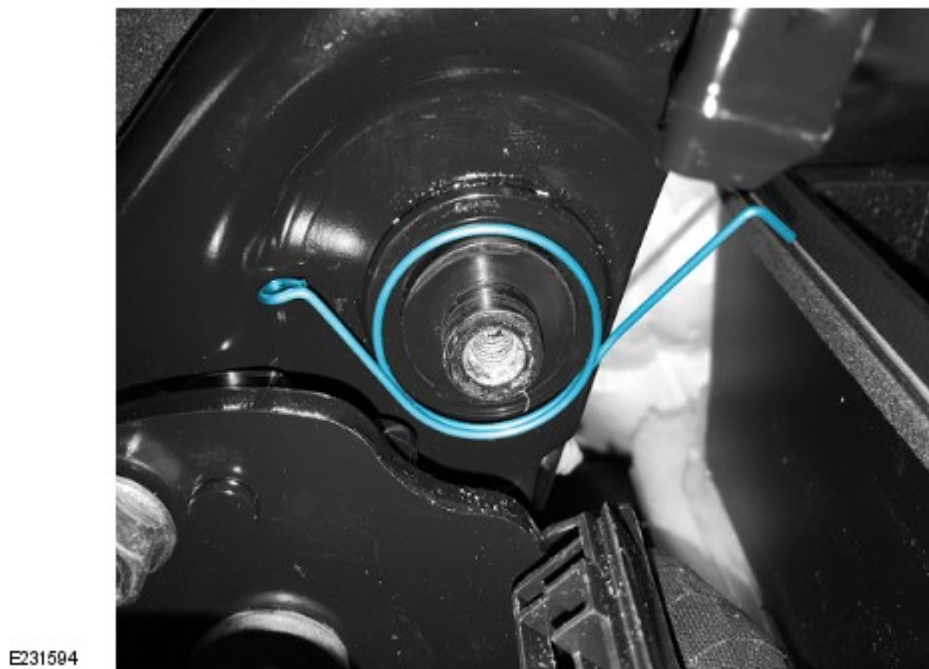
Take note of the installed position shown in the illustration above making sure the free play cam spring is seated on the boss.

Install a new free play cam spring.

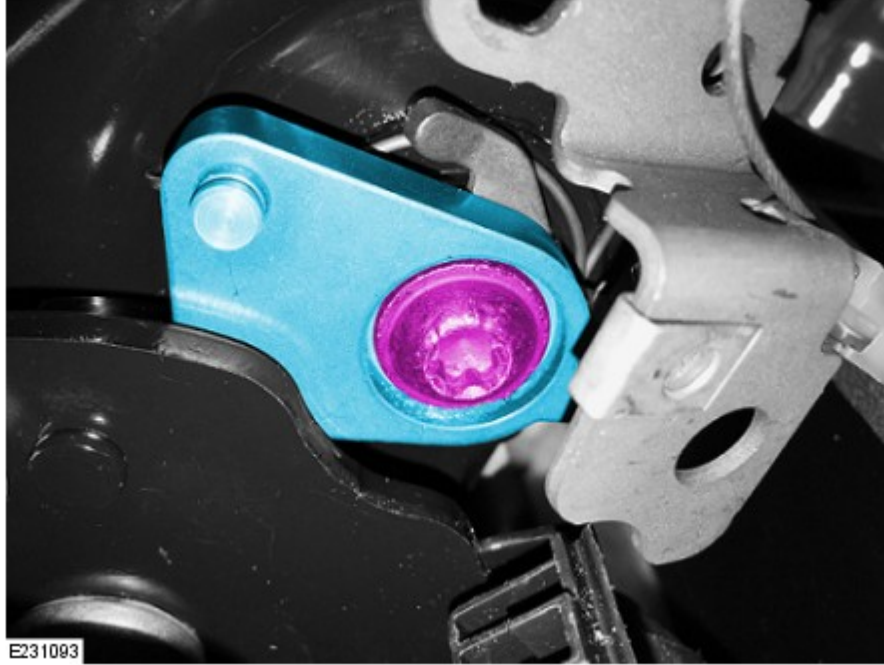
Make sure the free play cam and spring are seated correctly before tightening the retaining bolt.

Install a new crash lock and a new retaining bolt.

- ■ Torque: 25 Nm
