**ANC Booms/Rumbles**

**AFFECTED VEHICLES**

Year	Model	Trim
2018 - 20	Accord	ALL
2019 - 20	Insight	ALL

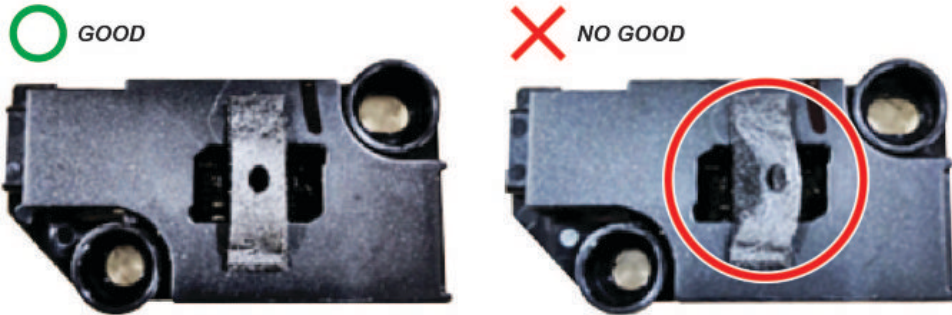
Are you hearing a booming or rumbling through the speakers? If you get a vehicle in for this, remove the covers in the headliner for the ANC microphones and check if the insulating foam is damaged or folded over as shown below. We've found this may be the reason for the noise.

Inspect the microphone assembly using the ANC MICROPHONE CHECK procedure on the next page.

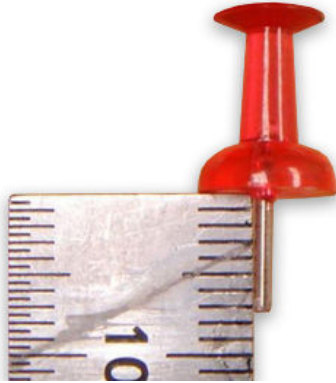
- The Accord has three microphones: front, middle, and rear. This procedure can be done only on the middle and rear microphones.
  - The Insight has two microphones: front and rear. This procedure can be done only on the rear microphone.
1. Take a push pin with a diameter of **1 mm**, and trim it to a length of **7 to 8 mm**.

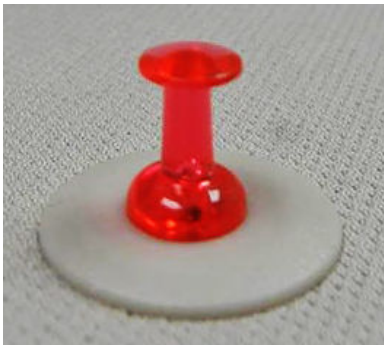
2. Insert the push pin into the microphone cushion hole.
  - If the push pin sits flush on the mic cover without resistance, the microphone assembly is good.

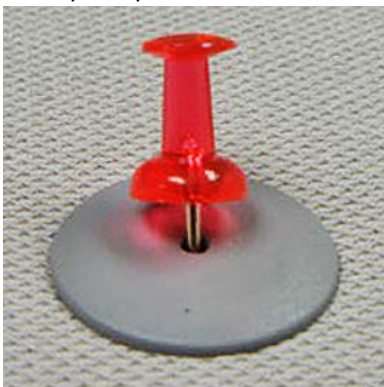
- If the push pin doesn't sit flush or there's resistance, you need to replace the microphone assembly.

3. Once the assembly is replaced, use the ANC MICROPHONE CHECK to make sure the repair was done correctly.

If the pin doesn't sit flush, depending on how damaged the foam is, you might have to replace the assembly again.
