Technical Service Bulletin

Topic	Rotating Display - Fault Diagnosis
Market area	Bentley: worldwide (2WBE),Hongkong-Macau (5HK)
Brand	Bentley
Transaction No.	2055580/2
Level	EH
Status	Released for publishing
Release date	Dec 16, 2019

New Continental GT

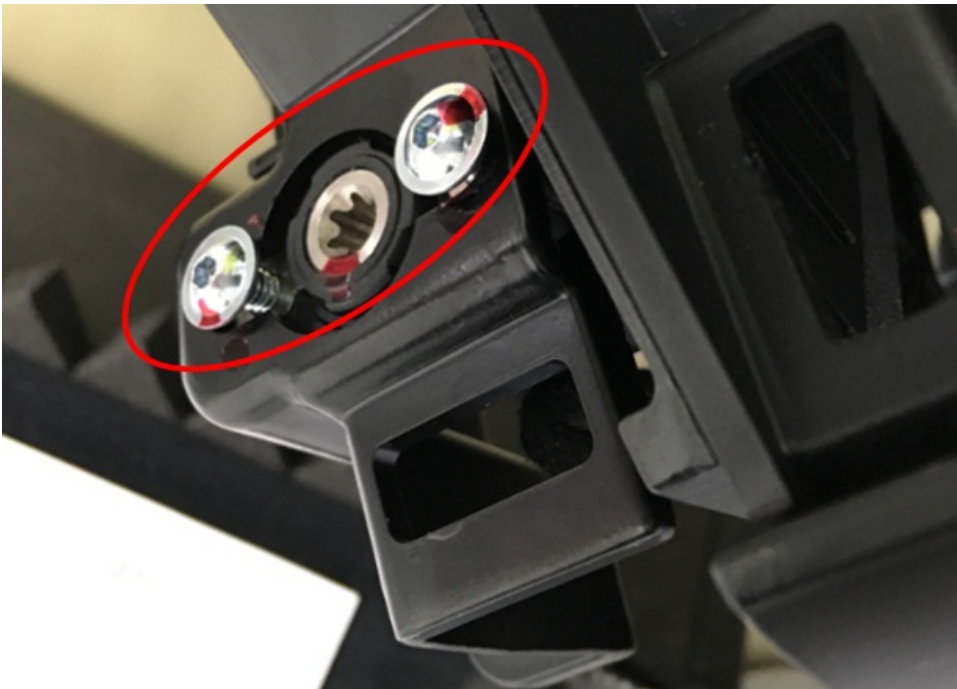
Figure 5

Check the tightness of the fixing screws highlighted (Figure 5), there are 8 fixing screws in total.

Check and retighten where necessary (3 Nm).
