## SERVICE ADVISORY # 19-365

### Sunset Convenience Center

It has been determined that the convenience center in certain models of Sunset Travel Trailers may allow any residual water from the various connections at the convenience center to leak on the pass-through compartment at the water hook-ups. The following procedure describes how to install a tray under the water hook-ups to divert water back outside if needed.

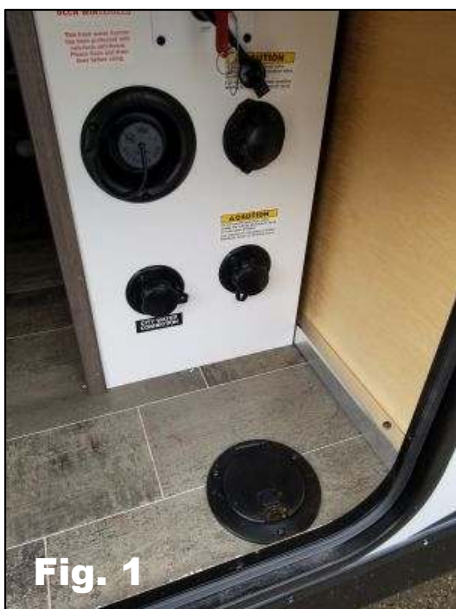
**Fig. 1**

Locate the convenience center box on the off-door-side pass-through compartment. Remove the existing hatch in the floor in front of the convenience center, Figure 1.

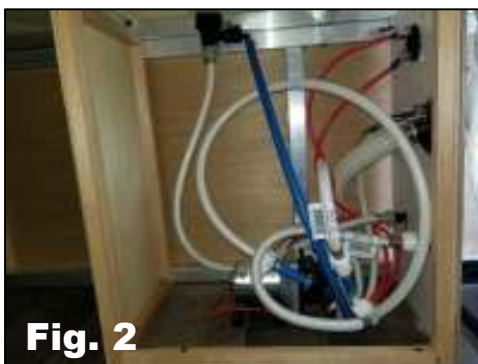
**Fig. 2**

From inside of the pass through compartment remove the access panel of the convenience center box that faces the front of the unit. Remove the mounting screws in the cleat at the floor and the back wall for the convenience center, Figure 2.

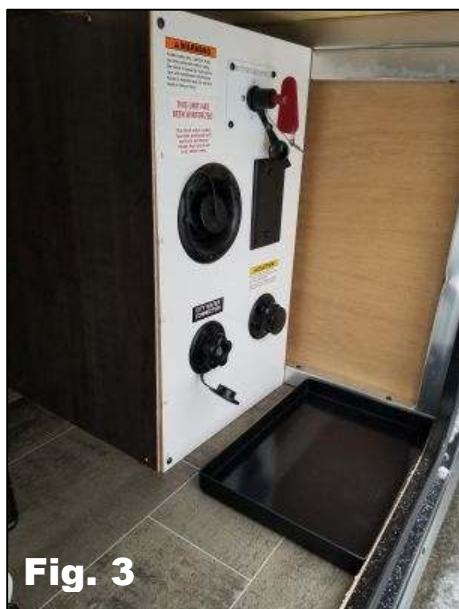
**Fig. 3****Step 4**

Place KRV# 650797 - Tray - Drip - ABS - Black on the floor between the off-door sidewall and convenience center box. Slide the convenience center box over so that the drip tray is tight against the sidewall and convenience center panel, Figure 3.

Attach drip tray to convenience center box and reattach the convenience center box to floor and pass-through compartment cross member. Typically the convenience center box will move towards the off-door-side several inches and will attach in the same manner as before.

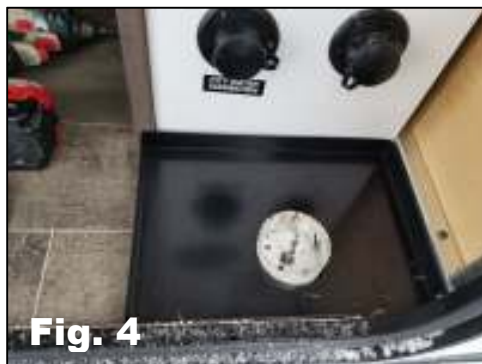
**Fig. 4****Step 7**

From the underside of the unit using the existing hole in the floor, cut the hole in the ABS tray using the correct sized hole saw or a jig saw, Figure 4.

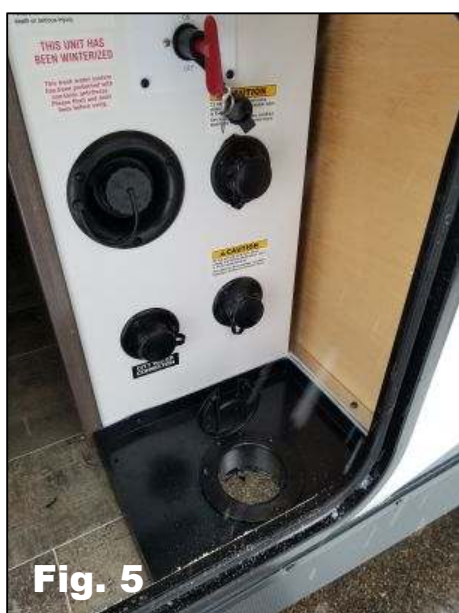
**Fig. 5****Step 8**

Attach the hatch over the hole using an appropriate silicone or butyl sealant. Seal edge of tray along convenience center panel, Figure 5.
