Technical Service Bulletin

SUBJECT:		No: TSB-19-52A-005	
SECOND ROW CENTER SEAT BELT BUCKLE INTERFERENCE WITH RIGHT SEAT BELT BUCKLE		DATE: December 2019	
		MODEL: 2014-19 Outlander, 2018-19 Outlander PHEV	
CIRCULATE TO:	<input type="checkbox"/> GENERAL MANAGER	<input checked="" type="checkbox"/> PARTS MANAGER	<input checked="" type="checkbox"/> TECHNICIAN
<input checked="" type="checkbox"/> SERVICE ADVISOR	<input checked="" type="checkbox"/> SERVICE MANAGER	<input checked="" type="checkbox"/> WARRANTY PROCESSOR	<input type="checkbox"/> SALES MANAGER

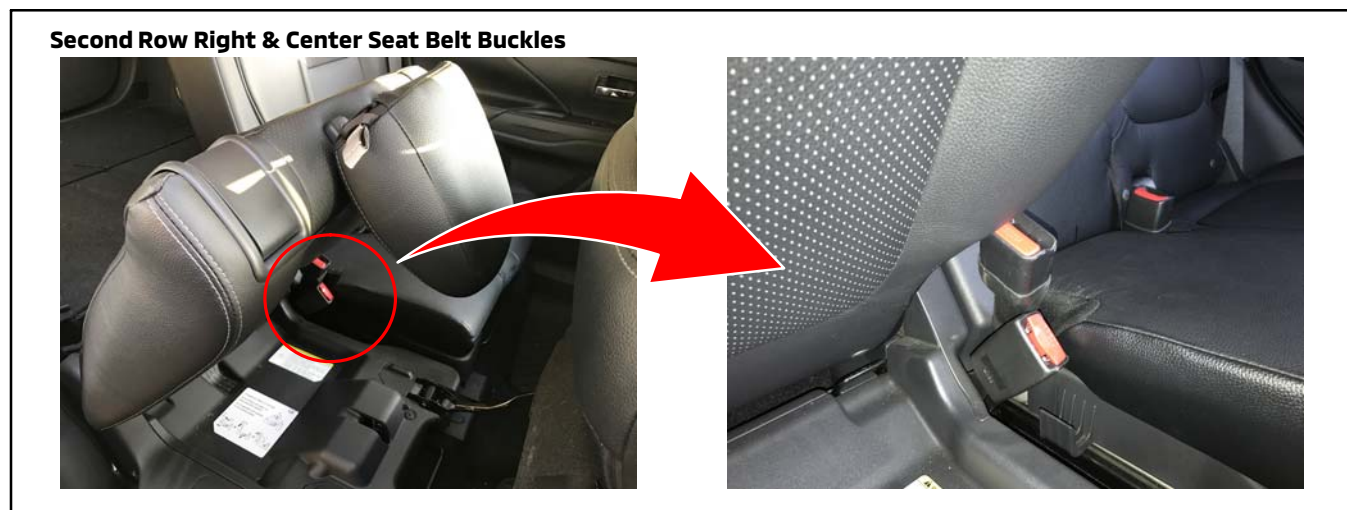
A customer may report that the second row right side seat belt buckle cover has come off, and in some instances, prevent the second row right side seat belt tongue from latching into the buckle when the internal buckle components have fallen off.

This may be caused by repeatedly folding the second row right side seat back while the center seat belt buckle is positioned on top of the right side seat belt buckle.

The second row center seat belt buckle length has been shortened by 14 mm to prevent the center seat belt buckle from covering the right side seat belt buckle.

This TSB instructs dealers to replace the second row right side seat belt buckle with a new part and install the countermeasure second row center seat belt buckle.
