| Title | Updated PM Sensor Removal Procedure - <b>US17+OBD16 and Newer Emissions</b> |

| <b>Cause</b> | When removing a PM sensor for replacement, the threads may be damaged during extraction of the failed sensor. |

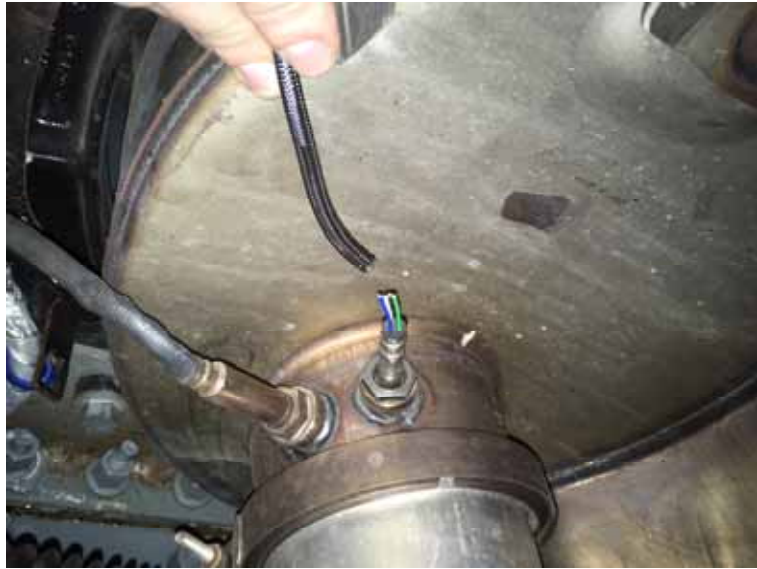
1. Cut the harness at the top of the sensor.

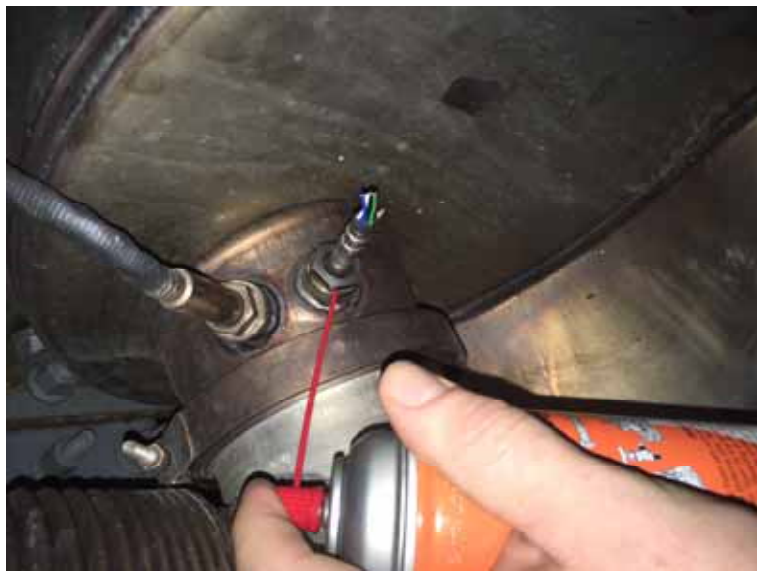
2. Spray the sensor nut with a suitable rust penetrant and let soak for approximately 5 minutes.

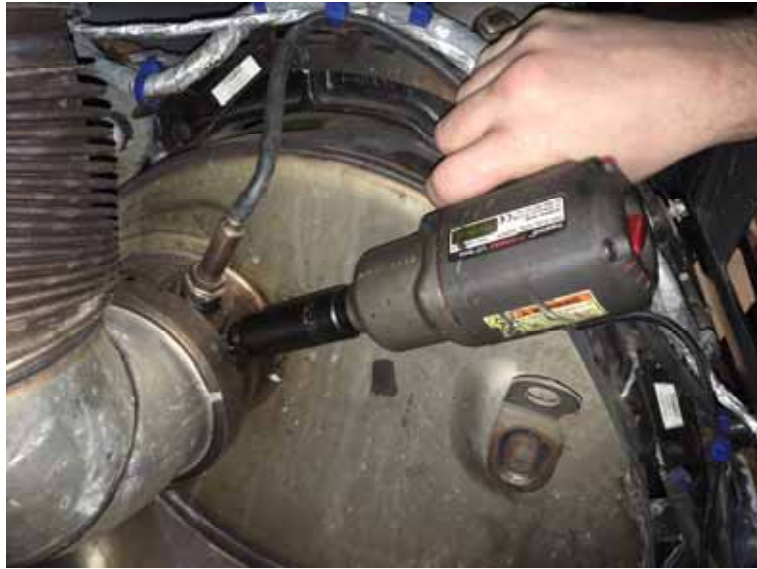
3. Remove the sensor with a ½" drive impact and appropriately sized deep socket.

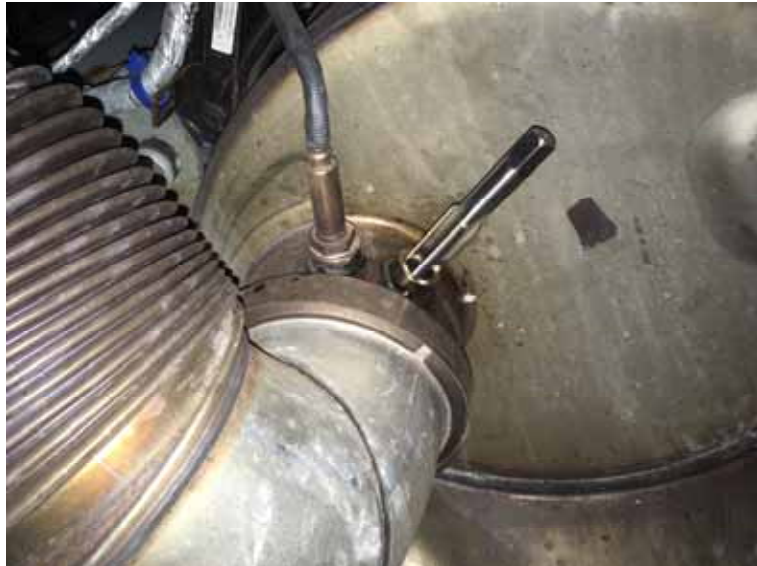
4. Use an M18 x 1.5mm **bottoming** tap to chase the SCR boss threads.

- Example bottoming tap – Grainger part # 2LWT5

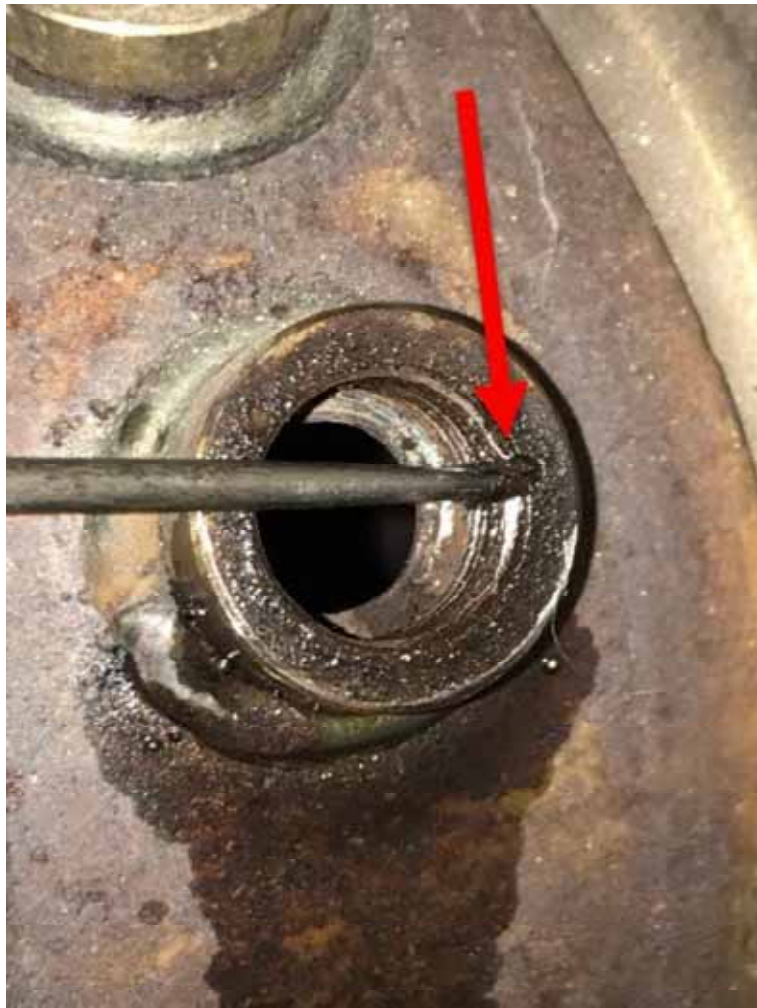
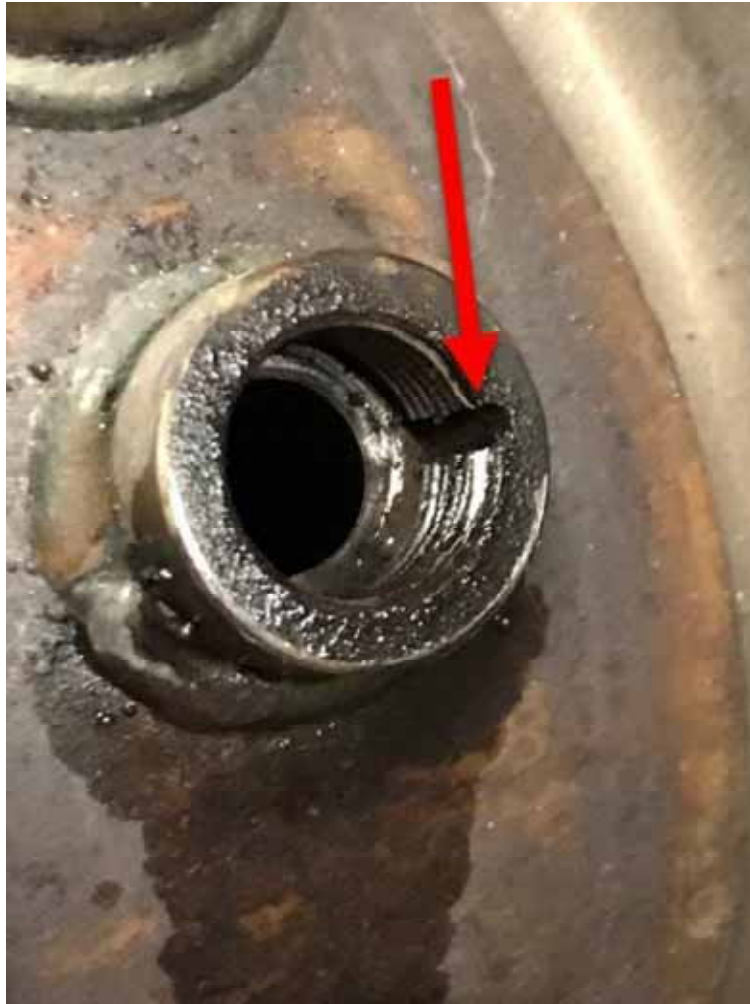
5. Inspect the boss threads and PM Sensor alignment notch for debris and clean if necessary.
