Technical Journal

Doorhandles exterior, not fully return

REF NO: TJ 25129.3.0	ISSUING DEPARTMENT: Technical Service	CAR MARKET: United States and Canada	
PARTNER: 3 US 7510 Volvo Car USA		ISSUE DATE: 2019-12-19	STATUS DATE: 2019-12-30
FUNC GROUP: 8340	FUNC DESC: Lock, handle	Page 1 of 4

Volvo Car Customer Service	
	TJ Instruction
	TJ No.25129
	Date January 2013 Issue 01
Title	Adjustment to door handles.

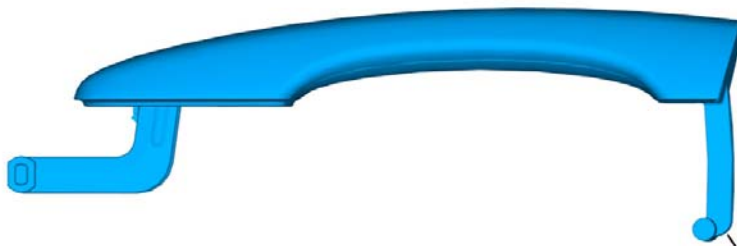
Adjustment

Use: Grease, 1161761

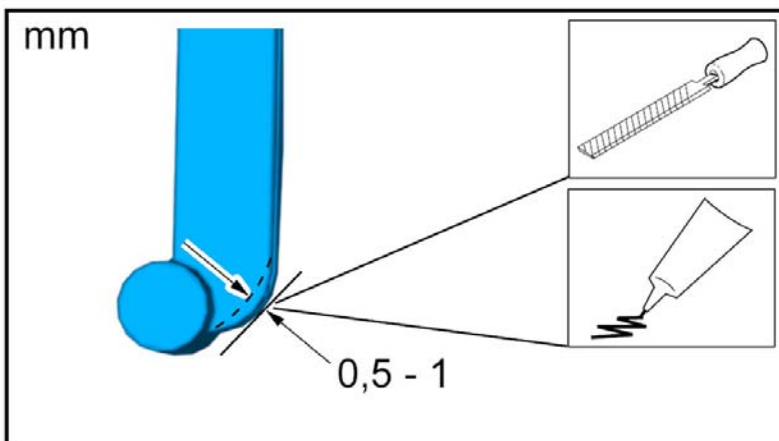
To install, reverse the removal procedure.
