Customer Satisfaction Notification VA2 Power Take-Off

2019 (DD) RAM 3500 Cab Chassis

2019 (DP) RAM 4500/5500 Cab Chassis

The Powertrain Control Module (PCM) on about 2,870 of the above vehicles may be damaged by a voltage spike when the aftermarket up-fit Power Take-Off (PTO) is disengaged. This can result in an illuminated Malfunction Indicator Lamp (MIL) and an inoperative PTO.

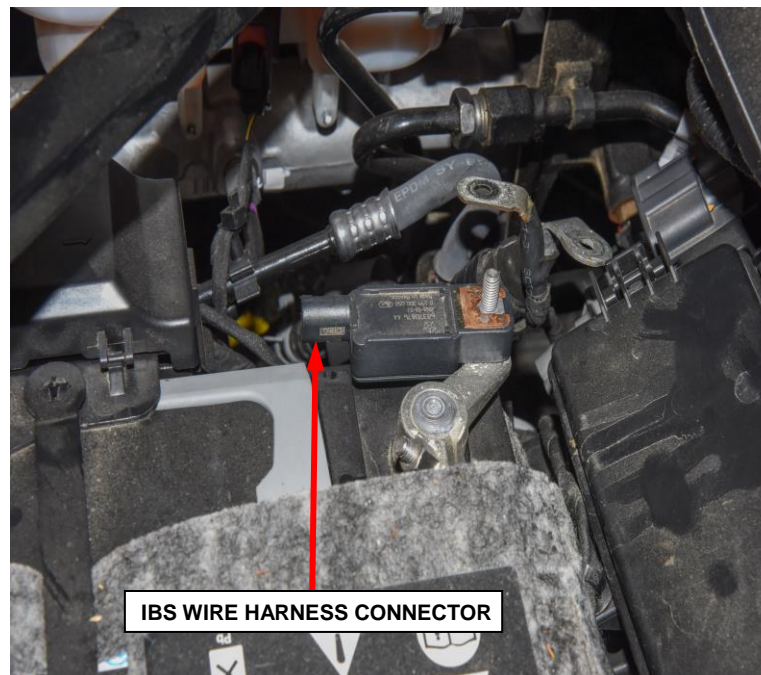
Figure 1 – IBS Wire Harness Connector

1. Disconnect the Intelligent Battery Sensor (IBS) wire harness connector (Figure 1).

31. Reconnect the IBS wiring harness connector (Figure 1).

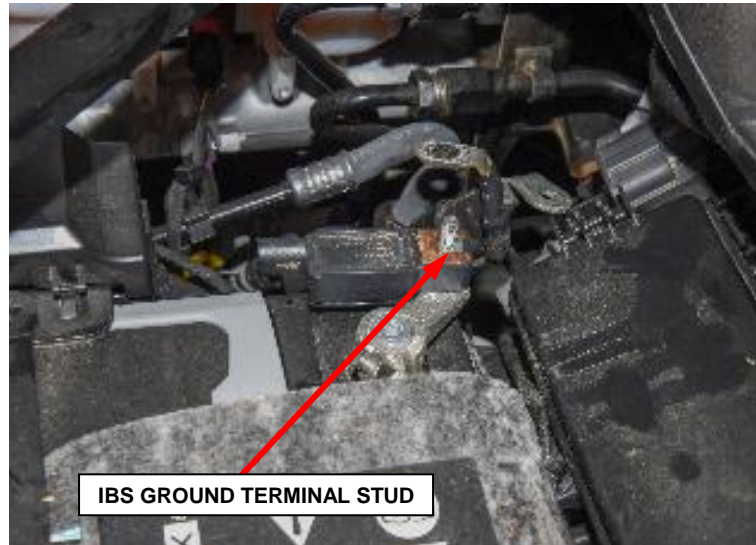
**Figure 2 – IBS Ground Terminal Stud**

2. Loosen and remove the ground terminal nut from the IBS ground terminal stud. Remove the negative battery cable from the IBS stud and isolate it (Figure 2).

30. Connect the negative battery cable to the IBS. Tighten the nut to 11 N·m (97 in. lbs.) (Figure 2).

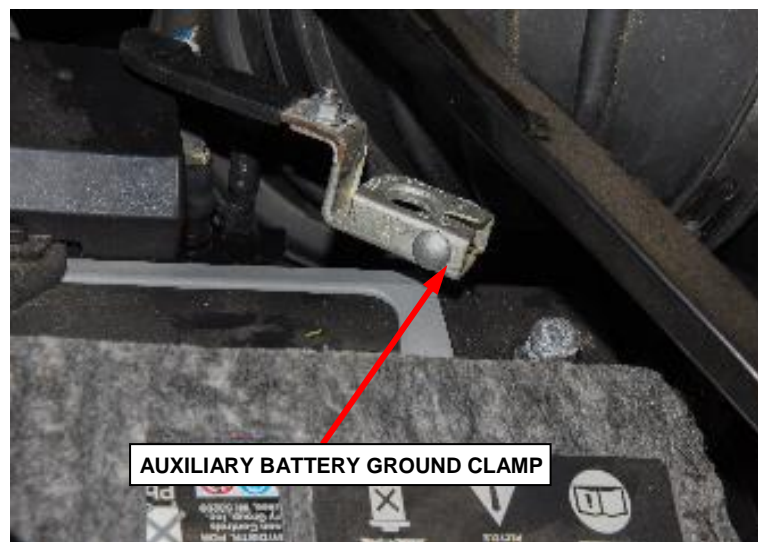
**Figure 3 – Auxiliary Battery Ground Clamp**

3. If the vehicle is equipped with an auxiliary battery, loosen and remove the ground clamp from the battery and isolate it (Figure 3).

29. Connect the auxiliary battery ground clamp to the battery. Tighten the clamp nut to 7 N·m (62 in. lbs.) (Figure 3).

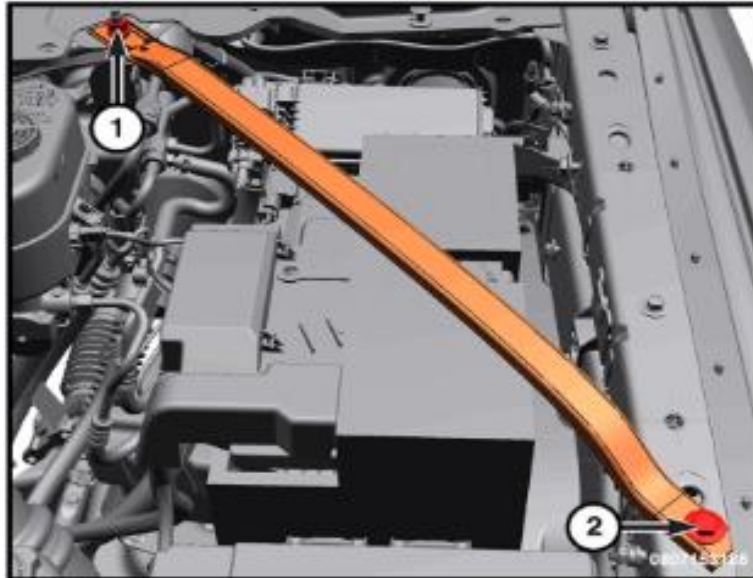
**Figure 4 – Support Brace**

4. Loosen the driver side support brace nut (1) at the cowl and remove the bolt (2) at the fender. Swing the driver side support brace aside (Figure 4).

28. Return the support brace to its mounting location. Install the bolt (2). Tighten the bolt (2) and nut (1) to 22 N·m (16 ft. lbs.) (Figure 4).

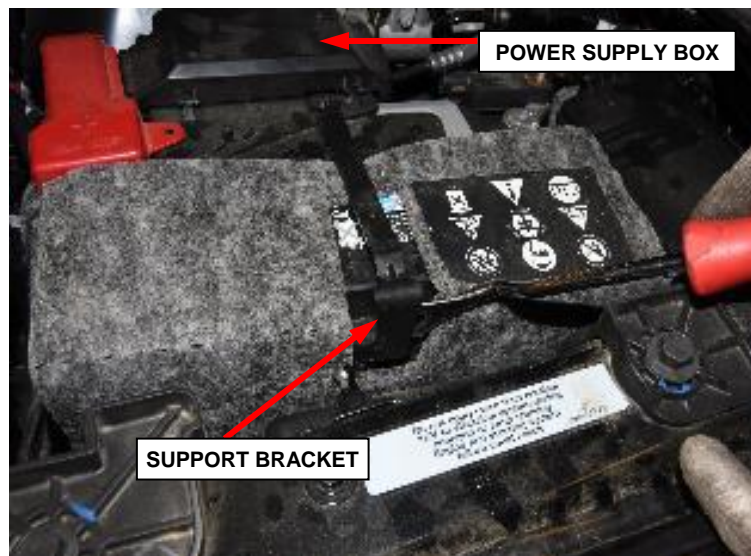
**Figure 5 – Support Bracket**

5. Disconnect the power supply box support bracket from the battery (Figure 5).

27. Install the support bracket for the power supply box to the battery (Figure 5).

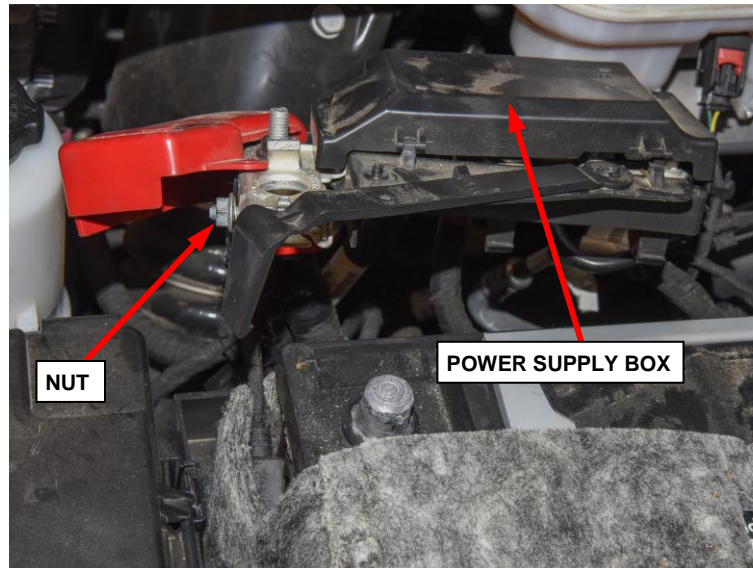
**Figure 6 – Power Supply Box**

6. Loosen the positive battery clamp nut and remove the positive battery cable complete with power supply box (Figure 6).

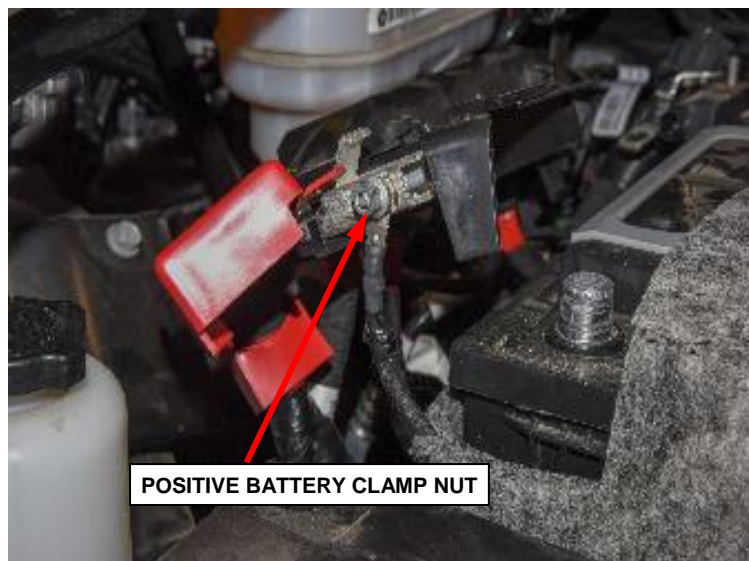
**Figure 7 – Positive Battery Clamp Nut**

7. Remove and save the positive battery clamp nut, then remove the eyelet (Figure 7).

26. Install the eyelet to the positive battery clamp stud, then install the nut. Install the clamp to the battery. Tighten the nut to 7 N·m (62 in. lbs.) (Figure 7).

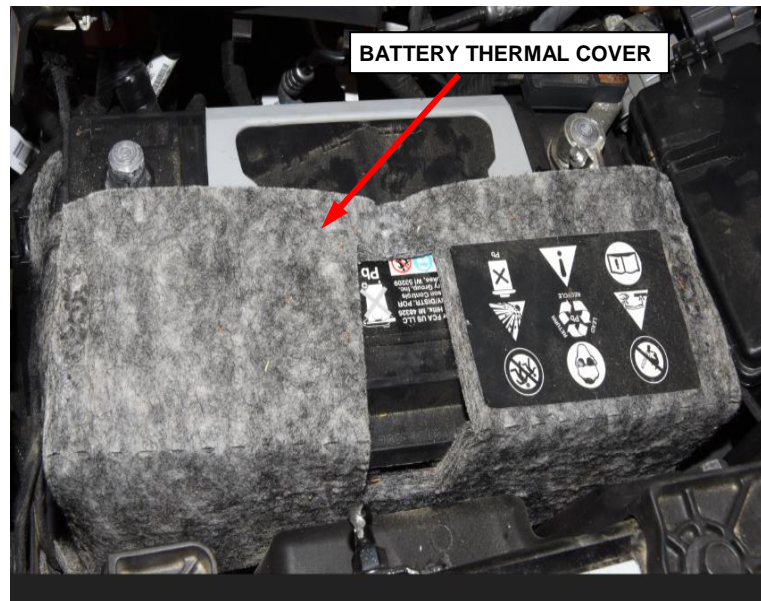
Figure 8 – Battery Thermal Cover

8. Remove the battery thermal cover from the battery (Figure 8).

25. Install the battery thermal cover to the battery. **Diesel engine only:** Ensure that the small wire and eyelet pass inside the cover as originally installed (Figure 8).

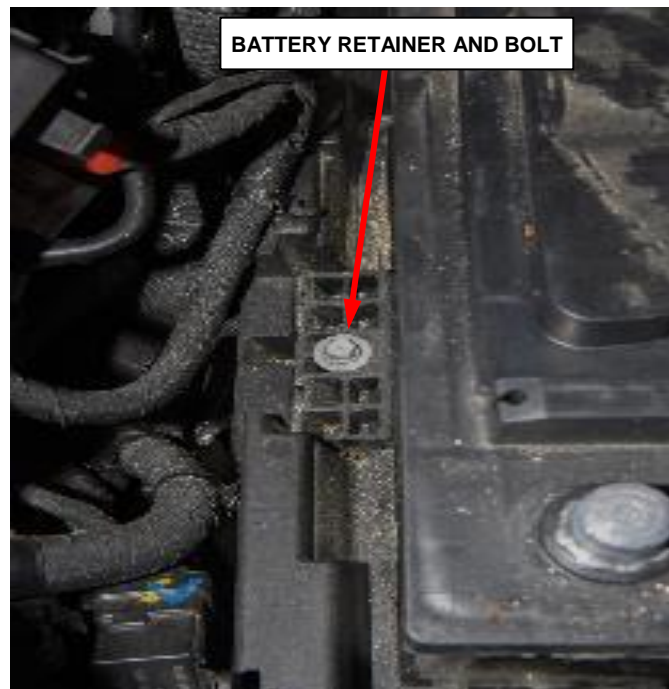
Figure 9 – Battery Retainer and Bolt

9. Remove the battery retainer bolt and remove the retainer that holds the battery to the tray (Figure 9).
10. Remove the battery from the vehicle.

23. Install the battery to the vehicle.

24. Install the battery retainer and bolt to the vehicle. Tighten the bolt to 8 N·m (71 in. lbs.) (Figure 9).

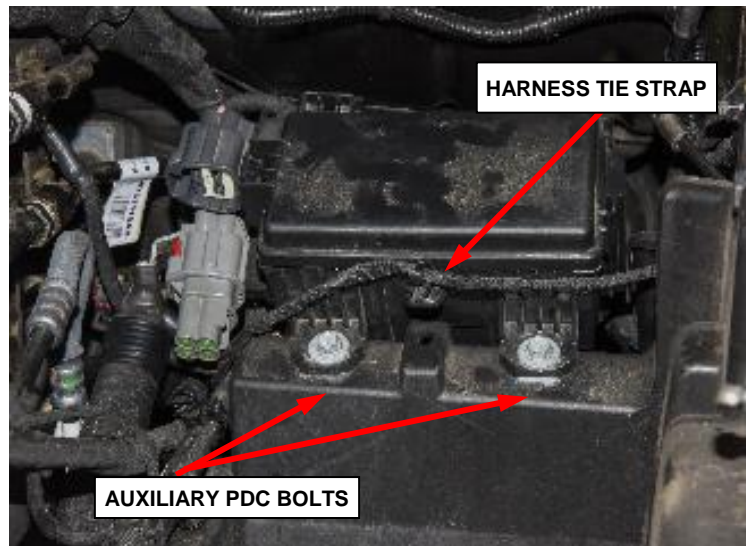
Figure 10 – Auxiliary PDC Bolts and Harness Tie Strap

11. Remove the two bolts retaining the auxiliary PDC to the battery tray. Remove the small harness fir tree tie strap from the tab on the auxiliary PDC (gas engine only) (Figure 10).

22. Install and tighten the two bolts retaining the auxiliary PDC to the battery tray. Secure the small harness fir tree tie strap to the tab on the auxiliary PDC (Figure 10).

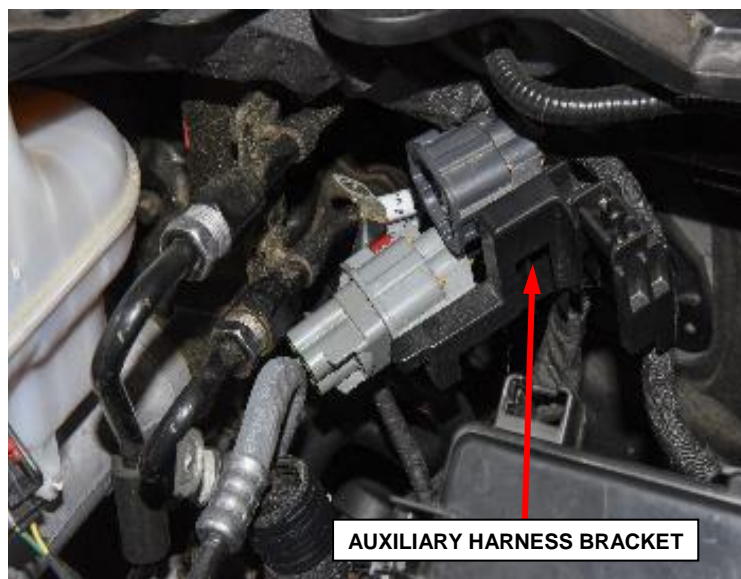
Figure 11 – Auxiliary Harness Bracket

12. Remove the auxiliary harness bracket from the auxiliary PDC by pressing the lock tab and pulling the bracket upward. Roll the auxiliary PDC forward into the open space of the battery tray (Figure 11).

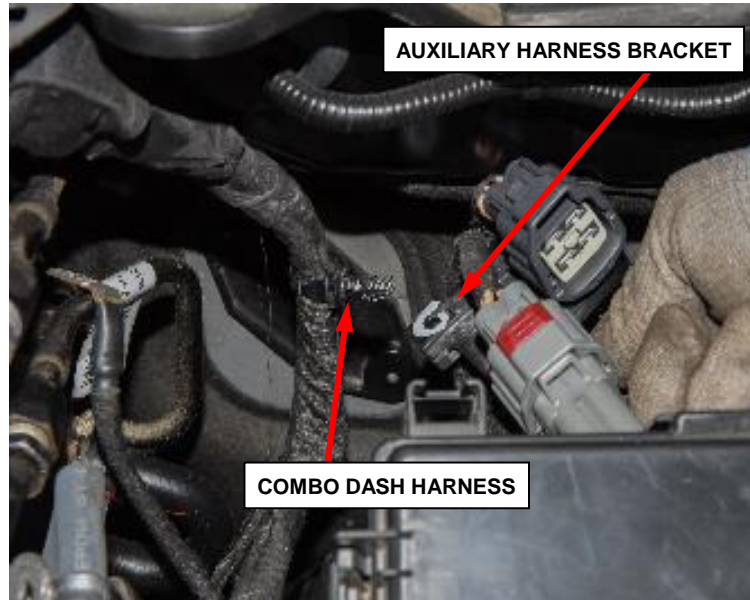
Figure 12 – Auxiliary Harness Bracket from Forward I/P Harness

13. Remove the auxiliary harness bracket from the fir tree tie strap on the combo dash harness (bracket hole circled for emphasis, diesel only) (Figure 12).

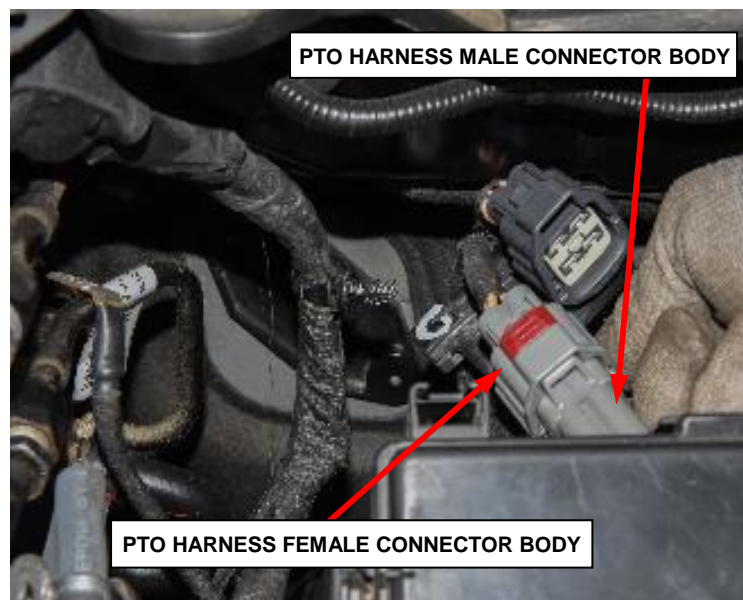
Figure 13 – PTO Harness Connector Bodies

14. Remove and save the male PTO harness connector body from the PTO harness (Figure 13).

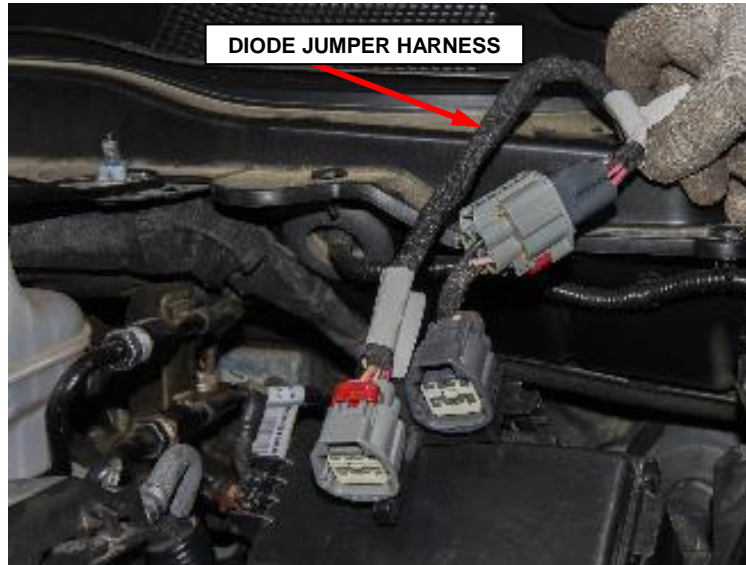
Figure 14 – Adding the Jumper Harness

15. Remove the PTO harness female connector body from the bracket.

16. Install the female end of the diode jumper harness to the bracket.

17. Connect the male end of the jumper to the female end of the PTO harness. Verify that the Connector Position Assurance (CPA) lock is secure (Figure 14).

18. Install the male PTO harness connector body, removed at step 14, into the female connector body of the diode jumper harness. Verify that the Connector Position Assurance (CPA) lock is secure.

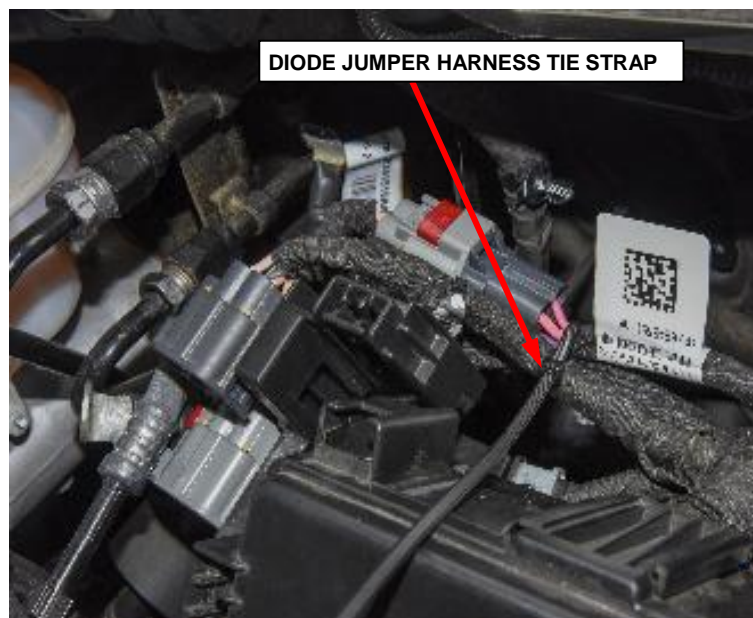
Figure 15 – Adding Harness Tie Strap

19. Install the new tie strap (without fir tree) from the kit to secure the bundle of harnesses. Remove the excess length from the tie strap (Figure 15).

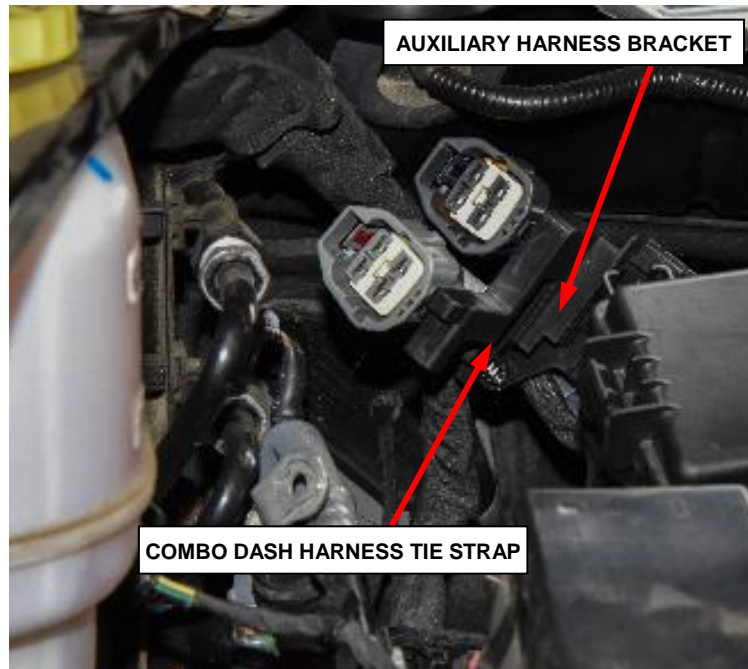
Figure 16 – Auxiliary Harness Bracket to Forward I/P Harness

20. Carefully remove the original fir tree tie strap from the combo dash harness. Secure the auxiliary harness bracket to the combo dash harness fir tree tie strap (Figure 16).

21. Roll the auxiliary PDC back into place while clipping the auxiliary harness bracket to the back side of the PDC.
