Bulletin No.: PIT5479C
Published date: 12/9/2019

PIT5479C Diagnostic Tip - Perceived Brake Fluid Leak at Caliper Piston Boot

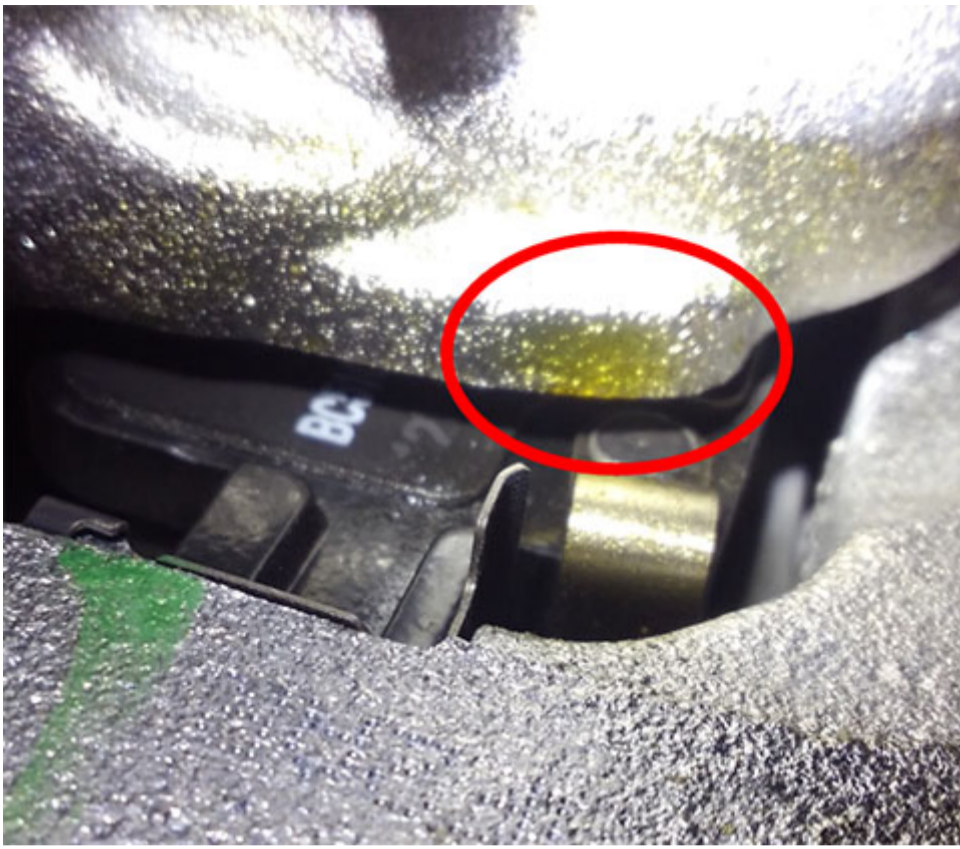
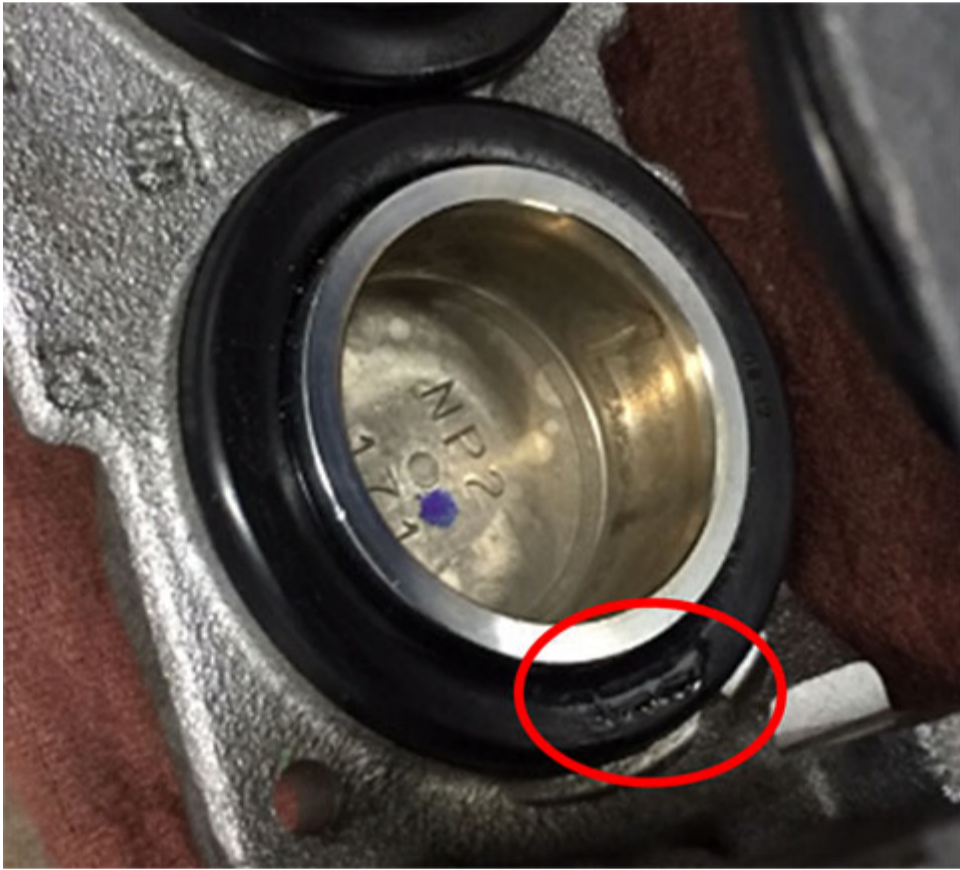
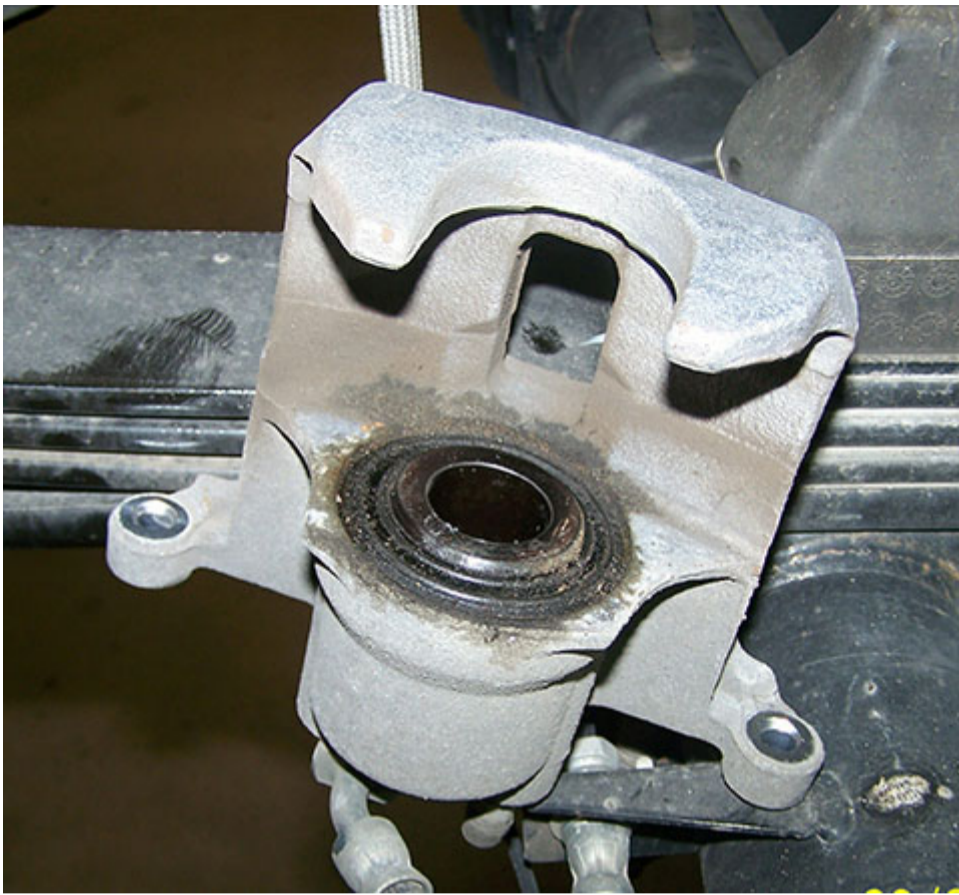
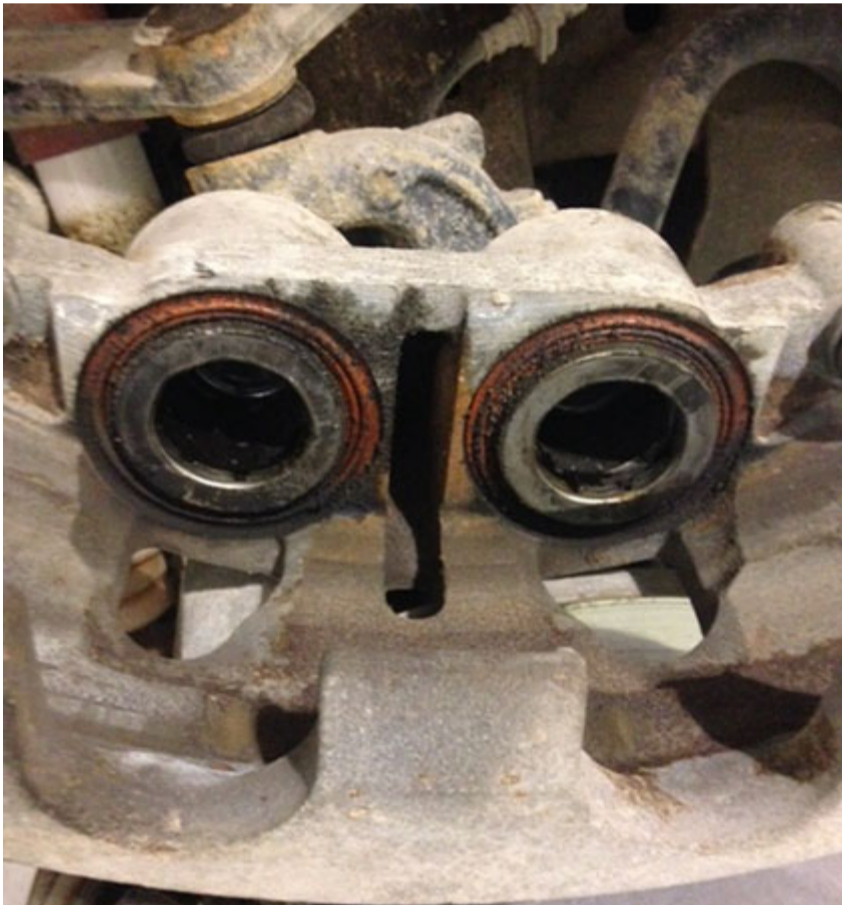
A technician may comment that, during service, it appears there is fluid leaking from the brake caliper piston area. Shown below are examples of newer low mileage vehicles and older higher mileage vehicles.

The substance shown is actually excess assembly grease from the caliper boot and piston installation. This grease can be cleaned off and the rest of the service completed.

NOTE: When diagnosing a brake fluid leak or certain DTC's for hydraulic brake circuit leaks, such as C05B0, do not confuse excessive assembly grease as a brake fluid leak. If it is uncertain what is seen is assembly grease, then clean off the excessive grease and apply the brake pedal 20 times and re-inspect for a leak.
