### **Technical Service Bulletin**

GROUP	NUMBER
Campaign	19-01-040H
DATE	MODEL(S)
December 2010	Palicado (LY2)

REAR SUNROOF GLASS REPLACEMENT GUIDE (SERVICE CAMPAIGN T4I)

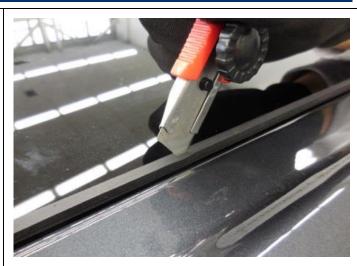
4. Attach masking tape (C) to the rear sunroof glass panel.

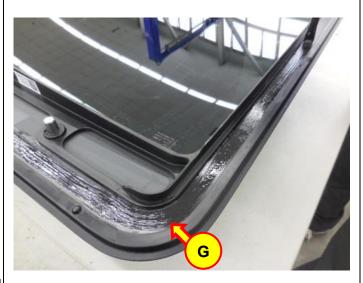
9. Apply primer to the sealant application surface (G) of the supplied rear sunroof glass.

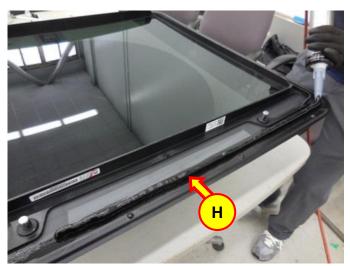
10. Apply sealant onto the center area of the rear sunroof glass assembly primer application surface (H).

Apply sealant in one direction.

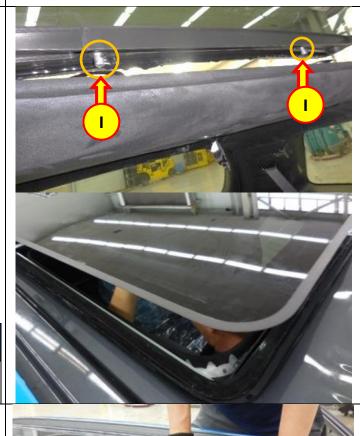
11. Align pivot pins (I) into the roof panel hole and install the rear sunroof glass using the glass holder.
