HYUNDAI

Technical Service Bulletin

| GROUP Body | NUMBER 19-BD-009H-1 |

SUBJECT: TRUNK LID TORSION BAR SERVICE GUIDE
AND WARRANTY EXTENSION (TXXF)

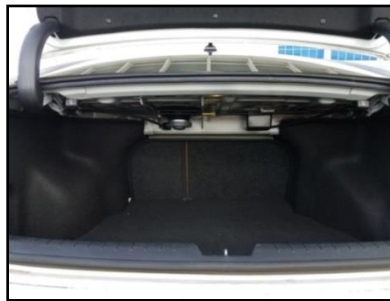
Description: On certain Sonata (LF) vehicles equipped with smart trunk, the trunk lid may not open to the desired height when using the smart trunk feature. Follow the procedure in the bulletin to inspect the trunk lid opening height and replace the torsion bars if required.

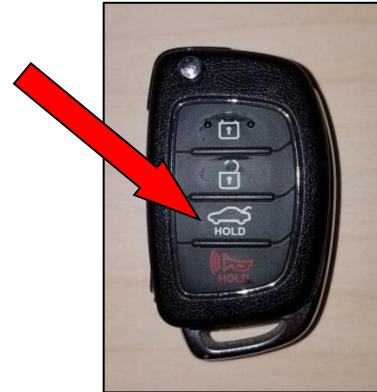
1. Using the key fob, perform an open and close cycle of the trunk lid ten times.

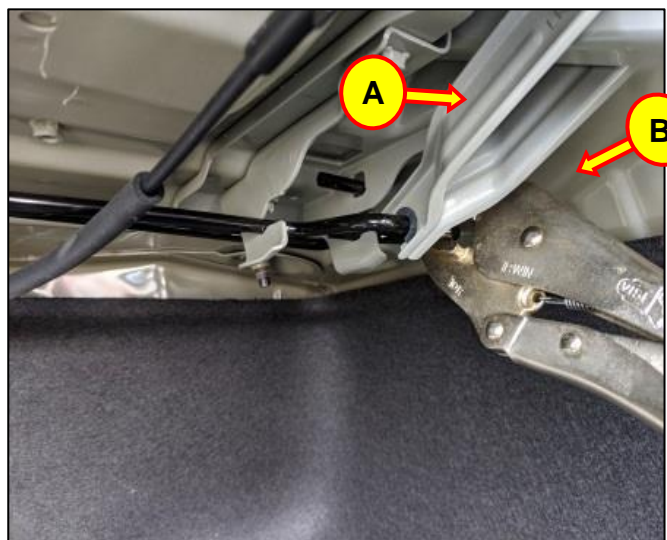
4. After opening the trunk, use a vice grip to push down on the outer side of the torsion bar away from the hinge (A).

Ensure the vice grip holds on to the outer edge of the torsion bar, outer side of the hinge (B).

There is an increase in tension while holding the vice grips after disconnecting the hinge from the torsion bar. If caution is not taken there may be a risk of injury.

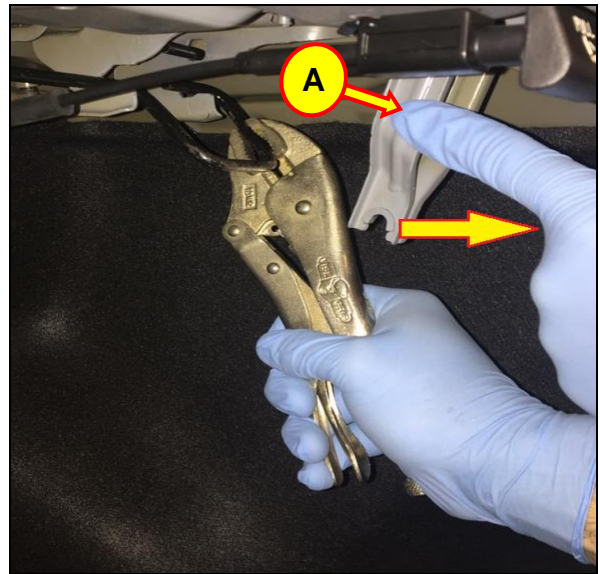
6. After releasing the hinge (A) from the torsion bar, slowly lift the torsion bar held by the vice grip and release the vice grip.

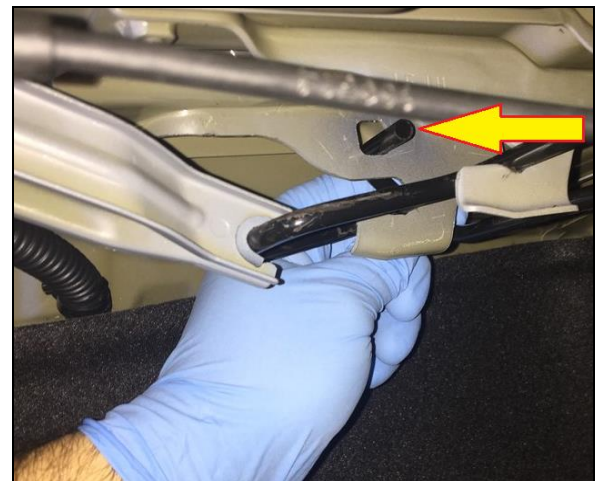
8. Remove the loose torsion bar from the mounting point on the opposite side and then remove from the vehicle.

After removing the first torsion bar, place a prop rod that is approximately 5 feet long to hold the trunk lid open while performing the procedure.

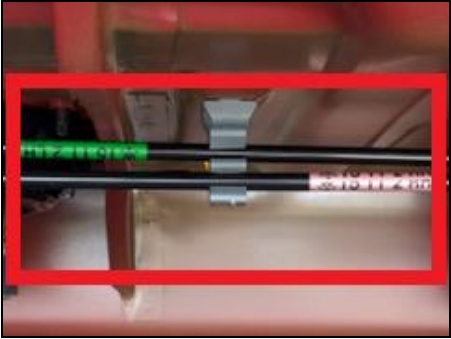
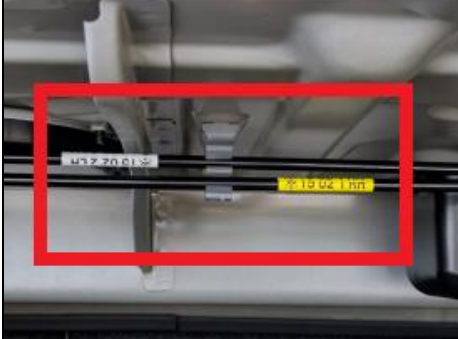
| Vehicles with LED tail lamps | Vehicles with non-LED tail lamps |

- The white/green labeled torsion bar is installed to the top of the clip.
- The yellow/pink labeled torsion bar is installed to the bottom of the clip.

| Vehicles with LED tail lamps | Vehicles with non-LED tail lamps |
|---|--|
| <p>Green labeled torsion bar on top (P/N: 79273-C2000) Pink labeled torsion bar on bottom (P/N: 79283-C2000)</p> | <p>White labeled torsion bar on top (P/N: 79273-C1010) Yellow labeled torsion bar on bottom (P/N: 79283-C1010)</p> |

10. Install the new torsion bars in reverse order of the removal.
