## SIB 11 16 18

### DELIVERY STOP: N63R AND N63M ENGINE - CHECK ENGINE OIL SUPPLY CIRCUIT FOR CONTAMINATION

The engine oil pan and oil lubrication circuit may be contaminated with metal debris from the engine manufacturing process.

Inspect the engine oil pressure sensor and solenoid valve for contamination. Repair as needed.

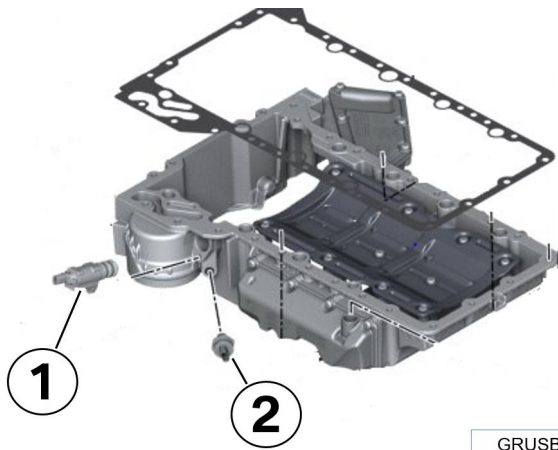
GRUSB1118-21

<p>The components are installed on the right side of the upper oil sump (oil pan)</p> <p>Component overview:</p>
--	--

- (1) Solenoid valve for oil pressure control
- (2) Oil pressure sensor

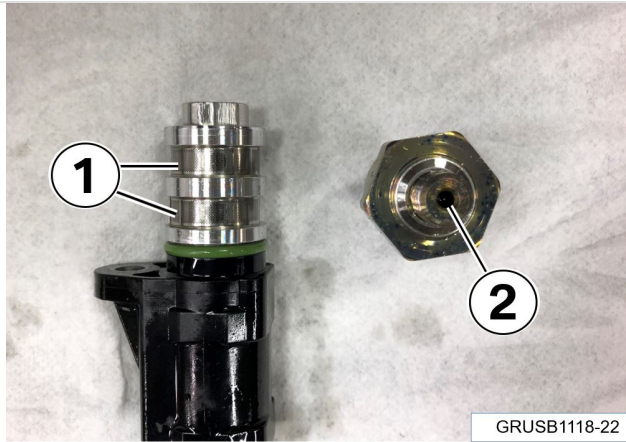
GRUSB1118-22

2. With the components removed, inspect the surfaces for metallic debris.

Inspect the solenoid valve screens (1).

Inspect the hole in the pressure sensor (2).

The screen on the solenoid valve and the pressure sensor bore should be clean; no debris is allowed to be present.

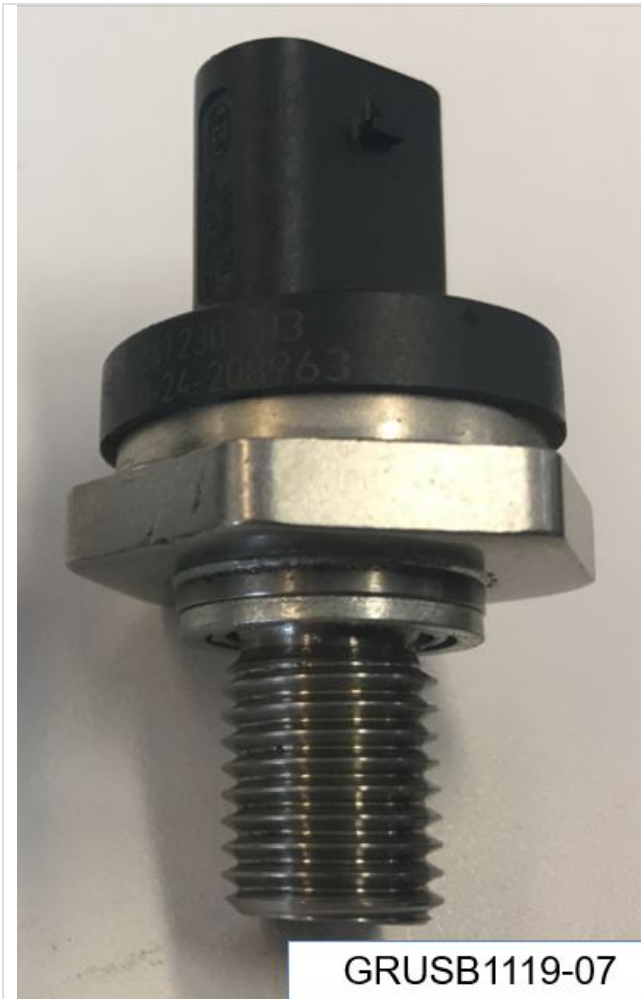
P/N 12 61 8 614 494

Silver and Black Sensor

M12 Thread

Note: Due to an ETK error you will need to determine which oil pressure sensor is installed and order the correct part number.

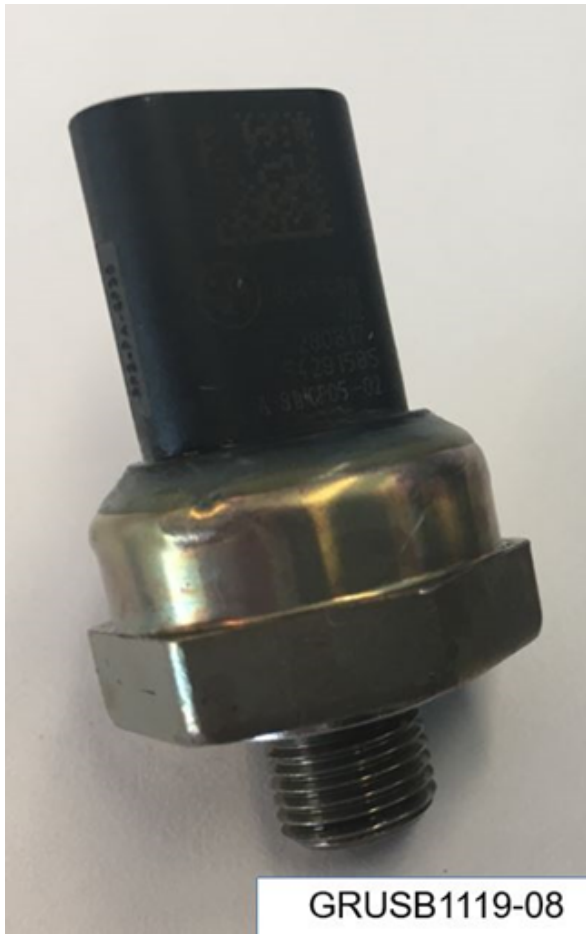
P/N [12 61 8 647 488](#)

Gold and Black Sensor

M10 Thread
