# Service Bulletin

Bulletin No.: 17-NA-302

**Subject: Dust, Snow or Water Around Fuel Filler Area**

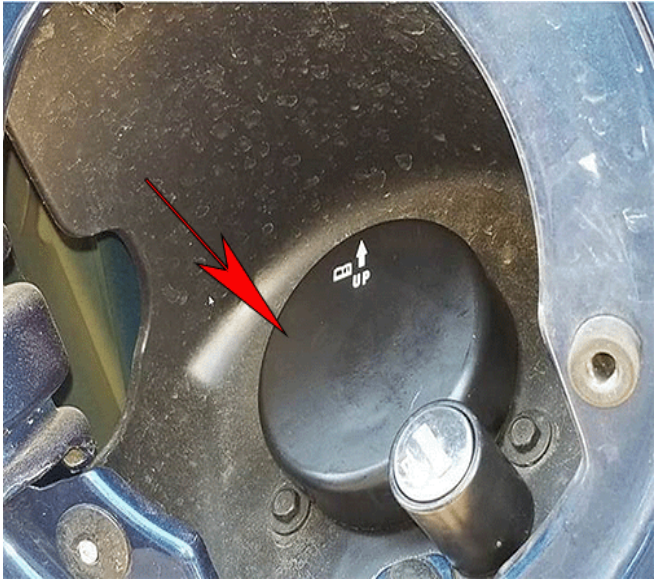
4869504

<b>Involved Region or Country</b>	North America, Middle East, Israel, Chile and Thailand.
<b>Condition</b>	Some customers may comment on excess amount dirt, snow or water that can build up around the fuel filler neck.
<b>Cause</b>	This condition may be caused when trucks are operated in high amount of dirt, dust or snow which can migrate to the filler cap area.
<b>Correction</b>	<p><b>Locking Gas Cap</b></p>

</div> <p style="text-align: right; margin: 0; font-size: small;">5458913</p> <p style="margin: 10px 0;">Notify the customer that GM has made available a gas cap for drivers that operate in these environments. This will help to protect the fill area and the fuel system.</p>
--	--

Causal Part	Description	Part Number	Qty
X	CAP ASM-F/TNK FIL LKG	84009129 (2017)	1
		84308352 (2018–2019)	
	CAP ASM - F/TNK FIL (Non Locking)	84689444 (2017 - 2019)
