Service Bulletin

Bulletin No.: 18-NA-189

Subject: Rattle/Noise in Headliner, Rear of Front Sunroof Window

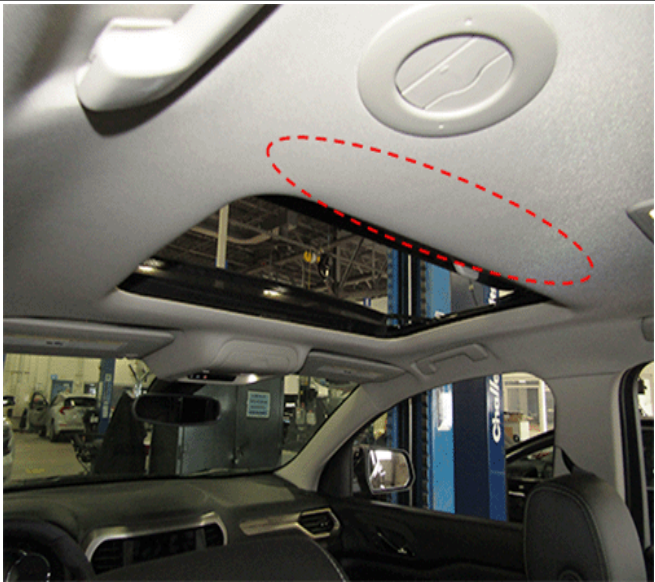
<p style="text-align: right; font-size: small;">5087144</p> <p>Customer may comment on hearing a Rattle/Noise in headliner, behind the front sunroof window.</p>
Cause	The cause of the condition may be that the sunroof opening trim ring is not securely glued to headliner.
Correction	<p>Note: The condition can commonly be verified by pushing upward on the headliner in the area shown circled in the previous graphic.</p> <p>Verify the condition, then using hot glue, secure the 2 large rear tabs of the front sunroof opening trim ring to the headliner. Follow the steps in the Service Procedure below.</p>

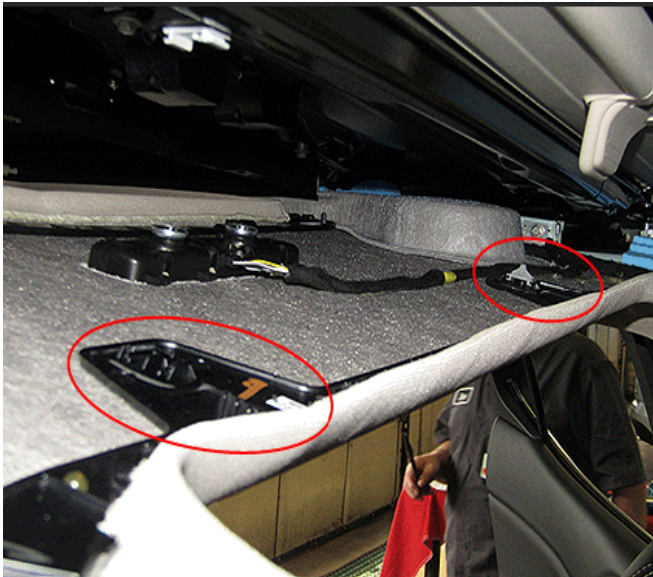
5087146

Note: In the graphic example above, the 2 tabs are void of any intended adhesive material.

2. Carefully pull down the headliner enough to inspect the 2 trim ring tabs.
