Service Bulletin

Bulletin No.: 19-NA-246

Subject: Engine Runs Rough, Misfire, Malfunction Indicator Lamp (MIL) Illuminated - DTC P0300 Set

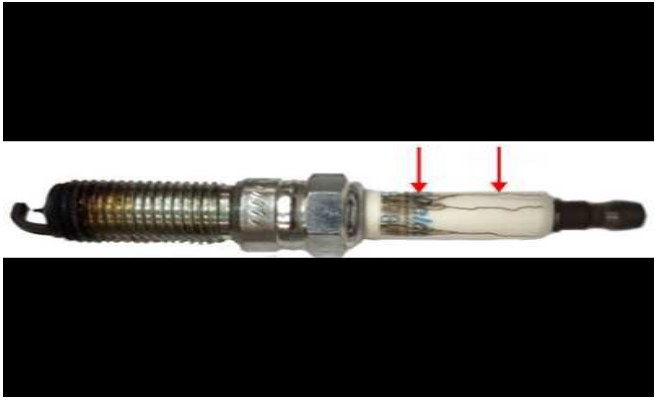
Involved Region or Country	United States, Canada, Mexico, Korea, Japan, Russia, Australia
Condition	<p>Some customers may comment on one or more of the following conditions:</p> <ul style="list-style-type: none"> • Rough running engine • Misfire • MIL Illuminated <p>Some technicians may find DTC P0300 (Engine Misfire Detected) set in the Engine Control Module (ECM).</p>
Cause	<p>This condition may be caused by the talc powder, inside the rubber boot of the ignition coil, having a lower insulation strength compared to dielectric grease:</p> <ul style="list-style-type: none"> ⇒ This may lead to possible arcing, eventual carbon tracking and ultimately, a misfire condition. A prolonged misfire condition can result in piston damage. ⇒ Talc was applied to prevent sticking of the rubber boot to the porcelain plug for serviceability.

<p style="text-align: right;">5423956</p> <ol style="list-style-type: none"> 1. Inspect all the spark plugs for signs of carbon tracking. 2. Perform a cylinder leak down test on the affected cylinder(s), making sure the misfire is not caused by piston leakage and leakage into the crankcase. Refer to <i>Cylinder Leakage Test</i> in SI. <ul style="list-style-type: none"> • If there is no high cylinder leakage found, refer to the Spark Plug Inspection Procedure section in this bulletin. • If there is high cylinder leakage found, refer to the Piston and Engine Cylinder Bore Inspection section in this bulletin.
--------------------------	---

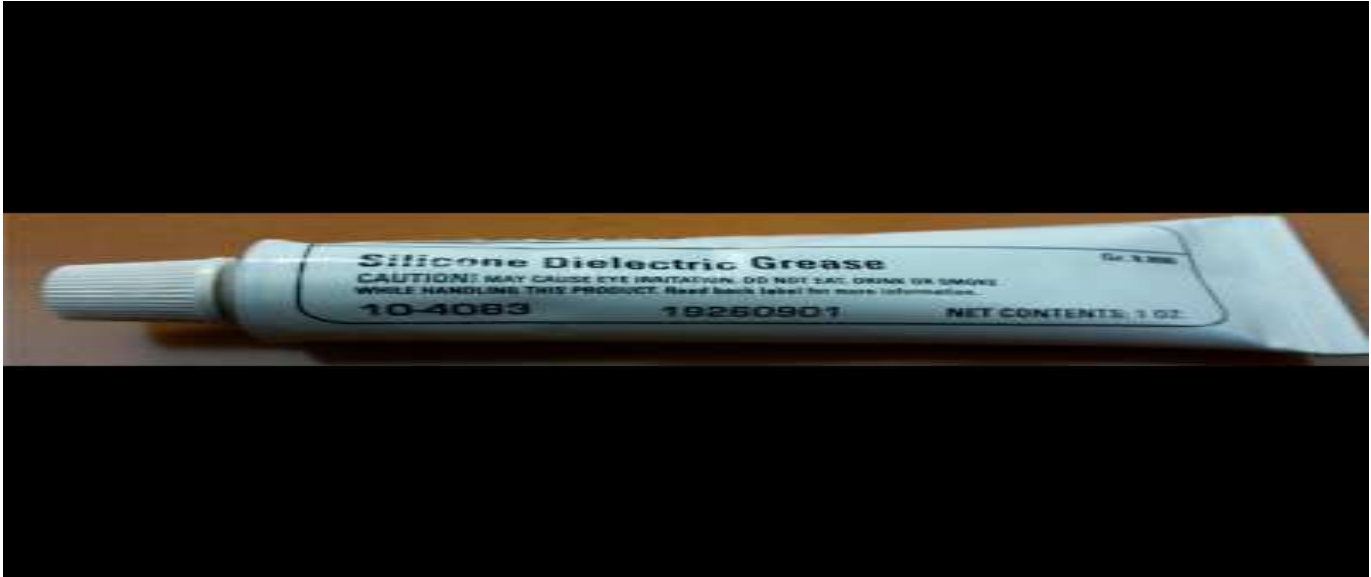
Use Molykote G-5008 Dielectric Grease.

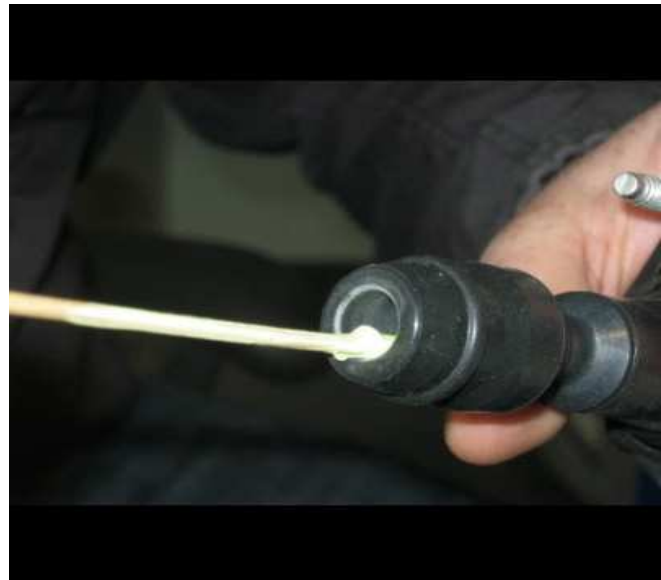
5424004

- Note:** Small amounts of grease “over spread” are allowed on the spring.
2. Apply a thin coating in the rubber boot of the coil, up to a depth of 15 mm.

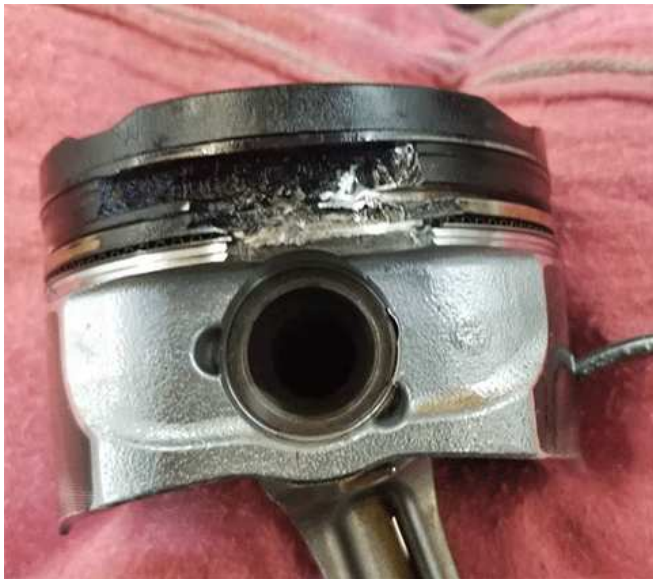
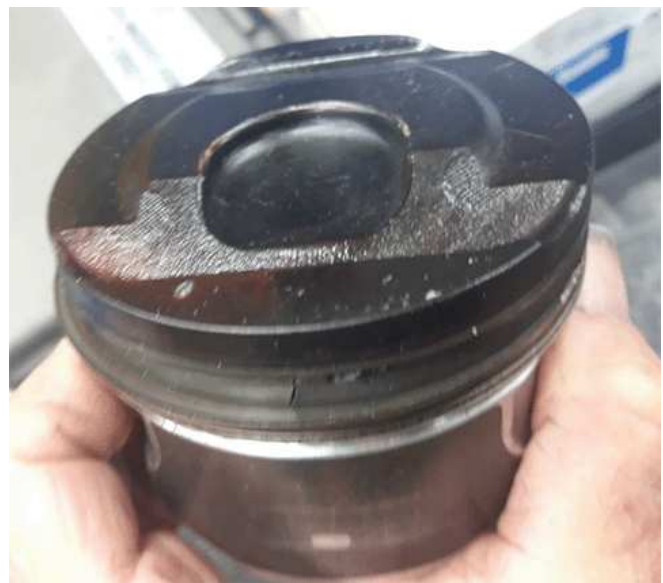
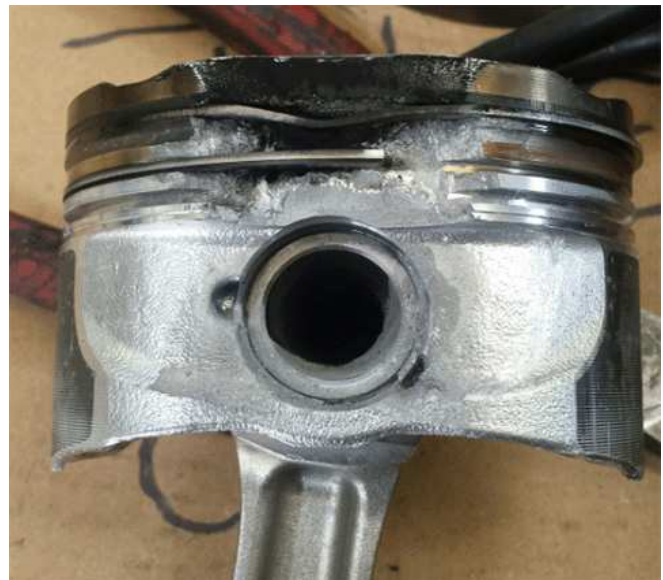
Inspect the condition of all cylinder walls. Some light vertical marks may be visible on the cylinder wall. In these areas, check that the cross hatch marks are still visible in this marked area. If they are, the cylinder surface has not been compromised and the engine block can be used. If you can catch your fingernail on anything on the cylinder wall, the engine assembly must be replaced.

- If any of the cylinder walls are damaged, replace the engine assembly (engine comes with spark plugs), all four ignition coils (apply dielectric grease to the spark plug boots. Refer to Dielectric Grease Application section above), the fuel injector of the cylinder(s) that had damaged pistons and other components necessary when an engine assembly is installed.
- If the cylinder walls are not damaged, remove the pistons and inspect for a fractured piston between the top and second rings.

The pictures below are some examples of what might be found.

If the cylinder walls are not damaged and one or more of the pistons are found fractured, replace all four spark plugs, all four ignition coils (apply dielectric grease to the spark plug boots. Refer to Dielectric Grease Application section above), the fuel injector of the cylinder(s) that had damaged pistons, all four piston kits, all ring sets for all four pistons, all rod bearings, all four connecting rod assemblies and other components necessary when pistons are replaced.

Note: When installing pistons, make sure to use the tapered ring compressor J-43953 special tool. Use care when installing the piston assemblies into the cylinder so the rings are not damaged.
