# White Paint Peeling From Metal Body Panels

YEAR(S)	MODEL(S)	ADDITIONAL INFORMATION
2012 - 2015	iQ	
2008 - 2015	xB

Some 2012 – 2015 model year iQ painted with 070 Blizzard Pearl and 2008 – 2015 model year xB vehicles painted with 040 Super White may exhibit peeling paint on one or more metal body panels. The paint may peel between the primer and E-coat layer, exposing the gray or brownish-green E-coat. The affected panel(s) will require prepping and repainting to address this condition. The paint repair may need to be sublet to a body shop.

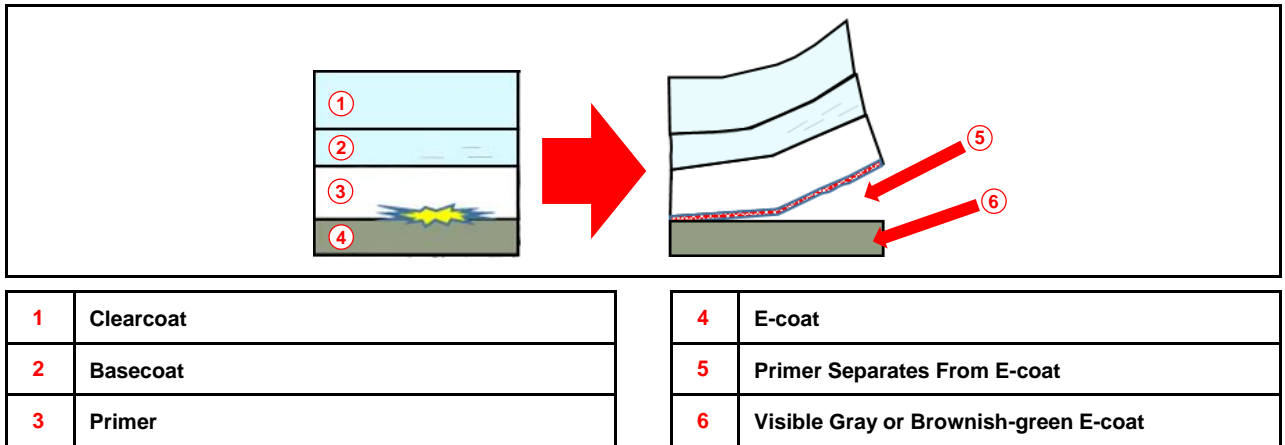
**Figure 1. Exposed Substrate**

Light surface rust may be present due to this condition but can be removed during the vehicle prep.

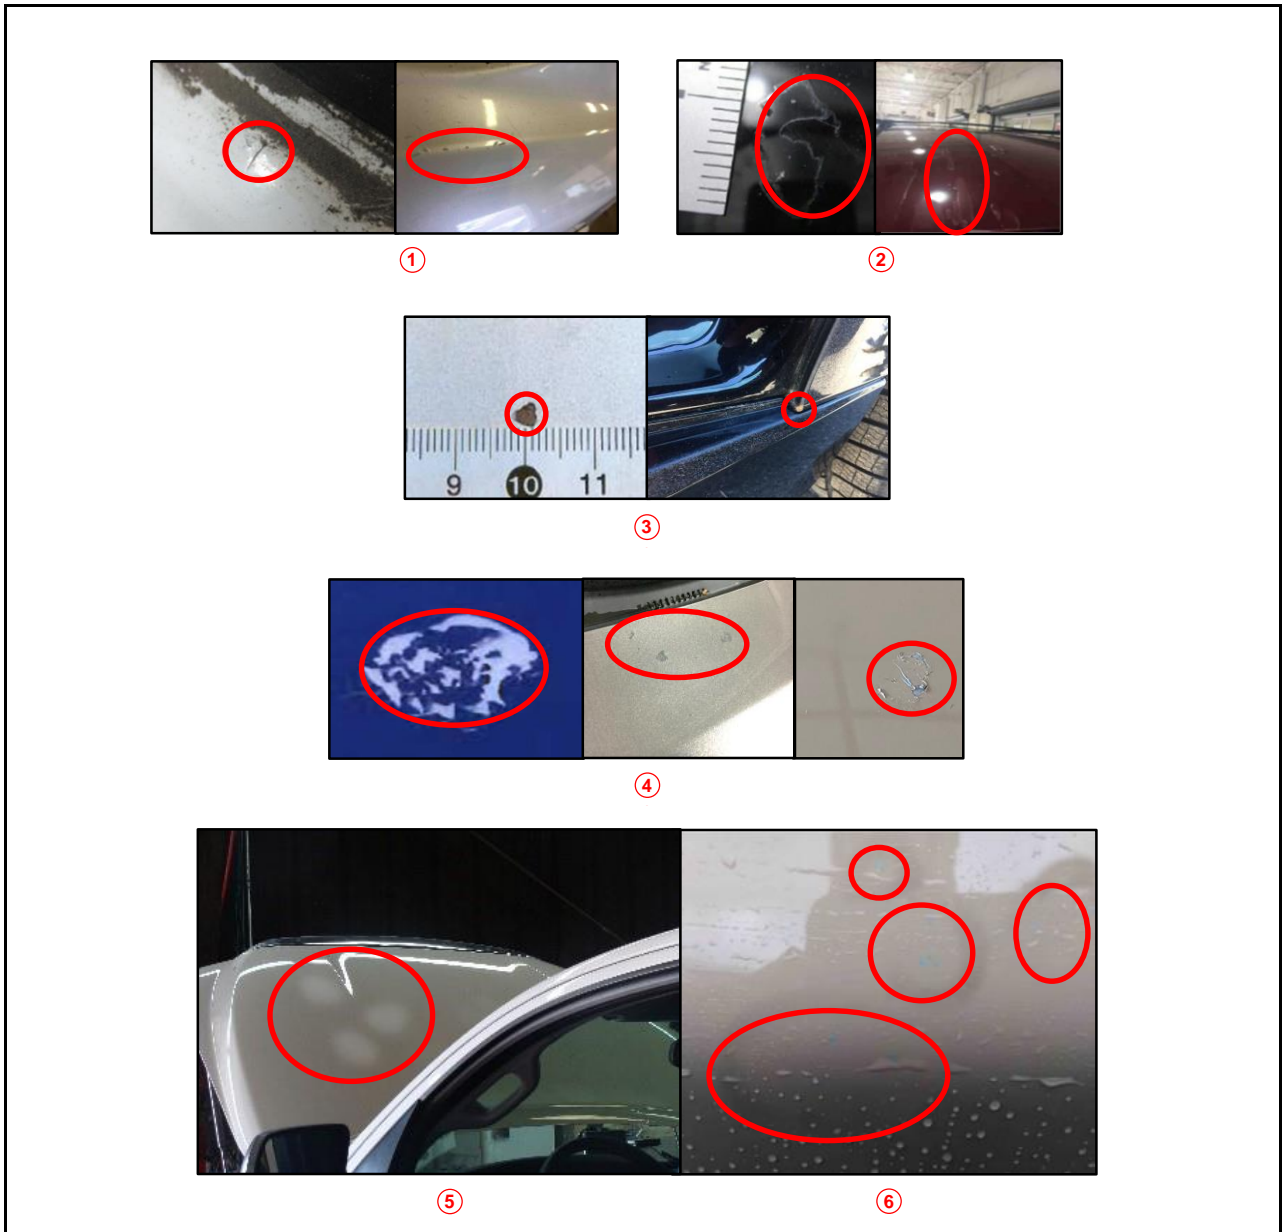
**Figure 3. Examples of Paint Conditions That Are NOT Applicable to This Service Bulletin**

1	Crack in Paint
2	Clear Coat Peeling or Delamination
3	Rock Chips

4	Damage From Bird Droppings or Chemicals
5	Damage From Poor Repair
6	Paint Stains

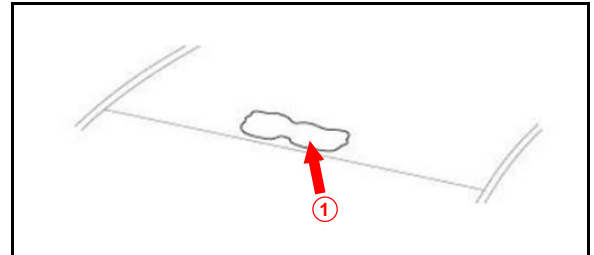
**Figure 4.**

1. Confirm the location of the exposed E-coat and peeling area.

- Exposed layer is gray or brownish green in color.
- The peeling area shown is larger than the actual requirement. The procedure is **ONLY** required if the area is smaller than 10 mm.

<b>1</b>	<b>Exposed E-coat and Peeling Area</b>
----------	--

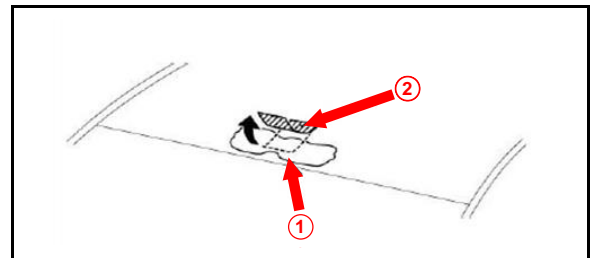
**Figure 5.**

2. Remove already loose paint chips from around the peeling area using packing tape.

<b>1</b>	<b>Exposed E-coat and Peeling Area</b>
<b>2</b>	<b>Packing Tape</b>

3. Wash and rinse the area of ANY dirt, sand, or debris.
4. Move the vehicle inside or under shade. Avoid working under direct sunlight and high temperatures (above 90°F).
5. Adhere another **NEW** piece of packing tape over the exposed E-coat to cover a minimum of 2 in. across the painted surface of the panel. Ensure you have continuous adhesion between the tape and panel.
6. Beginning with the end of the exposed E-coat side, quickly pull the packing tape at a 45-degree angle until the tape is completely removed.
7. Did the packing tape remove ANY additional paint?
  - **YES** — Send the vehicle to the body shop to have the affected metal body panel(s) painted.
  - **NO** — Continue to the Damp Cloth Confirmation section.

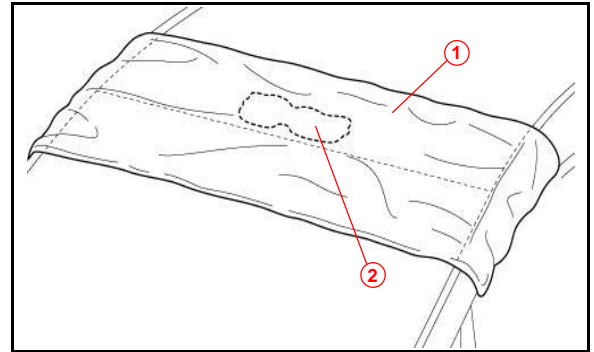
**Figure 6.**

1. Cover the entire width of the panel, including the exposed E-coat area, with a clean cloth or towel.

If the exposed area is on a vertical panel, use the packing tape to hold the cloth or towel in place.

<b>1</b>	<b>Clean Cloth or Towel</b>
<b>2</b>	<b>Paint Peeling</b>

2. Soak the cloth with clean water but DO NOT wring out.
3. Leave the soaked cloth in place for 3 hours.

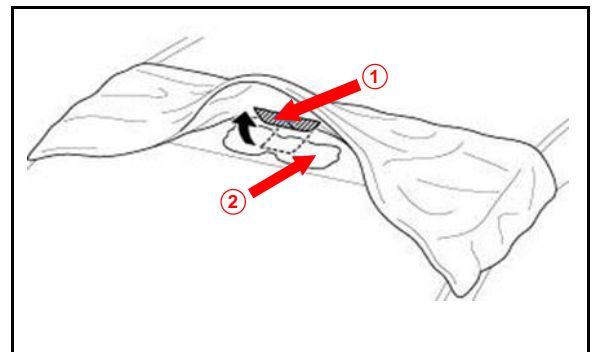
**Figure 7.**

4. After 3 hours, remove the cloth or towel.
5. Use a dry, clean cloth to dry the area near the exposed area.
6. Adhere a NEW piece of packing tape over the exposed E-coat to cover a minimum of 2 in. across the painted surface of the panel. Ensure you have continuous adhesion between the tape and panel.

<b>1</b>	<b>Packing Tape</b>
<b>2</b>	<b>Paint Peeling</b>

7. Beginning with the end of the exposed E-coat side, quickly pull the packing tape at a 45-degree angle until the tape is completely removed.

8. Did the packing tape remove ANY additional paint?
  - YES** — Attach photographic evidence of each affected panel(s) to the warranty claim. Send the vehicle to the body shop to have the affected metal body panel(s) painted.
  - **NO** — This bulletin does NOT apply. Continue diagnosis using the applicable Repair Manual.
