Special Coverage Adjustment

18358 - Evaporative Emissions Vapor Tube Blockage Diagnostic

Release Date: January 2019

Reference Number: N182192810

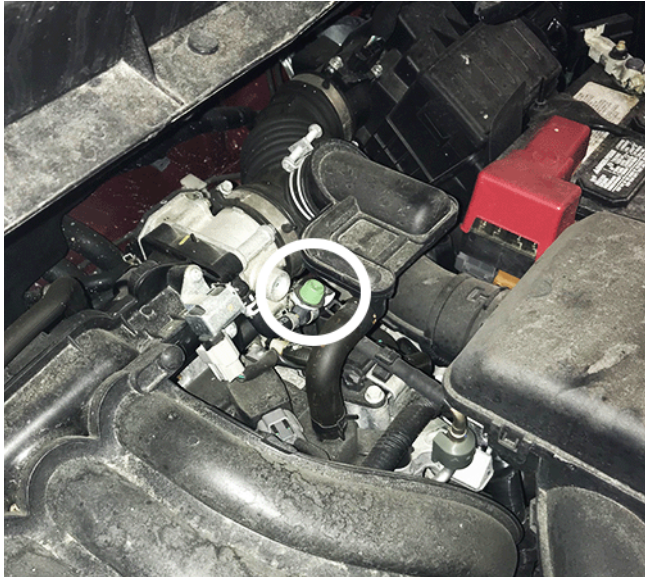
5181939

1. Using the evaporative emissions service port located in the engine bay, perform a smoke test of the evaporative emissions system using GE 41413-A evaporative emission system tester, Kent Moore J41413-200, or equivalent. Open the fuel filler cap and observe for smoke coming out.

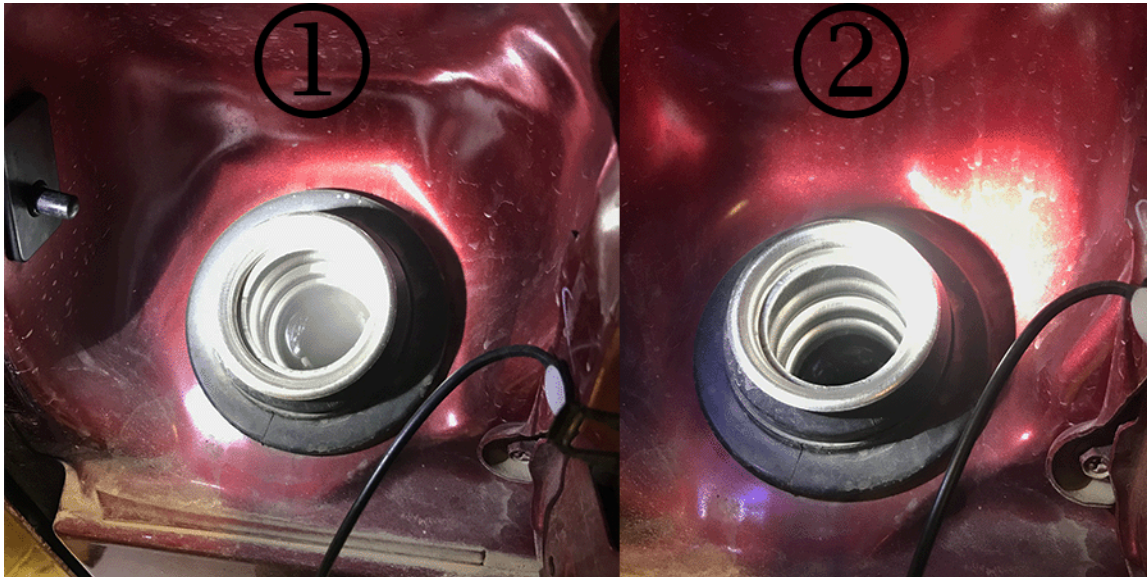
5181941

- If smoke is observed coming out of the fuel filler neck (1), no further action is required.
 - If no smoke is observed coming out of the fuel filler neck (2), proceed to step 2.
2. Lift the vehicle. Refer to *Lifting and Jacking the Vehicle* in SI.

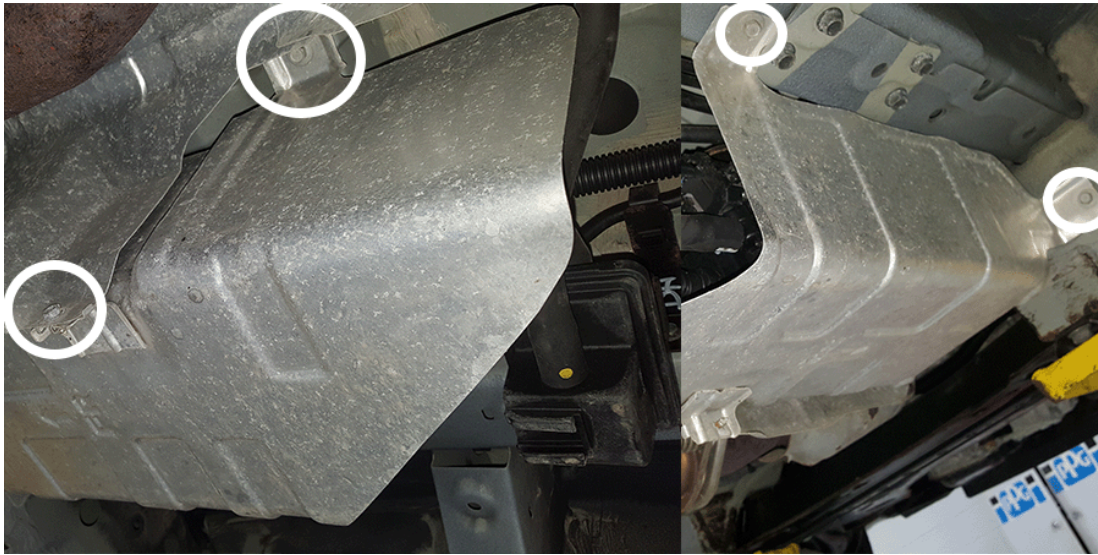
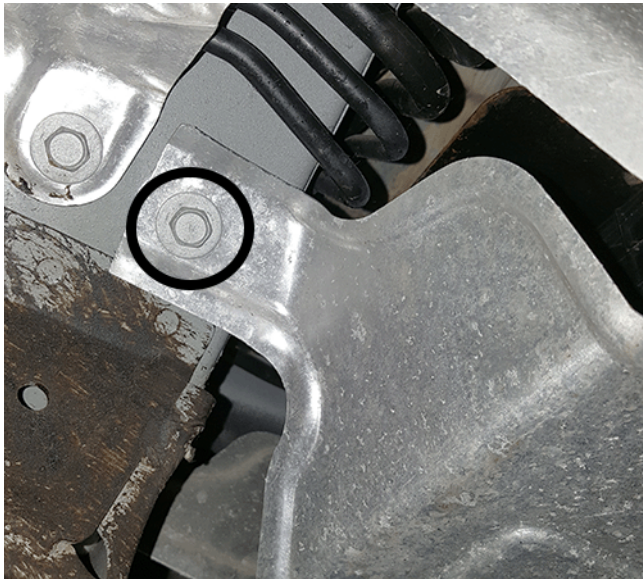
5197605

3. Remove the heat shield surrounding the Evaporative Emissions Canister by removing the five fasteners as shown.

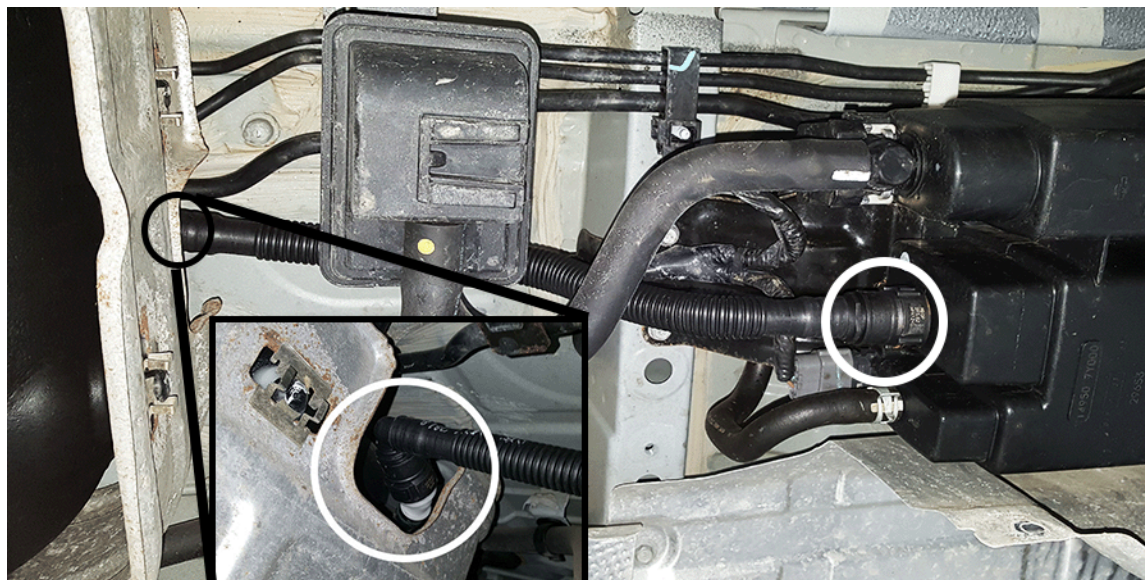
5198105

4. Remove the Fuel Tank Fill Evaporative Emission Pipe by disconnecting the indicated quick connect fittings at each end.
5. Install the new Fuel Tank Fill Evaporative Emission Pipe.
6. Reinstall the heat shield. Tighten the fasteners to 10N-m (89 lb-in).
7. Lower the vehicle. Refer to *Lifting and Jacking the Vehicle* in SI.
