Service Bulletin

Oggetto: **Lower triple clamp update**

Prodotto: **Brutale 800 RR – DRAGSTER RR**

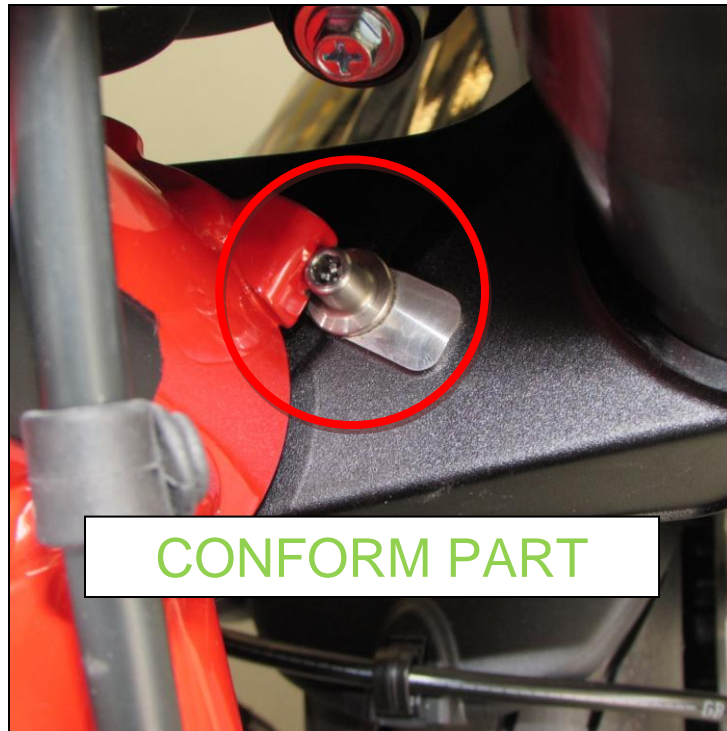
To performing the check of the components on the motorcycles involved, it is necessary to visually check the area of the lower triple clamp where the steering lock pins are present, paying particular attention to the finish in the proximity of the pins;

If a configuration with visible aluminium (machined) is detected as picture below, the part is conform and no update will be necessary:

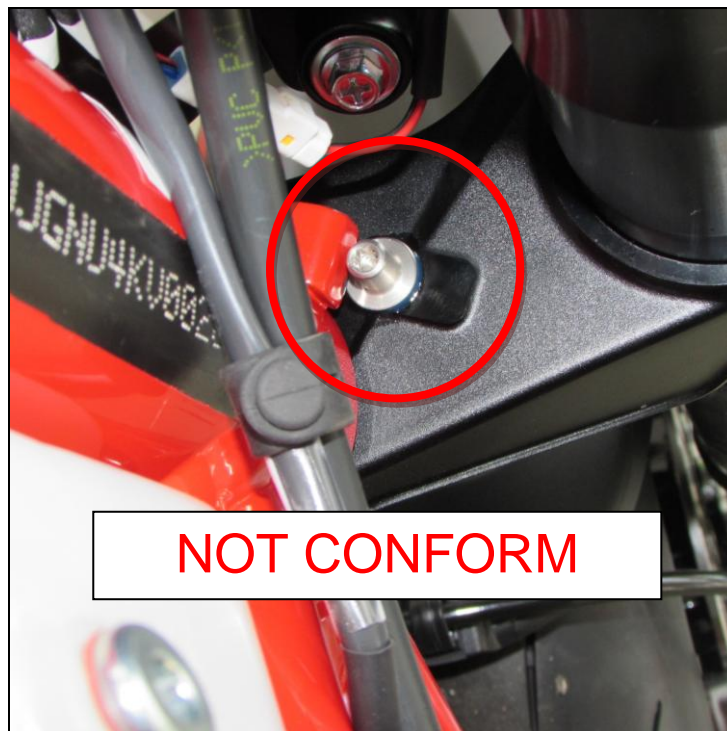
As a result of continuous monitoring of the quality of our product, it was found that on some MV Agusta models was fitted a lower triple clamp with steering lock pins without threadlock. The remedy is to check the steering lock pins and apply the threadlock if the described non-conformity occurs. The procedure to update and reimbursement of operations is outlined in this Technical Bulletin.

If a configuration **without visible aluminium and black color (anodized)** is detected as picture below, the **part is NOT CONFORM** and it will be necessary to update it by following the procedure described in the section "PROCEDURE OF INTERVENTION".

If the verified lower triple clamp does not comply, it is necessary to remove two steering lock pins and apply Loctite 2400 (Medium) to the threads:

- Place the bike on the sidestand
- remove two retaining pins using a 4mm allen tool
- apply **Loctite 2400 (Medium)** to the threads
- re-assembly the steering lock pins and tighten them with a torque of **8-10 Nm**
