GROUP	NUMBER
INTERIOR	19-BD-004G
DATE	MODEL(S)
AUGUST 2019	G80 (DH)

Technical Service Bulletin

SUBJECT: SEAT BACKBOARD CLIP REPLACEMENT

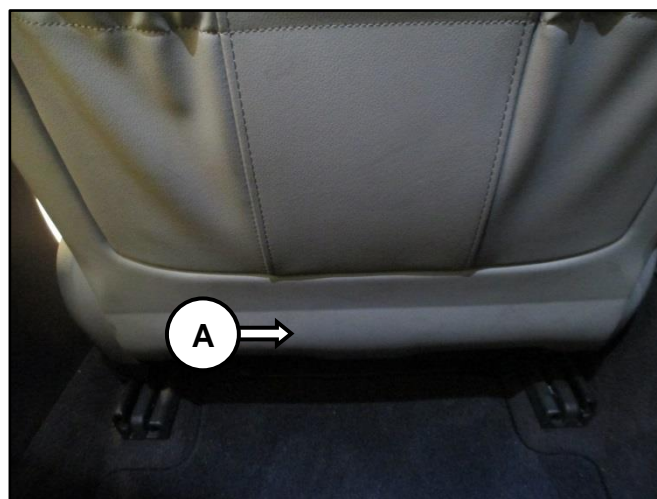
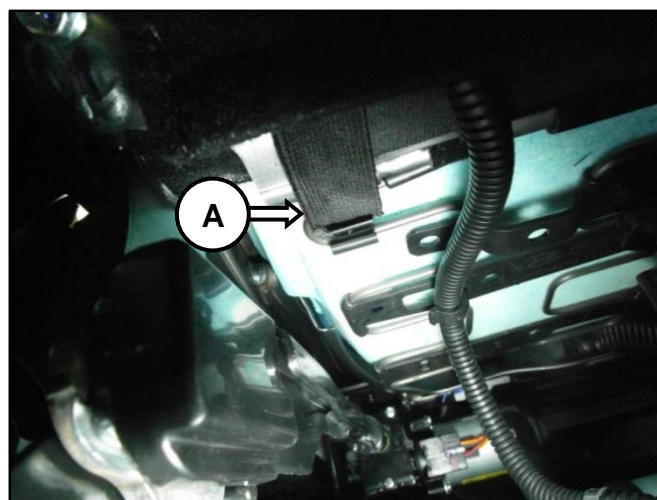
1. Remove the protector (A) bottom straps located under the seat.

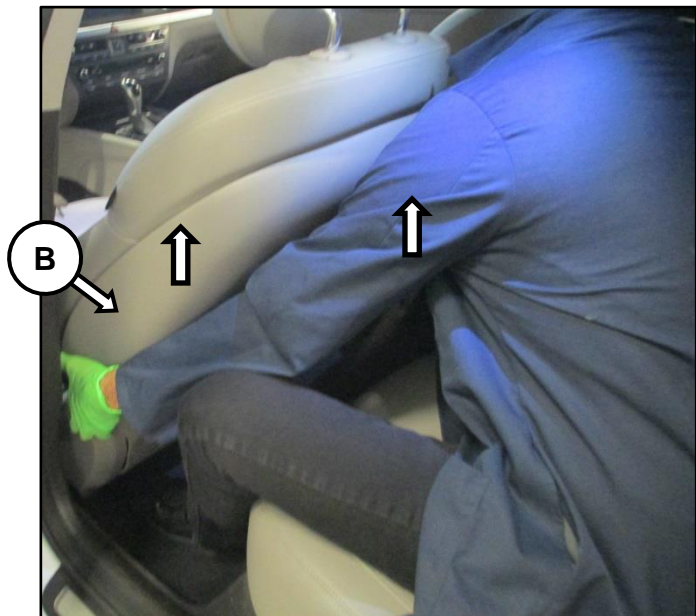
- 2. Place both hands at the bottom of seat backboard (B) and lift to remove from the seat assembly.

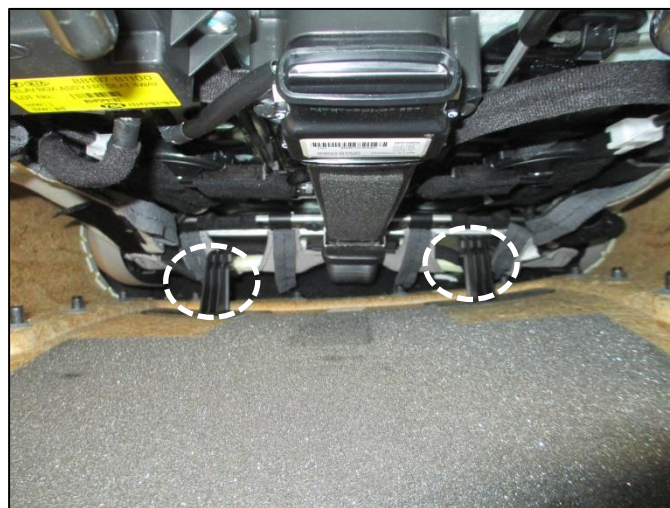
⚠ CAUTION
When removing, ensure not to damage bottom seat back retention hooks.

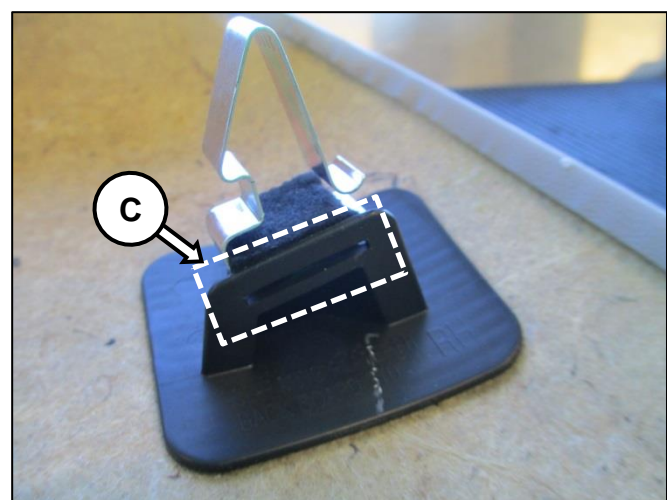
- 3. Lay the seat backboard on a clean workbench and inspect base clips (C).

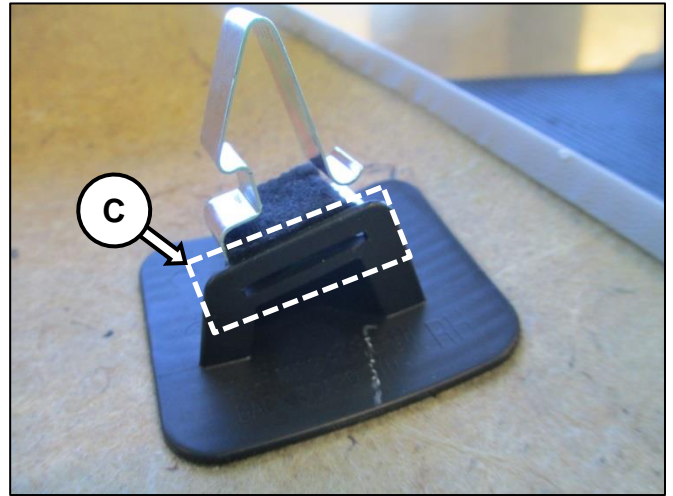
Base clip (C) appears normal.

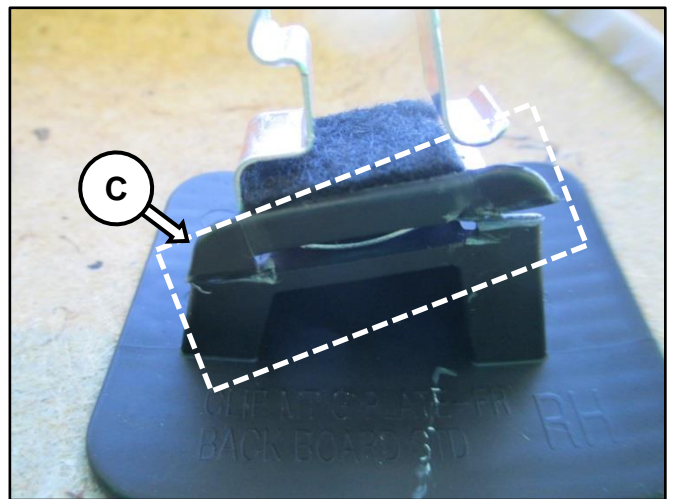
Base clip (C) is broken.

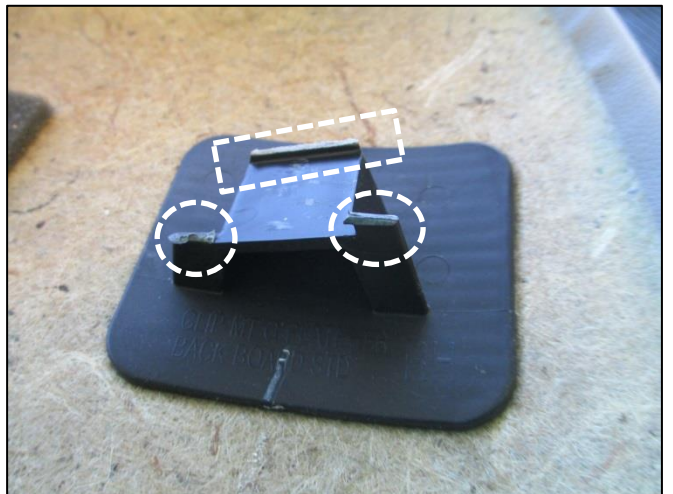
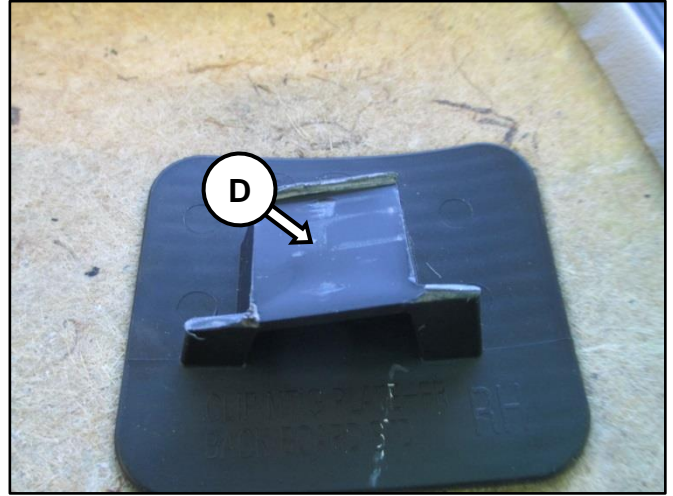
4. Remove broken base clip (C) and remove excess plastic to ensure base (D) is flat.

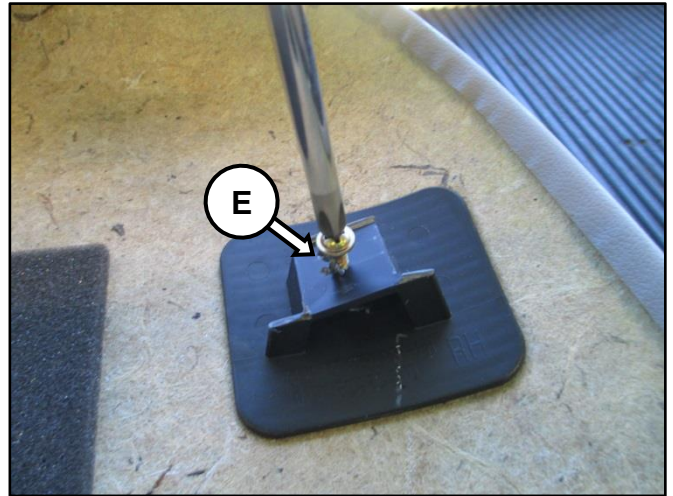
5. Tighten supplied screw (E) to half screw length in the center of the base.

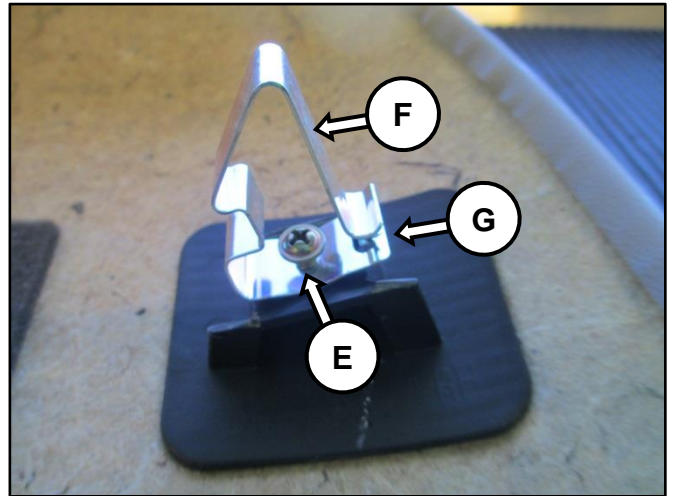
6. Assemble screw (E) into the supplied new clip (F) and fully tighten to base.

Ensure opening (G) of clip is facing upward.
