## Technical Service Bulletin

<b>GROUP</b>	<b>NUMBER</b>
<b>INTERIOR</b>	<b>19-BD-004G-1</b>
<b>DATE</b>	<b>MODEL(S)</b>
<b>OCTOBER 2019</b>	<b>G80 (DH)</b>

**SUBJECT:** SEAT BACKBOARD CLIP REPLACEMENT

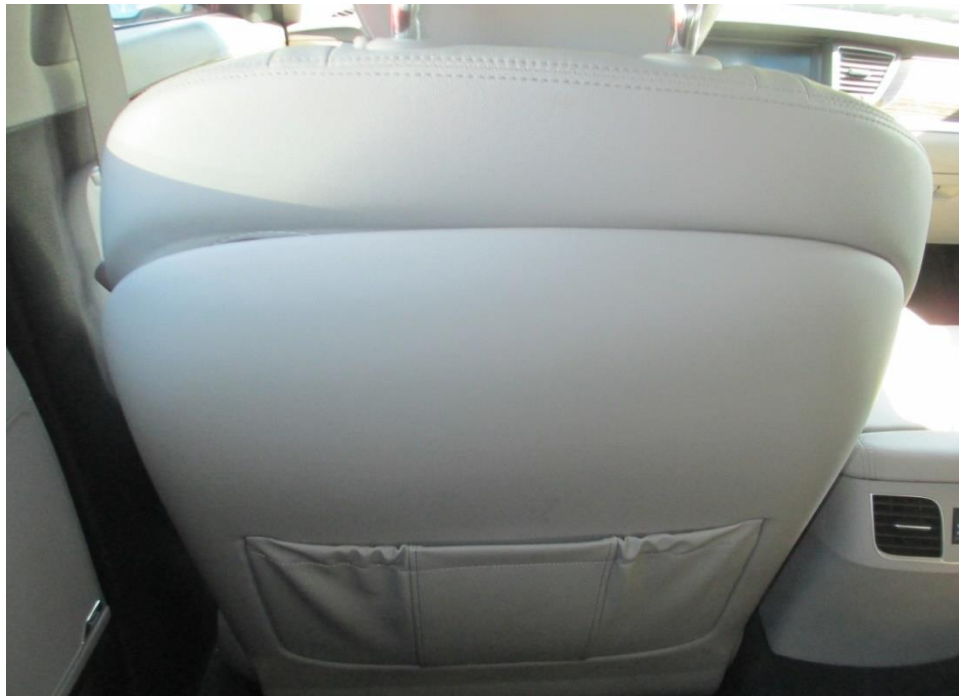
**Description:** Certain 2019-2020 G80 (DH) vehicles may have a condition where the seat backboard comes loose. This bulletin describes the procedure to replace the seat backboard clip.
