SUBJECT: **GHG17 Heavy Duty Engine Platform 1-BOX™ Aftertreatment System (ATS) Wire Harness**

ISSUE

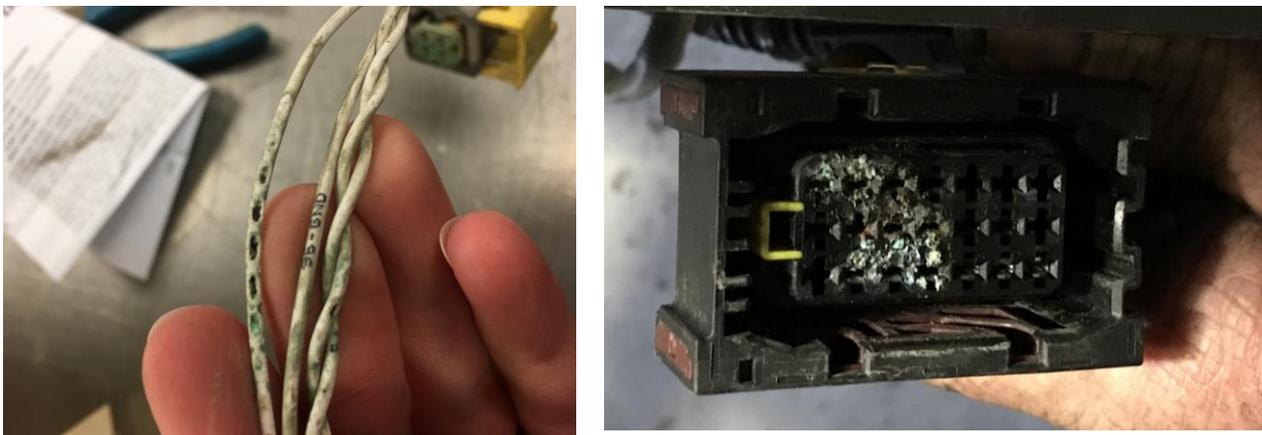
Figure 1 – GHG17 1-BOX™ ATS Wire Harness

For GHG17, the main Aftertreatment Control Module (ACM) harness shifted from a Daimler Trucks North America (or vehicle OEM) part to a Detroit™ part. There are two main issues with the 1-BOX™ ATS harness. Reference Figure 1.

- Harness shows chaffing on the branch to the 21-pin connector and Soot Sensor
- Harness and ACM show corrosion at the 21-pin connector

The chaffing is caused by vibration and dirt collecting inside the harness conduit. The water intrusion at the 21-pin connector is a secondary failure due to chafing and water entering the harness wiring.

Anti-chaffing tape should be applied to the current ATS harness, or to a new replacement harness if it does not have the tape. See the Repair Procedure section for instructions on installing the tape.

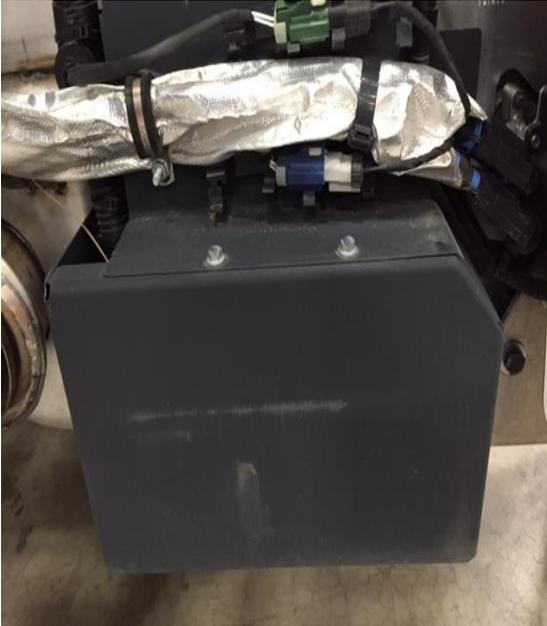
Figure 2 – ACM Cover

4. Remove the six bolts securing the ACM protective cover to the ATS. Reference Figure 2.

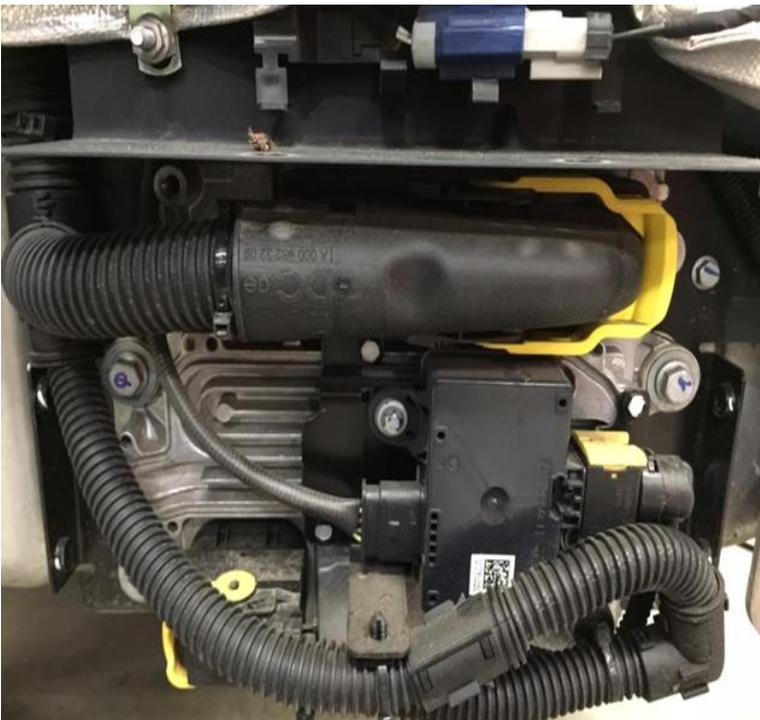
Figure 3 – Harness Routing and Zip Tie Location

5. Note the location of the zip ties securing the wiring harness to the ATS and the harness routing location. Remove the zip ties securing the wiring harness to the ATS. Reference Figure 3.

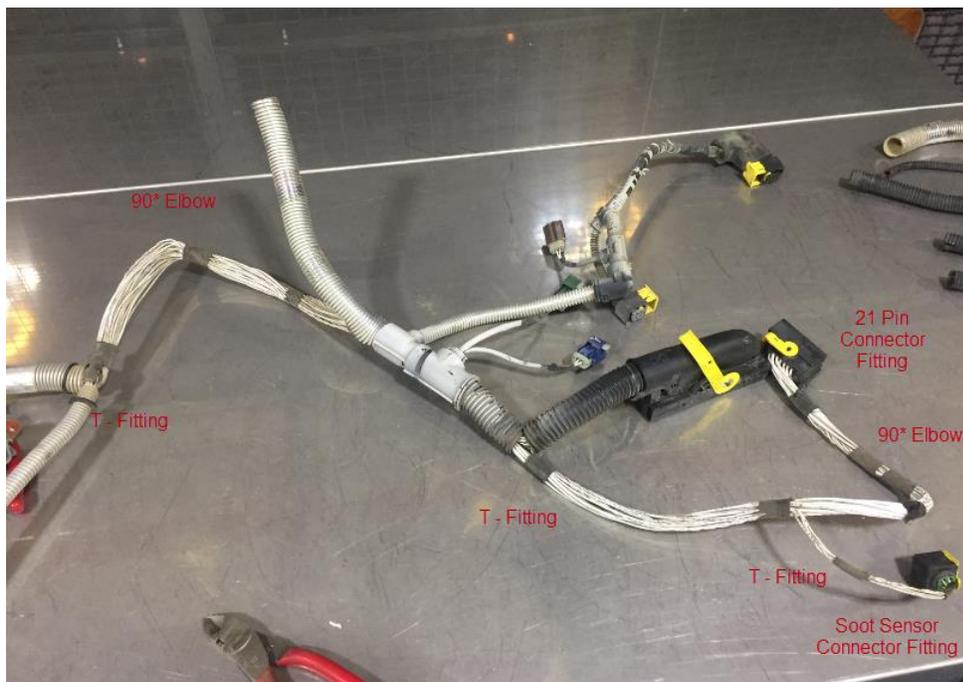
Figure 4 – Harness Clip Removal

6. Remove the following plastic connector clips. Reference Figure 4.

- Two 90-degree elbows
- Three T-fittings
- 21-pin connector fitting
- Soot Sensor fitting

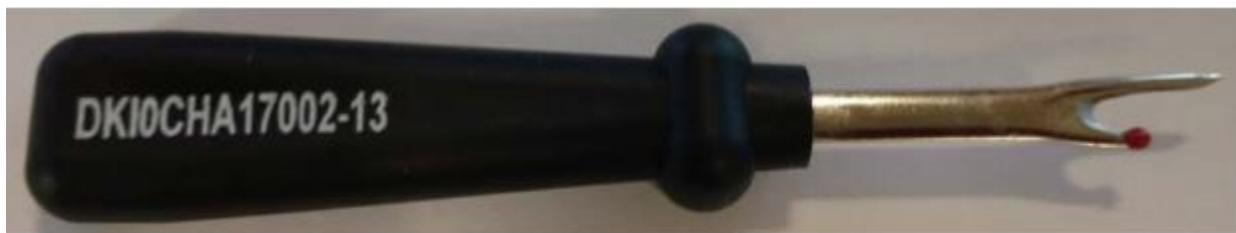
Figure 5 – Harness Fiber Tape Wrap Cutting Tool

7. Remove the convoluted tubing using scissors or tool DK10CHA17002-13 from the Chassis Terminal Extraction Tool Kit DK10CHA17002. Take care not to cut the wire harness. **DO NOT USE A RAZOR BLADE.** If using the Harness Fiber Tape Wrap Cutting Tool, use the sharp end to make an incision in the tubing, and then insert the blunt end to cut the tubing. Reference Figure 5.

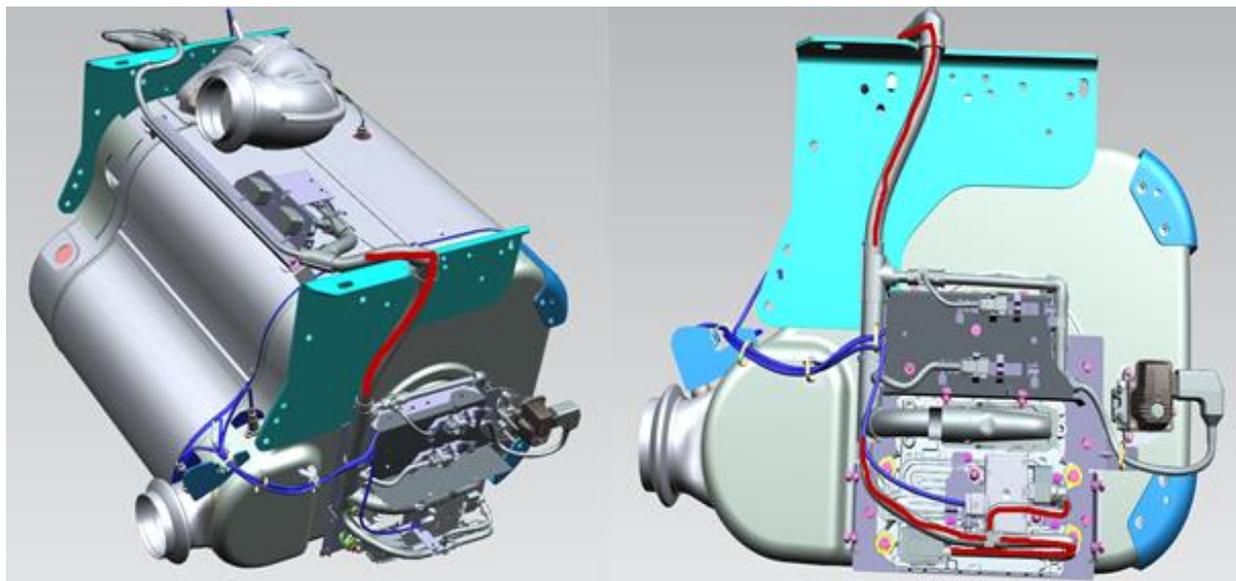
Figure 6 – Convoluted Tubing Removal

8. Carefully remove all convoluted tubing shown in red below. Reference Figure 6.

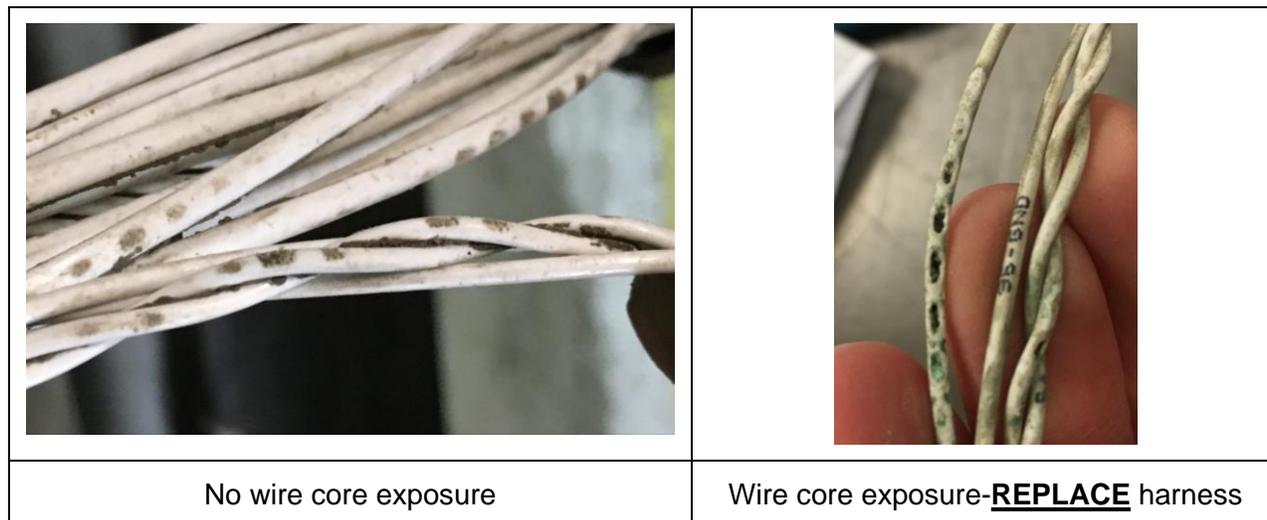
Figure 7 – Wire Harness Inspection

9. Inspect all exposed wires for damage or corrosion, looking carefully for wire insulation that has worn through, exposing the wire core. Is there exposed wire core? Reference Figure 7.
- Yes; replace the ATS harness. Reference the removal and installation sections for the 1-BOX™ Aftertreatment Harness in the *GHG17 Heavy Duty Workshop Manual* (DDC-SVC-MAN-0190). Instructions for adding anti-chaffing tape are further below. Go to step 11.
 - No; go to step 10.

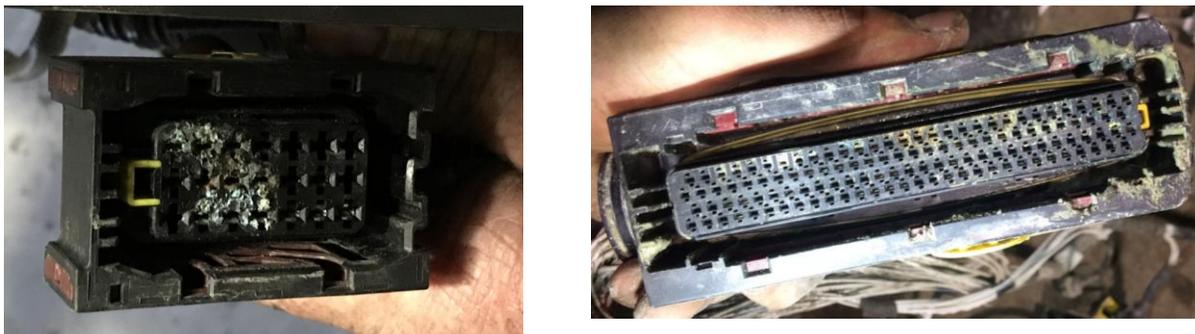
Figure 8 – ATS Harness 21-pin and 120-pin Connector Inspection

10. Inspect the ATS harness 21-pin and 120-pin connectors for excessive corrosion. Reference Figure 8. Is excessive corrosion present at one or both connectors?
- Yes; replace the ATS harness. Reference the removal and installation sections for the 1-BOX™ Aftertreatment Harness in the *GHG17 Heavy Duty Workshop Manual* (DDC-SVC-MAN-0190). Instructions for adding anti-chaffing tape are further below.
 - No; the harness will be reused.

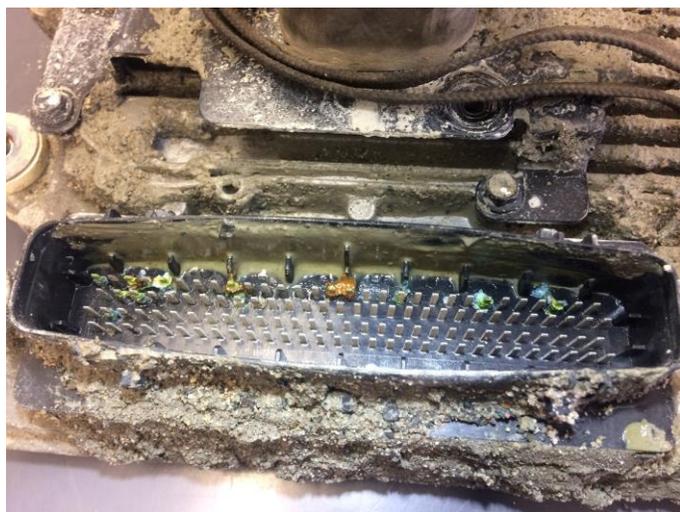
Figure 9 – ACM 21-pin and 120-pin Connector Inspection

11. Inspect the ACM 21-pin and 120-pin connectors for excessive corrosion. Reference Figure 9. Is excessive corrosion present at one or both connectors?
- Yes; replace the ACM. Reference the removal and installation sections for the 1-BOX™ Aftertreatment Control Module in the *GHG17 Heavy Duty Workshop Manual* (DDC-SVC-MAN-0190). Go to step 13.
 - No; go to step 12.

12. If light corrosion is present in the ACM 21-pin and 120-pin connectors, clean them with commercially available electrical contact cleaner and an insulative nylon brush such as Techni-Stat Insulative Brush P/N: 758PR499 (reference Figure 10) or Techni-Tool ESD Brush P/N: 758PR121. Gently blow out the connector with compressed air until dry.

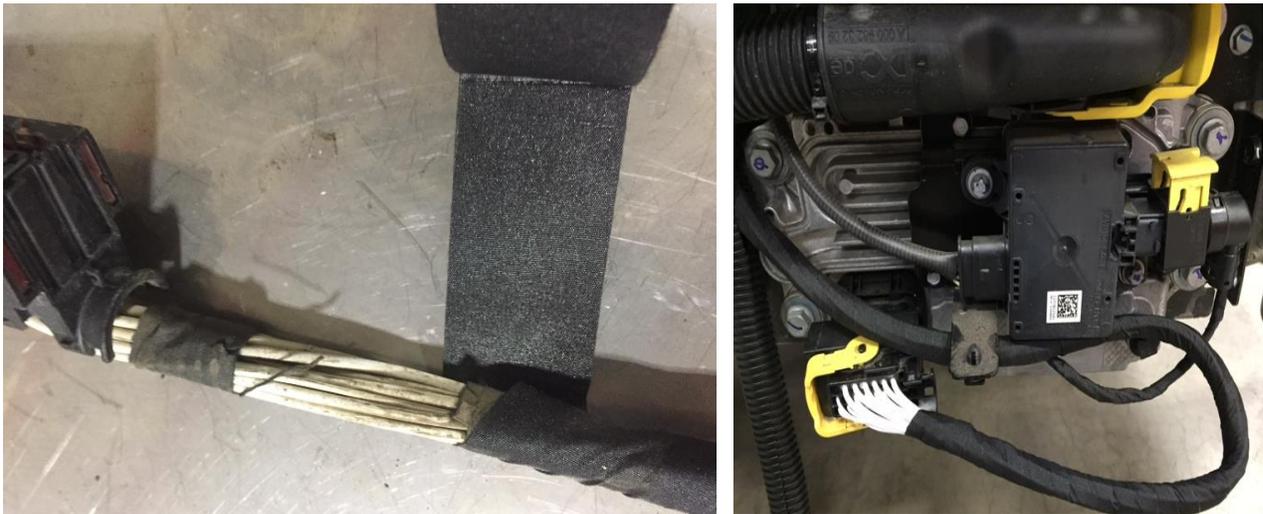
Figure 11 – Anti-Chaffing Tape Installation

13. If reusing the existing ATS harness or installing a new ATS harness P/N: A4721503620, install anti-chaffing tape around all exposed wires as shown in Figure 11. **Overlap the tape by 50%** and proceed to step 14. If installing a new ATS harness P/N: A4721504320, note that it already comes with anti-chaffing tape under the loom and proceed to step 15.

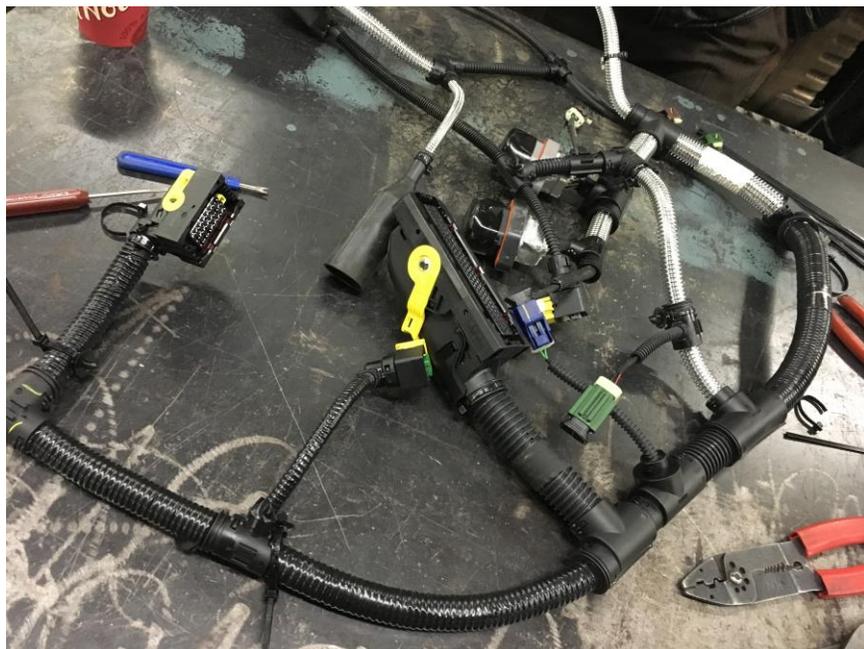
Figure 12 – Tape Installation

14. Reinstall the convoluted tubing and install existing elbows, tees and connector fittings. Fully apply electrical tape around the convoluted tubing. Reference Figure 12.

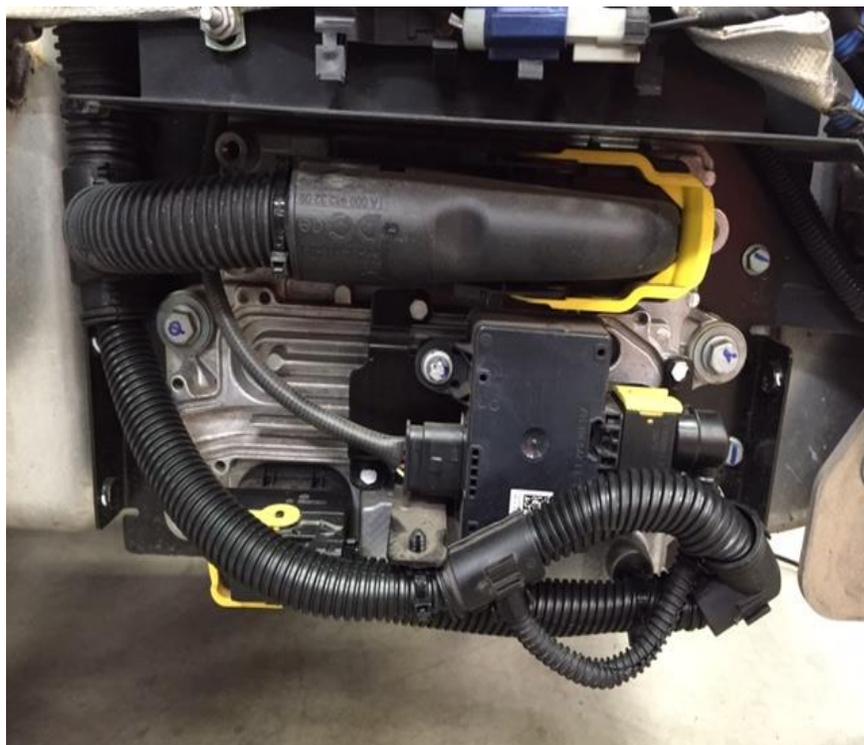
Figure 13 – Zip Tie Location

15. Connect the 120-pin and 21-pin electrical connectors and make sure the latches are fully closed. Connect the soot sensor electrical connector. Install new zip ties in the original locations, securing the harness to the ATS. Reference Figure 13.

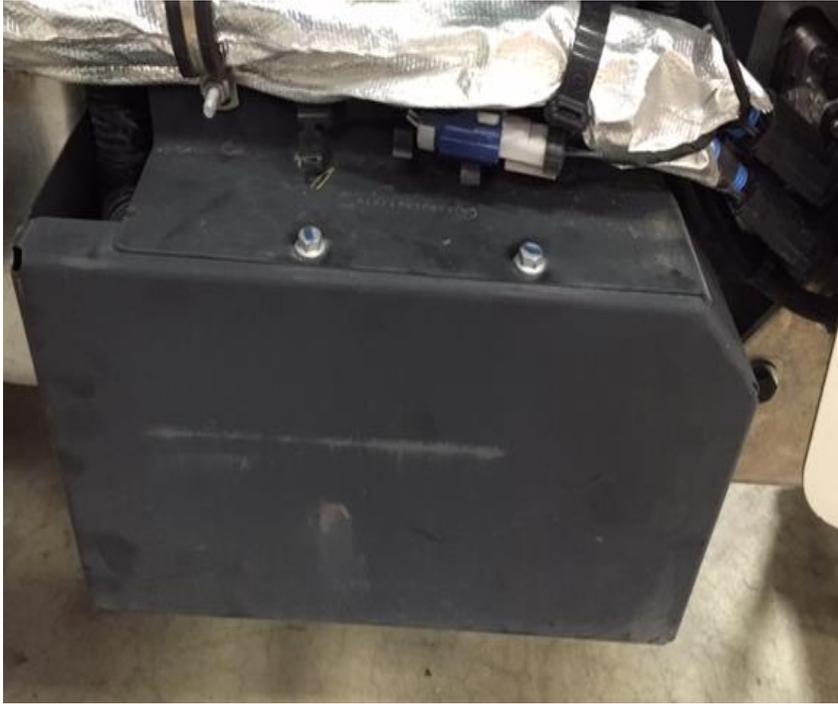
Figure 14 – ACM Cover Installation

16. Install the ACM protective cover and hand-tighten the bolts. Torque the bolts to 10 N·m (7.4 lb·ft). Reference Figure 14.
