1/15/2020  
CAL FTL 31-002

## **Subject: Fifth Wheel Air-Operated Kingpin Release Functionality Inspection**

**Models Affected: Specific 2020 model year Freightliner Cascadia and M2 vehicles manufactured in Santiago between January 16, 2019, and November 26, 2019 equipped with a dash controlled fifth wheel air operated king pin release valve.**

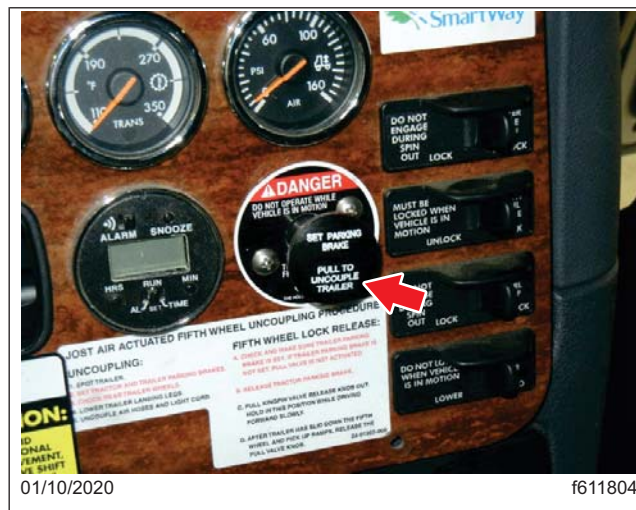
Fig. 1, Air-Actuated Kingpin Release Knob

1. Turn the ignition ON and insure the tractor parking brakes are set.
2. Pull the air-actuated kingpin release knob on the dash panel to open the jaws of the fifth wheel. See [Fig. 1](#).
