SERVICE ADVISORY # 20-367

Suburban Nautilus IW60RL Water Heater

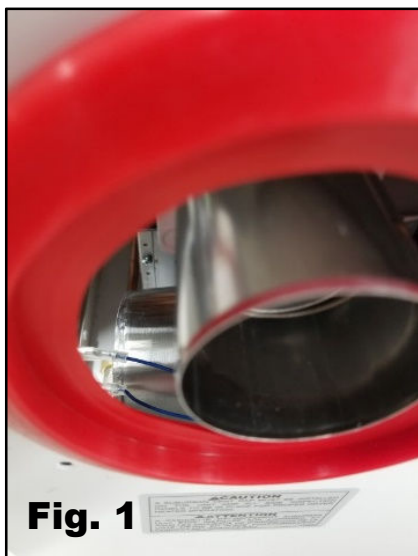
Fig. 1

The internal storage tank can be seen through the red exhaust gasket on the access panel. Use a flashlight to view whether the tank appears to be damaged. Refer to Figure 1. If no physical damage to the tank is

visible continue to Step 4. If the tank is physically damaged, submit pictures along with the model and serial number on a pre-authorization to replace the water heater using industry standards.

Make sure that the water heater is not bypassed on the convenience panel. Using the winterization port in the convenience center, purge the IW60RL system of water, turn on the unit's on-board water pump. Pump RV NON-TOXIC antifreeze through the unit while opening a hot water faucet or low-point drain until the system is full. When starting the purging process, watch for any antifreeze leakage around the internal storage tank. Refer to Figure 1. If the tank is leaking, replace the water heater using industry standards. Perform a drop pressure test on the propane gas system. Model and serial number are required for the claim to be processed when water heater is being replaced.

Once the water runs pink with the RV antifreeze, the system is correctly winterized. Turn off the unit's on-board water pump and proceed to warranty reimbursement instructions.
