Alignment of specific Roof Ladder Legs to backers in rear wall.

Bulletin Type:	Technical Service Bulletin TSB	Publication Date:	January 2020
Bulletin #:	20-001	Make:	Jayco Entegra
Job Code:	9803504	Models:	Greyhawk Prestige Esteem
Flat Rate:	.5 Hour	Model Year:	2020
Incident:	Specific legs of the roof ladder are located in the wrong position and do not match up to the backers in the rear wall.		
Affected Units:	2020 Entegra Esteem <u>L1BU8051-8076</u> 2020 Jayco Greyhawk Prestige <u>L1MU0137</u>		
Parts Kit:	Parts Kit #: 20-001JM		
	Parts Kit Contents: 4 Ladder legs with gasket attached 4-Caps for ladder legs 4-2 ¼" Bolts 16 – Screws, PH #8 x 1" Blk sq drv		
Misc. Tools & Supplies:	Drill with ¼" drill bit Philips screwdriver #2

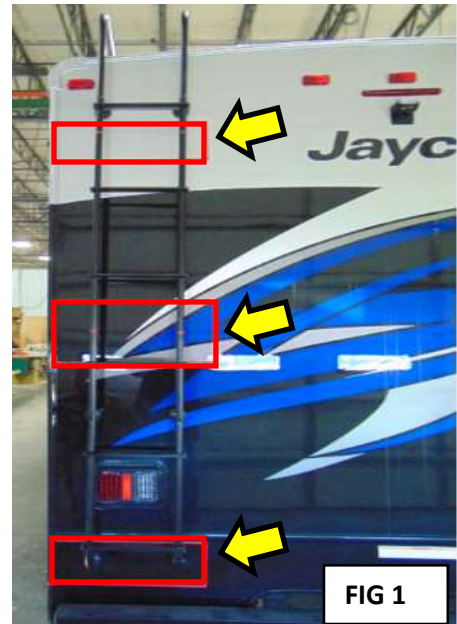
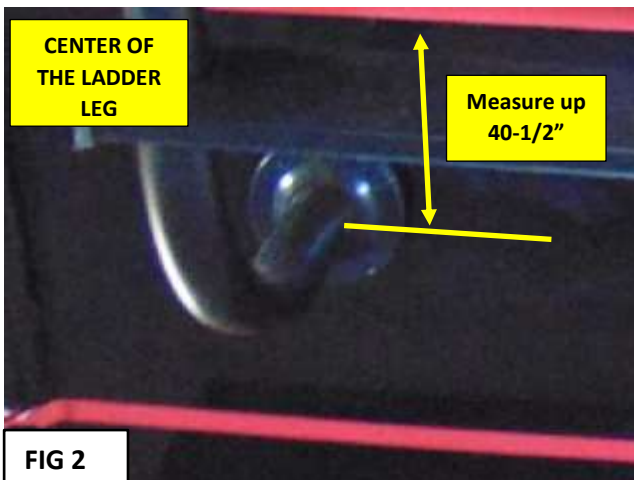
FIG 2 and 3:

- Measure up 40-1/2" from the center of both bottom legs of the ladder and mark both with tape.

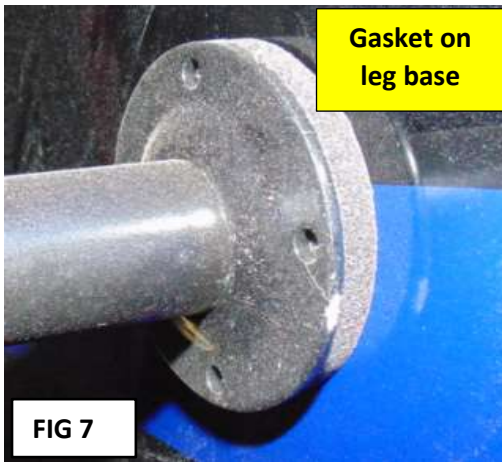
FIG 7:

- Each ladder leg base in kit has the required foam gasket.

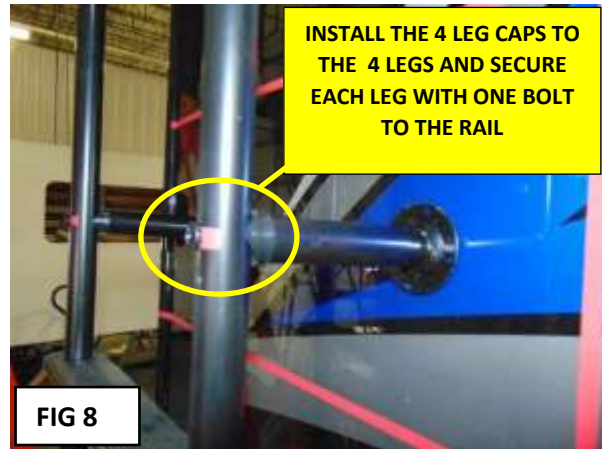
FIG 8:

- Insert the 4 leg caps onto each of the 4 legs from the kit.
- Attach the 4 legs (with caps) to the ladder rail.
- Install one 2-1/4" bolt through the ladder rail and into the cap & leg and tighten. (repeat for other legs)

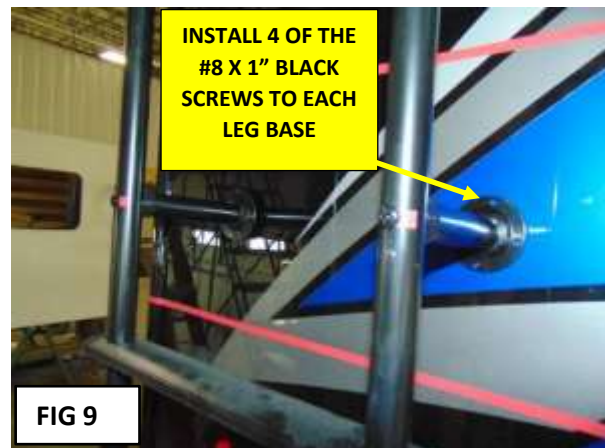
FIG 9:

- Install 4 #8 x 1" black screws in each of the 4 leg bases and into the rear wall and backer.

- 2 sets near the top of the ladder
- 2 sets in the middle portion of the ladder
- 1 set at the bottom of the ladder
- 1 set on the roof ladder.
