THIS IS A TECH TIP, NOT A TECHNICAL BULLETIN.

Applicable Vehicles					
Model(s)	Year	Eng. Code	Trans. Code	VIN Range From	VIN Range To
Atlas, Tiguan LWB	2018-2019	All	All	All	All

Rear lid may open a few inches and stop, not able to set basic settings; rear lid may lose basic settings.

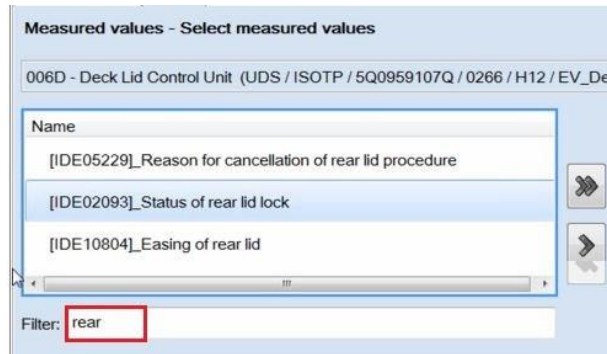
Figure 1

1. Search "Rear" (Fig.1) in MVB information under control module OBD function.
2. Select "Status of rear lid lock", move to the right column to view and expand the values monitoring "Safety catch".
3. Verify the value changes for actual position of the rear lid for open & closed positions.

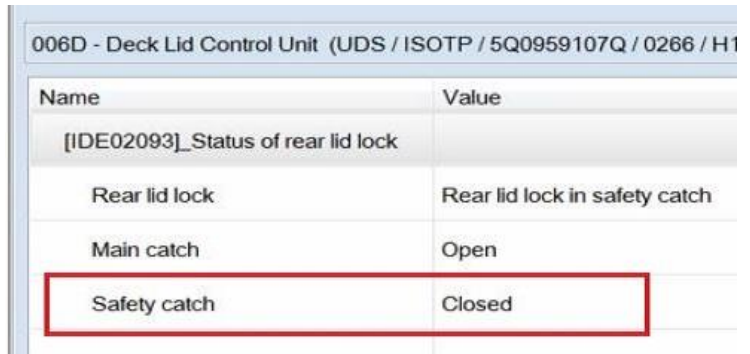
Figure 2

If it's found that the value for Safety catch remains unchanged (Fig.2) for rear lid operation, replacement of rear lid latch is required.
