<b>HYUNDAI</b> <b>Technical Service Bulletin</b>	<b>GROUP</b> <b>AUTOMATIC TRANSMISSION</b>	<b>NUMBER</b> <b>20-AT-005H</b>
	<b>DATE</b> <b>JANUARY, 2020</b>	<b>MODEL</b> <b>SONATA (LFA)</b> <b>SANTA FE (TMA)</b> <b>PALISADE (LX2)</b> <b>SONATA (DN8)</b>
<b>SUBJECT:</b> AUTOMATIC TRANSAXLE SOLENOID DTC P074100, P074300, P074800, P075300, P075800, P076300, P076800, P077300 & P270900

**This TSB supersedes TSB 19-AT-017H to add the Sonata DN8.**

**Description:** If you are servicing an applicable vehicle with a “Check Engine” light on and one or more of the DTC listed below, follow the repair procedure and replace the related solenoid and oil pressure harness.

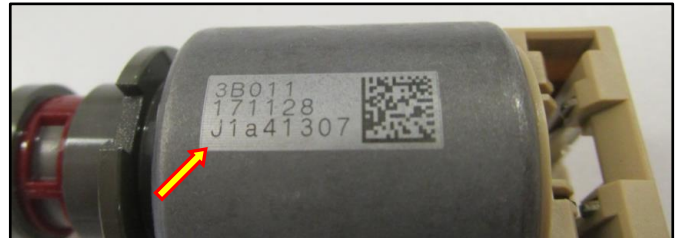
14. Record the 8-digit code on the solenoid.

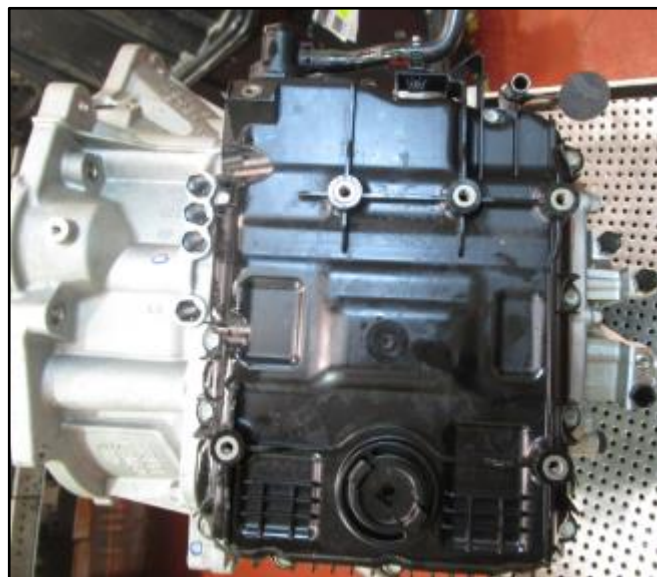
23. Install a new gasket to the oil pan and reinstall the pan.

Install 14 bolts to the pan and tighten the bolts to specification.

**Torque: 8~10 lb.ft (1.2~1.4 kgf.m/12~13 N.m)**
