## Technical product information

<b>Topic</b>	Door mirror mounting foot cracked
<b>Market area</b>	Russische Föderation (5RU),Australia E04 Bentley rest Asia and Australia (6E04),China 796 VW Import Comp. Ltd (Vico), Beijing (6796),Germany E02 Bentley rest Europe (6E02),Hong Kong 966 Volkswagen Group Hongkong/Macau (NSC) (6966),Japan E03 Bentley Japan (6E03),United Arab Emirates E06 Bentley Middle East and Africa (6E06),United Kingdom E01 Bentley UK (6E01),United States E05 Bentley USA and rest America (6E05)
<b>Brand</b>	Bentley
<b>Transaction No.</b>	2058194/1
<b>Level</b>	EH
<b>Status</b>	Approval
<b>Release date</b>

### New Continental GT/C

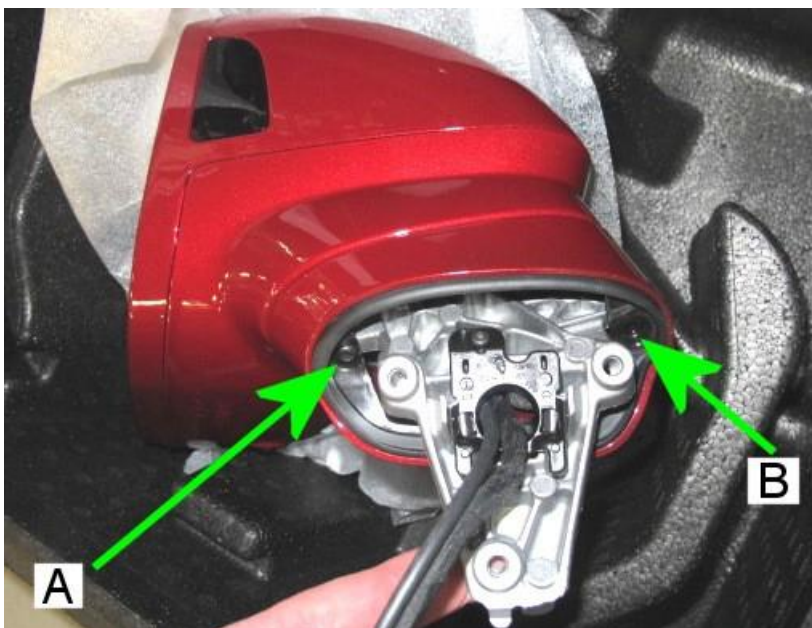
Door mirror mounting foot is cracked

- Referring to Figure 1 (showing the left hand mirror as an example) ONLY fit and secure the rear most fixing (A)
- **IMPORTANT:** Do Not Fit the front fixing at the location shown at (B)

In the event the door mirror mounting is cracked, the mounting must be replaced as per the current Repair manual instructions. Please Note: The repair manual instructions will be revised to include the information within the Measure section of this TPI, these instructions MUST be followed until the repair manual is revised.

1) When a left/right hand door mirror foot is fitted to the door mirror housing you must observe the onward instructions:
