# SERVICE BULLETIN

Classification: BT17-003c	Reference: NTB17-023c	Date: January 24, 2020
------------------------------	--------------------------	---------------------------

## 2017-2020 ARMADA; OUTSIDE MIRROR(S) LOOSE AT BASE

**APPLIED VEHICLES:** 2017-2020 Armada (Y62)

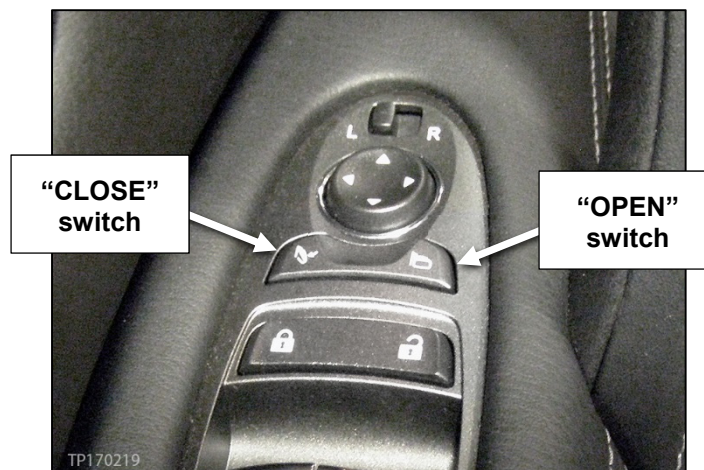
Figure 1

If the power foldable outside mirrors are manually folded/unfolded or bumped, the mirror body can become loose at the pivot point.

To readjust the mirrors, press the “CLOSE” switch (see Figure 1) until the mirrors are fully folded in, and then press the “OPEN” switch until the mirrors are fully open.

If this occurs, the mirrors should be adjusted again electrically before driving.

- DO NOT replace the power foldable outside mirrors for this condition, should it occur.
- This condition is not covered under the Nissan New Vehicle Limited Warranty.
